A Pipeline Inspection Case Study: Design Improvements on a New Generation UT In-line Inspection Crack Tool

This paper is a joint collaboration between AWP, represented by Mr. Michael Huss, and Weatherford P&SS.

Adria–Wien Pipeline (AWP) Pipeline

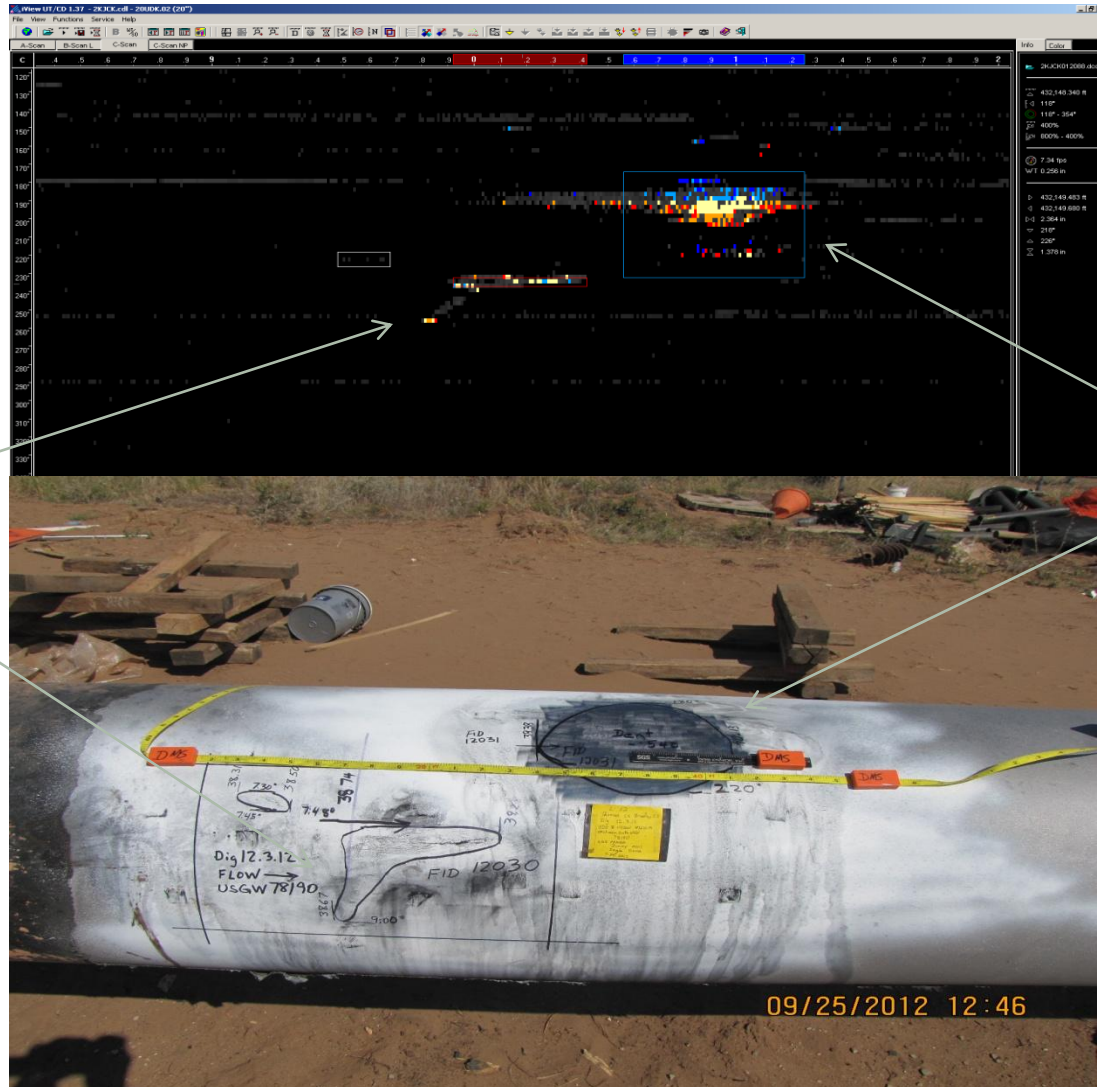
Crack-field

Dent

- Zoomed photo of the crack field

**ILI:
crack-field
Depth: 40-
80 mils**

**Field:
crack-field
Max Depth:
80 mils**

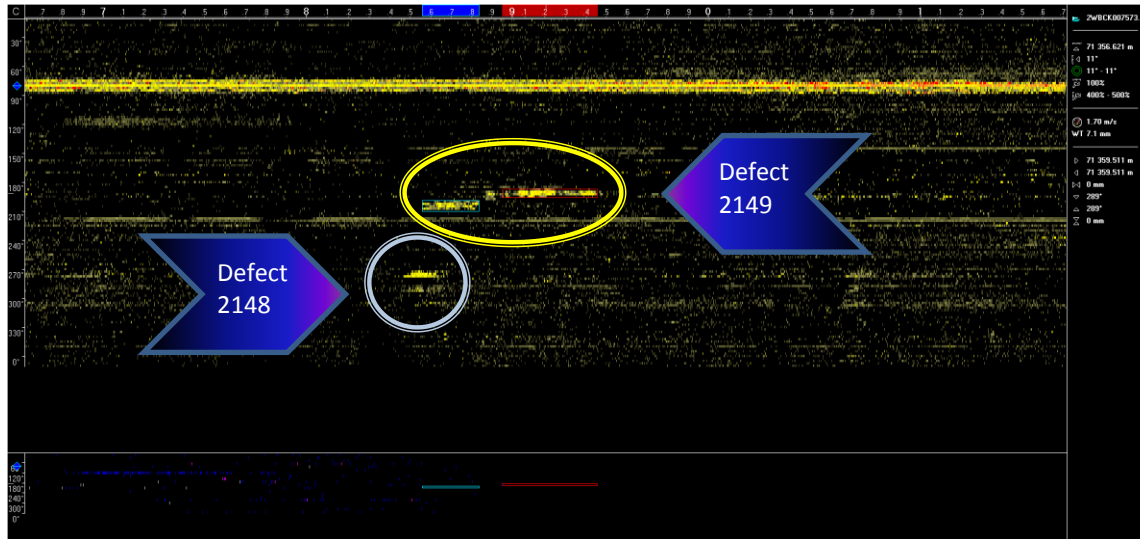
I-View™ Screenshot of Anomalies 2148 and 2149

18" PS06 – PS09, 121.5 km Defect no. 2148		
Defect Parameters	ILI Results	Dig verification results
Feature	Possible crack	Laminations and crack
Orientation	204°	210°
Length mm	281	300
Nominal wt in feature area	7.1	7.3
Maximum depth mm	1.0	1.1

18" PS06 – PS09, 121.5 km Defect no. 2149		
Defect Parameters	ILI Results	Dig verification results
Feature	Crack	Laminations and surface cracks
Orientation	191°	195°
Length mm	507	500
Nominal wt in feature area	7.1	7.3
Maximum depth mm	2.0	0.9

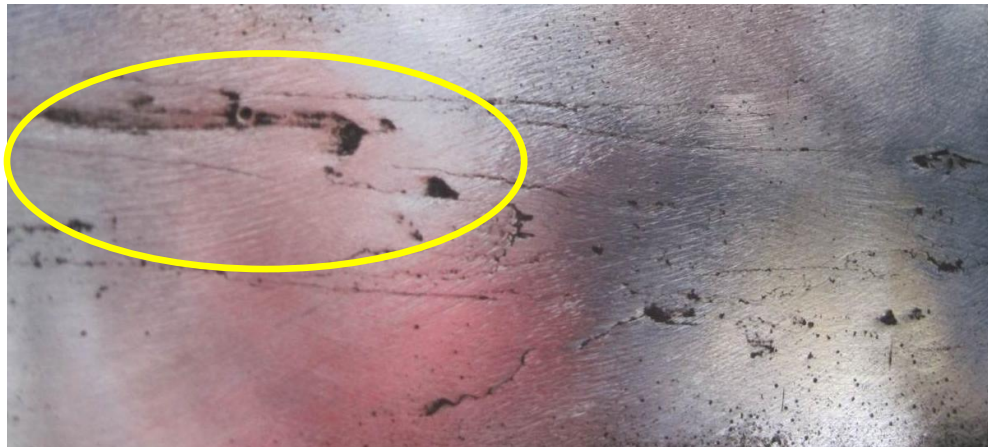
Photo of pipe joint - Anomalies 2148 and 2149

- These two tables highlight the predicted versus actual results from 2 anomalies identified on the same pipe joint.

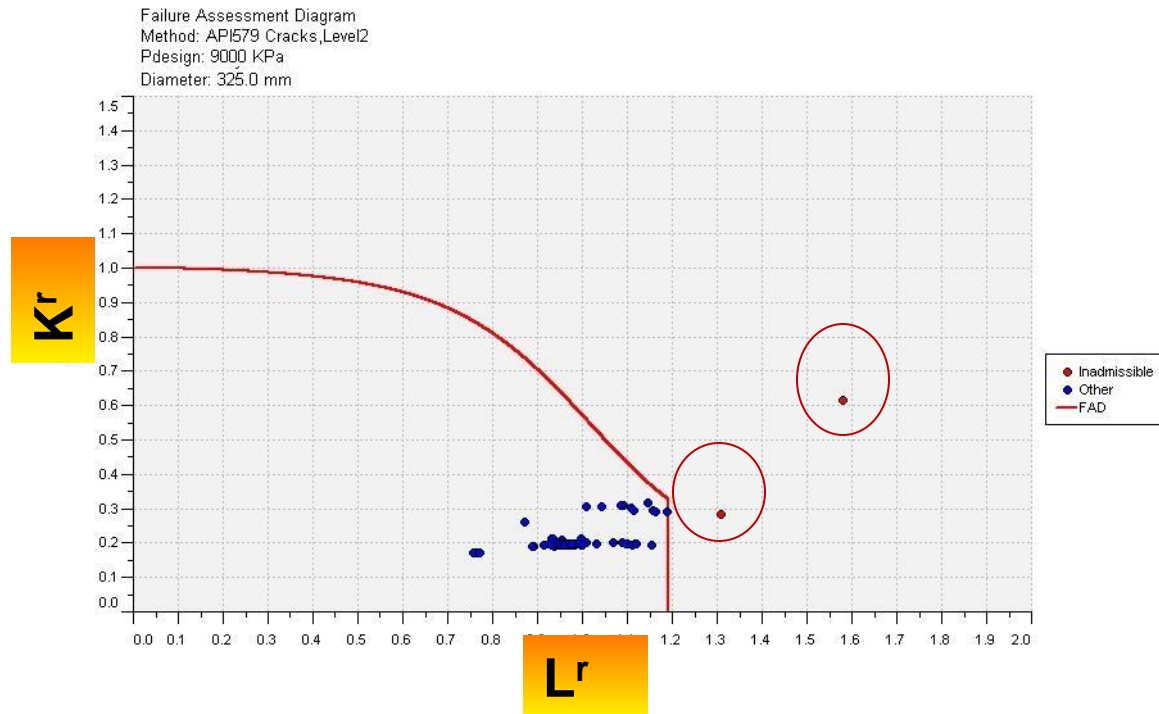
Example of FAD diagram, API 579 Level 2

- Crack assessment calculations
 - Performed in accordance with API 579 methodology (LEVEL 2)
 - Example of a Failure Assessment Diagram (FAD)
 - Defects in red outside the acceptable size for the pipeline section. The defects in red represent those that are > 1 for the Defect Acceptability Factor (DAF) described in API 579 or BS 7910.
