PIPELINE LIFE EXTENSION USING CUSTOM BUILT INSPECTION TOOLS

GUILLEMOT WEST (GW) FIELD

2 x 12" PL1652 / PL1653 PRODUCTION PIPELINE LOOP

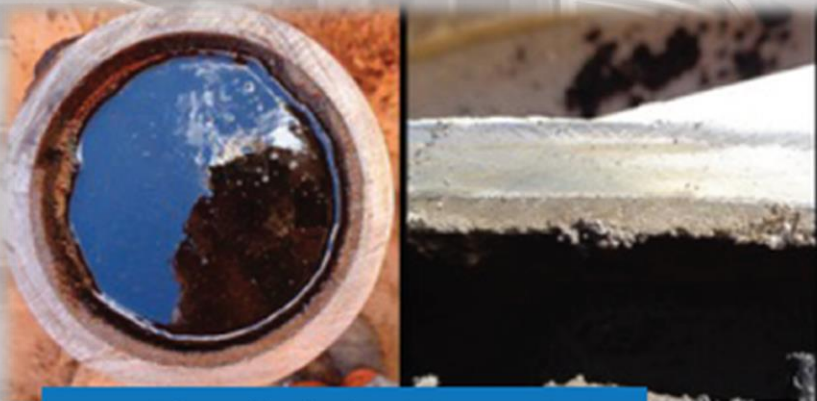
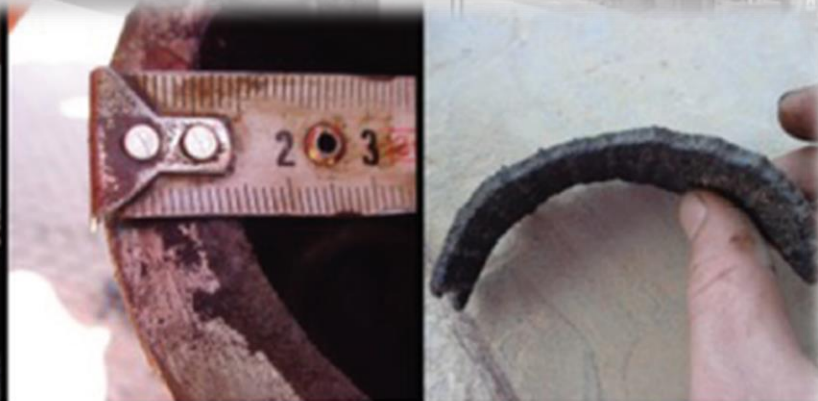
Volume of hard sediment remaining in a 6" crude line measured and mapped by GEO+

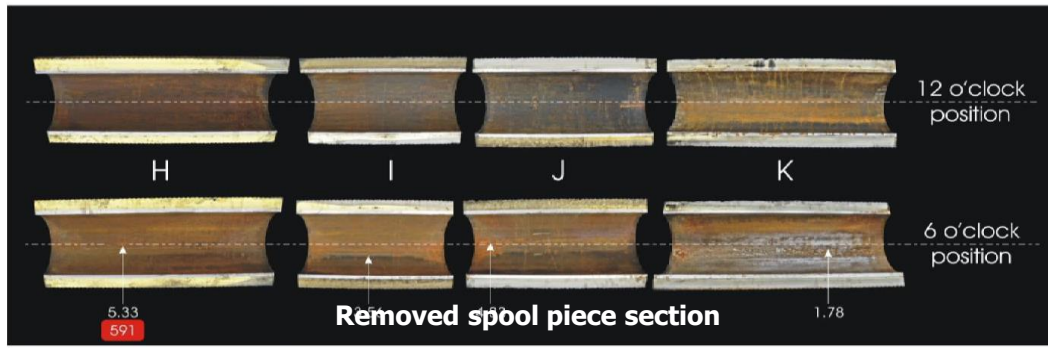
After detailed review of the ILI report in 2013 a rigid pipe section was replaced by a new 12" flexible piping. A part of the removed pipe section was deeply investigated. A spool where severe spots of corrosion were reported was examined using different measuring methods.

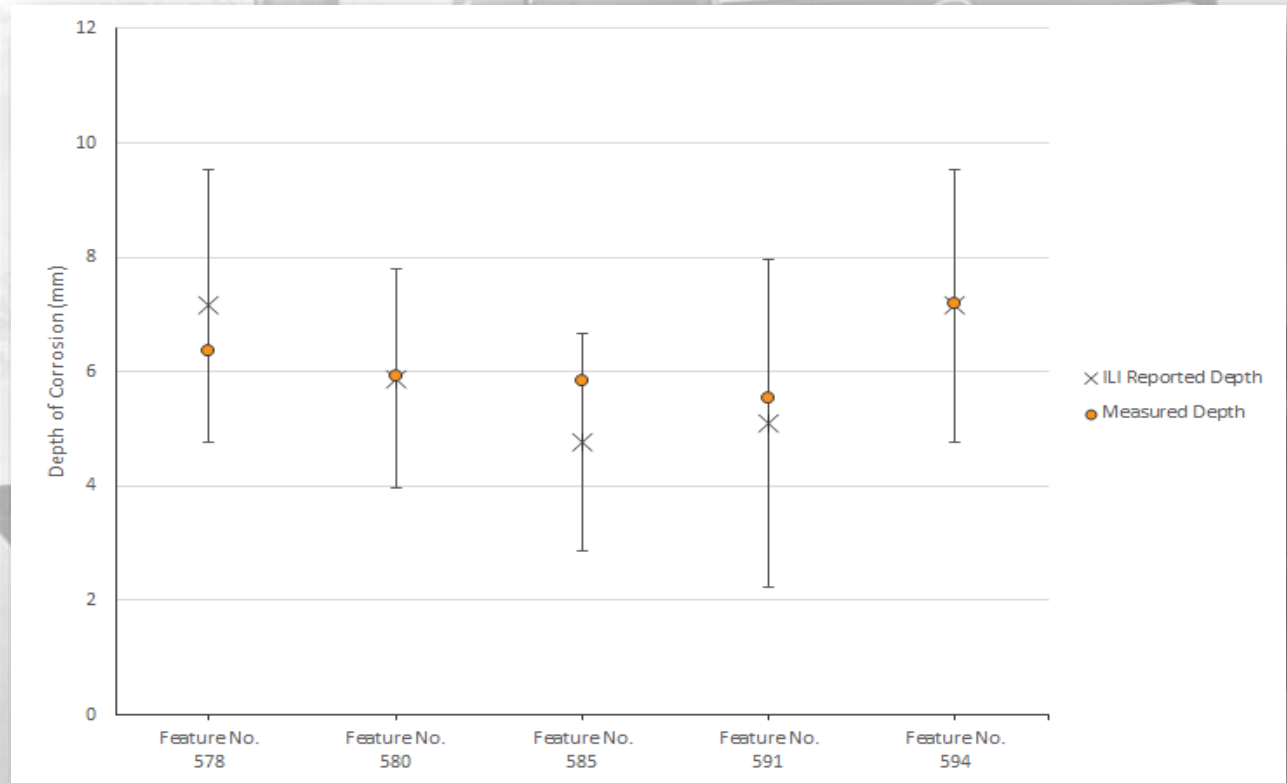
Comparison reported depth vs. measured depth
