# **CLEANING & ILI OF HEAVY WALL SUBSEA PIPELINE WITH IMPROVED DIFFERENTIATION BETWEEN DEBRIS AND CORROSION**

Presented by: Abeeruddin Syed  
3P Services, Germany

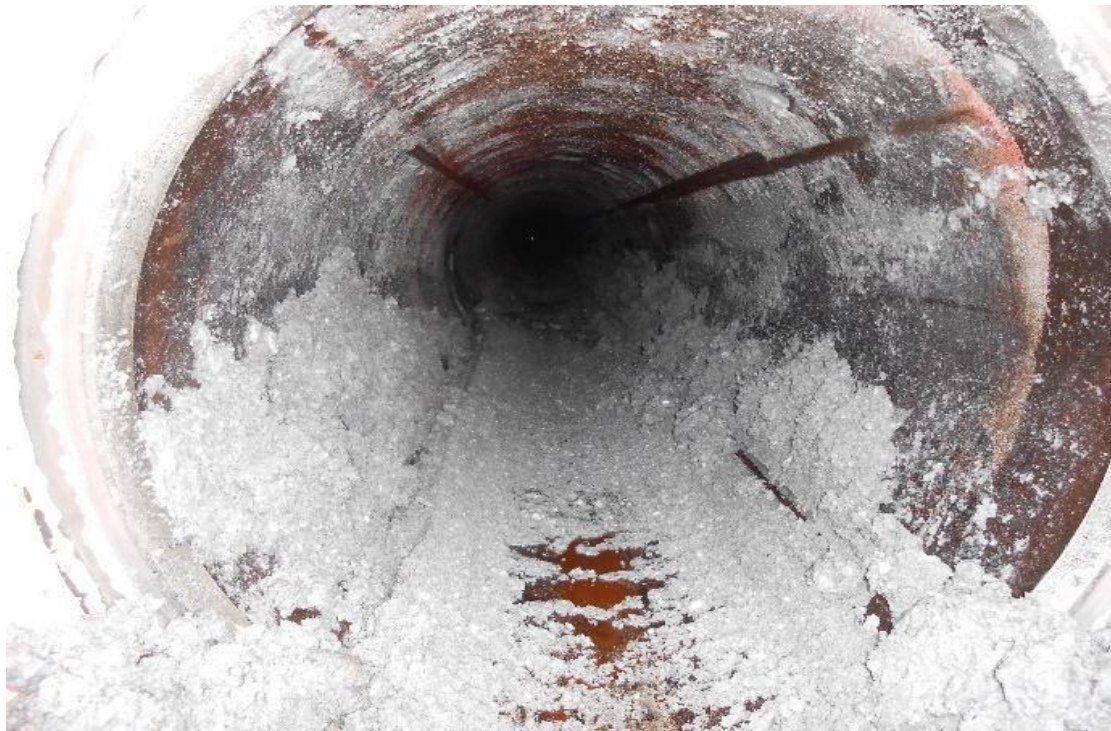
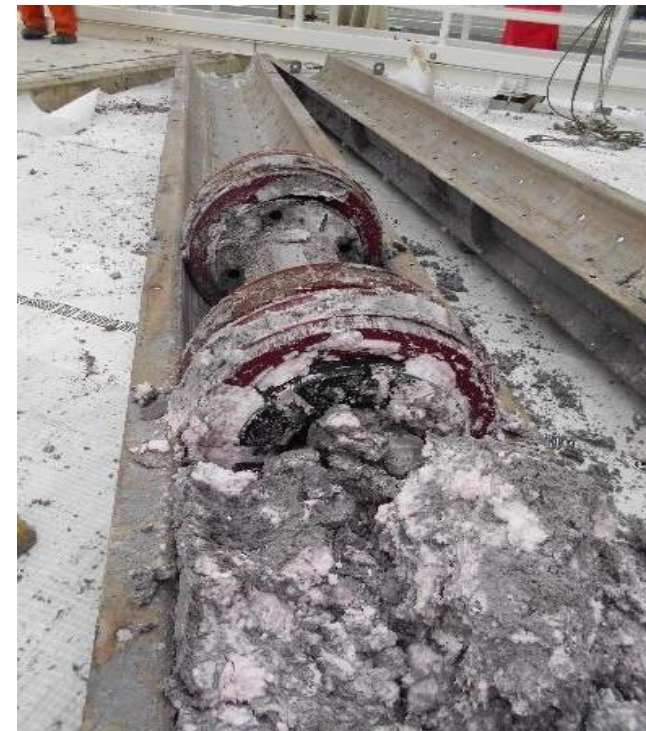
### 2. Pipeline cleanliness

- leading to vibrations, stand-off problems ultimately degrading data quality.

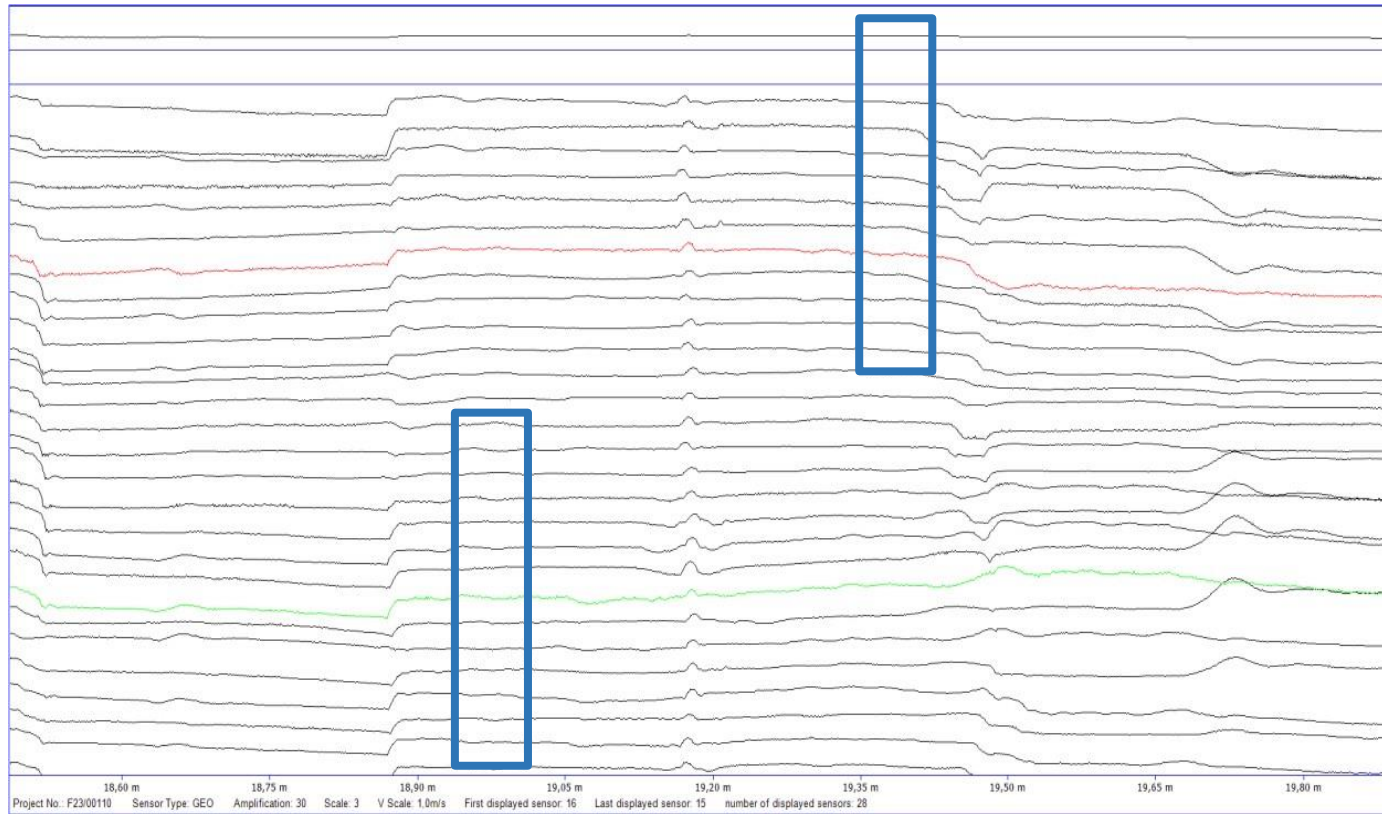
GEO data – blue rectangle shows anomaly location (red/green sensors = 12h/6h)

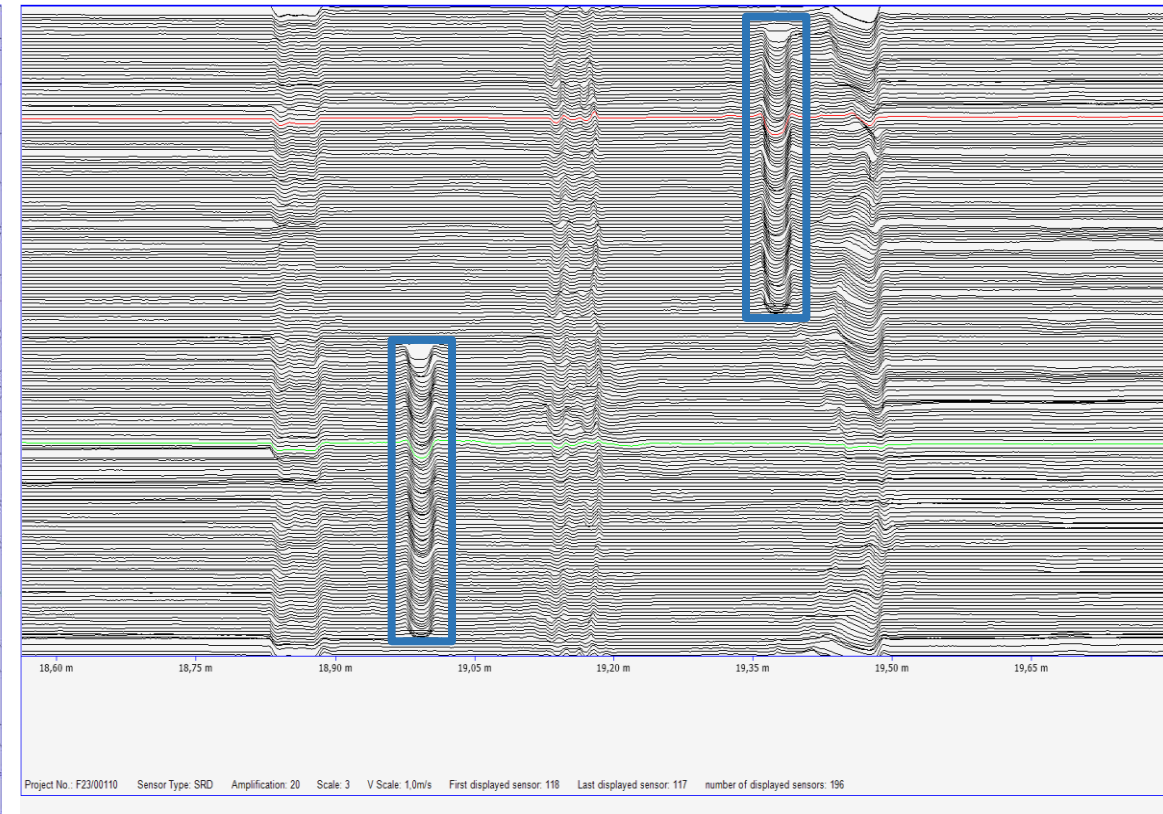
wall-guided magnetic sensors data – blue rectangle shows anomaly location (red/green sensors = 12h/6h)

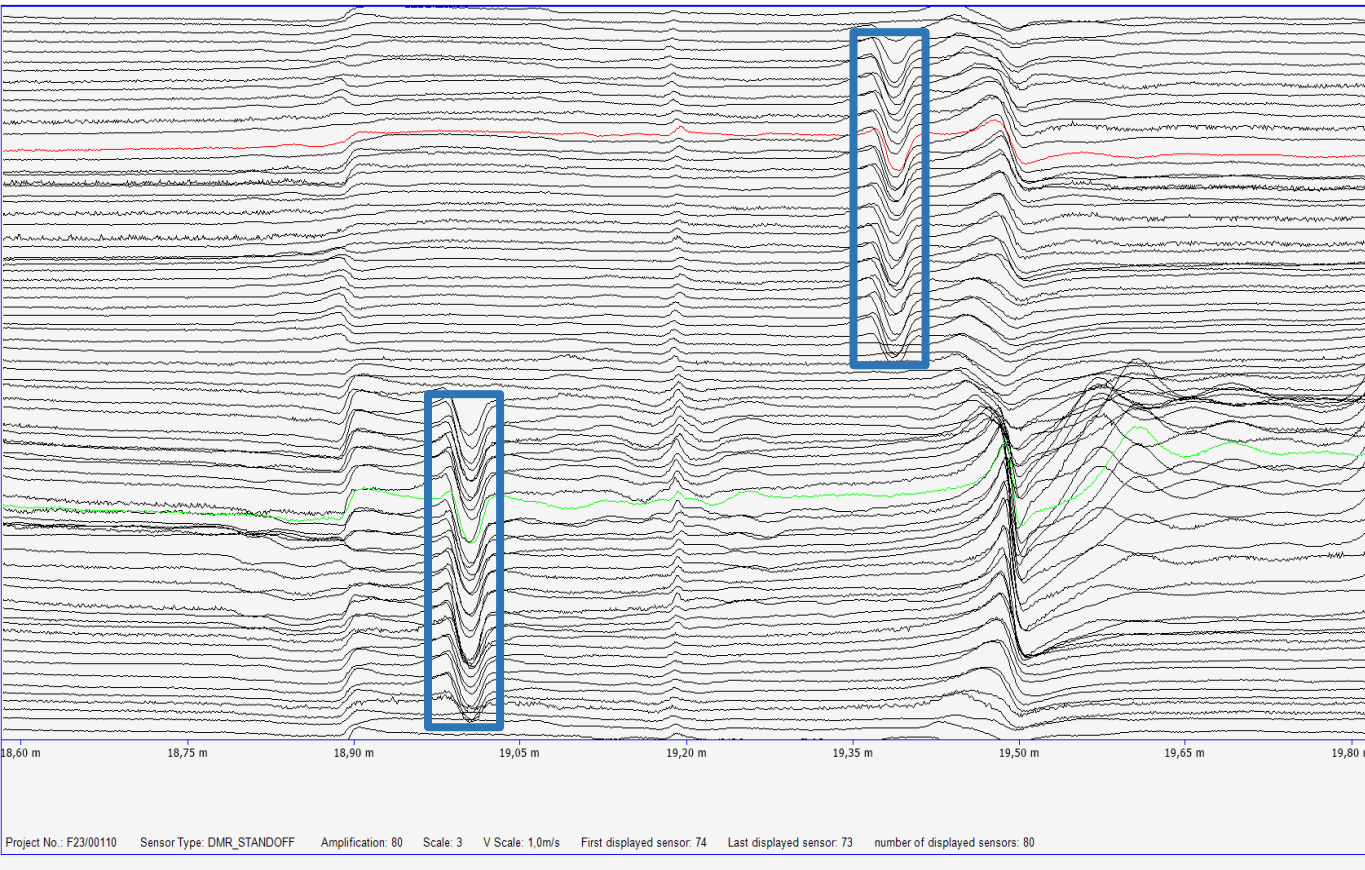
stand-off magnetic sensors data – blue rectangle shows anomaly location (red/green sensors = 12h/6h)

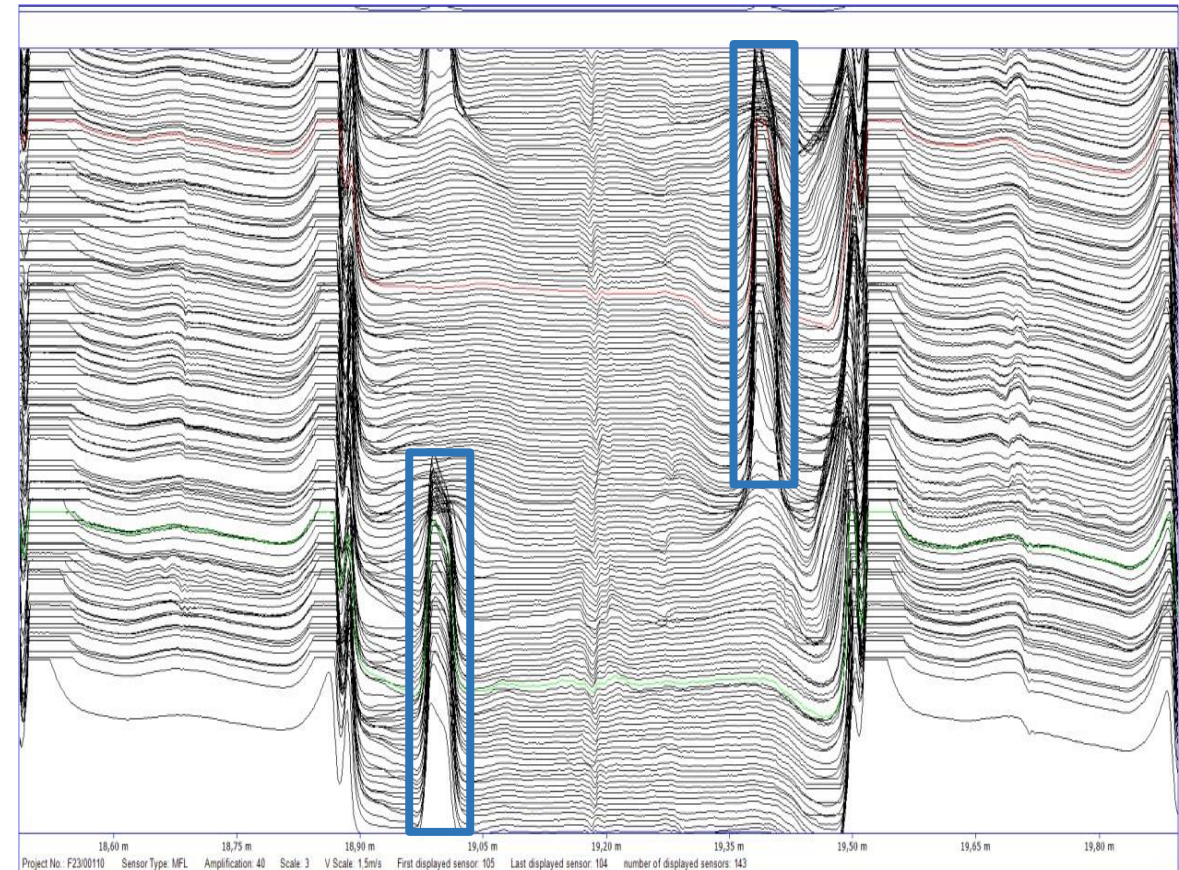
MFL sensors data – blue rectangle shows anomaly location (red/green sensors = 12h/6h)
