Evaluation of a High Resolution GEOPIG to detect and size Slab Erosion

Stephen Westwood

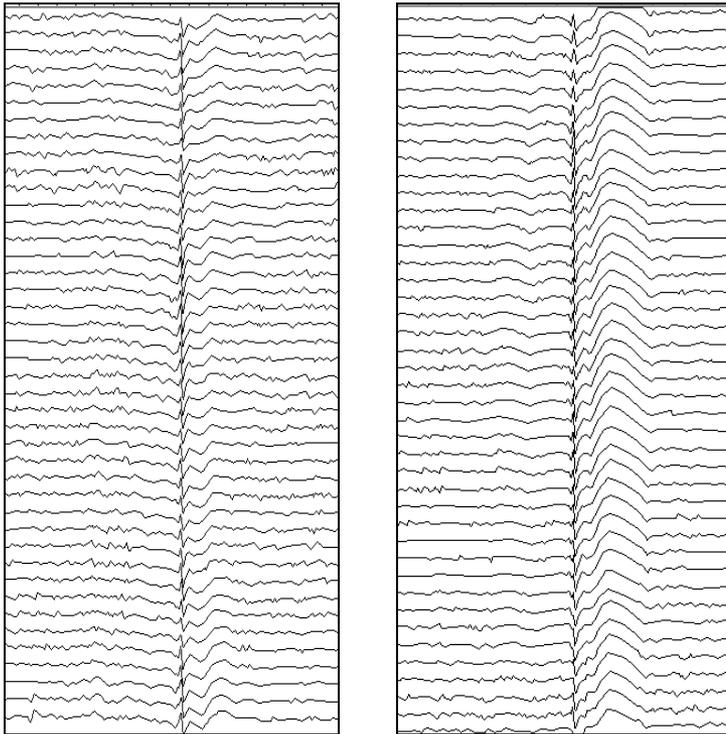
Weld signals at start and end of the pipeline

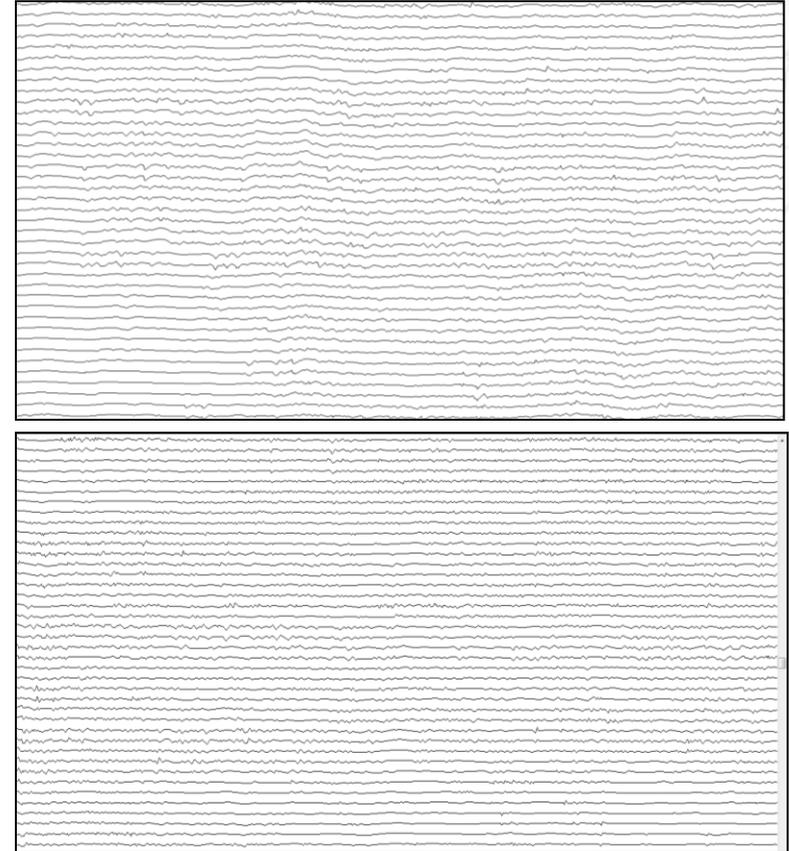
Seamless pipe signals clearly visible

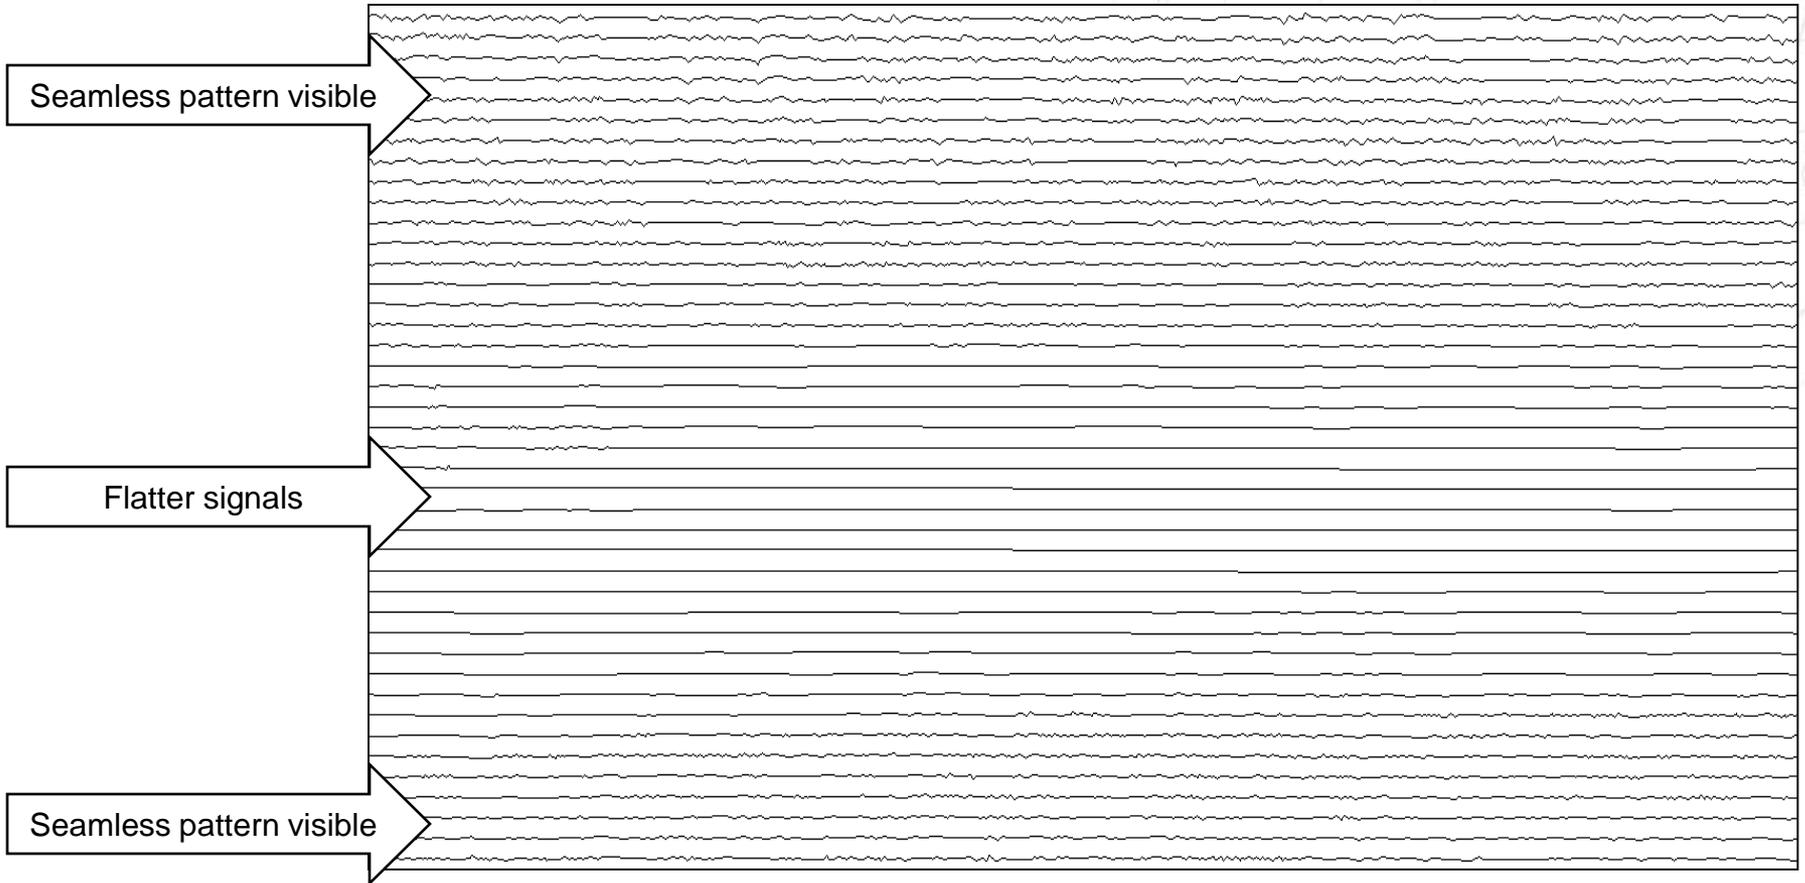
- Seamless pattern is visible throughout the data; however the signals reduce in size from approximately 150m into the inspection
- Seamless pattern is always discernible at the “sides” of the pipeline – centred around the 3 o’clock and 9 o’clock orientations
- Towards the 6 o’clock and 12 o’clock orientations of the pipeline the signals within many pipe spools appear to be fairly flat, which would indicate that the pipe is much smoother as virtually nothing is being recorded by the sensors
- The extent of the “flatter” signals varies around the pipe circumference and throughout the inspection data

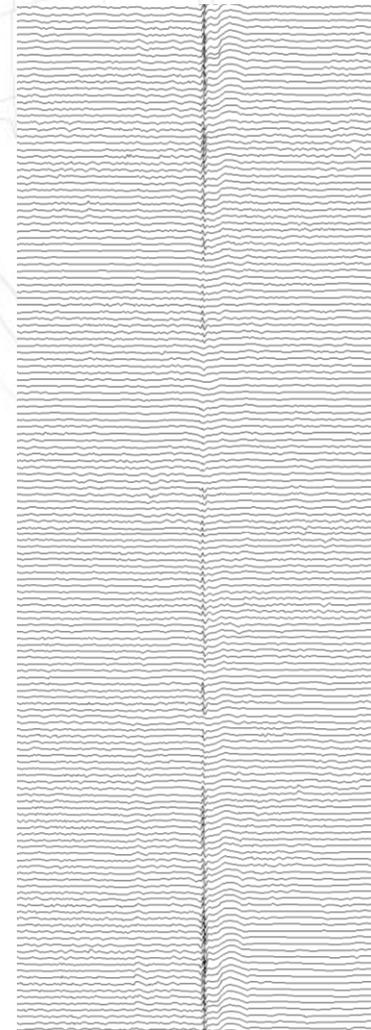
Smaller signal recorded for many of the girth welds and on some welds the signals virtually disappear completely at various orientations

Weld signal between 5:15 and 6:45 barely visible

Weld signal at 12:00 “normal” signal

Seamless pattern clearly visible on the data
