EXPERIENCES WITH ULTRASOUND IN WAX RICH PIPELINES

By: Roger Hunsbedt, Thomas Jung, Mikael Georgson, Alf Tordal, Kristine R. Martinsen
Statoil ASA

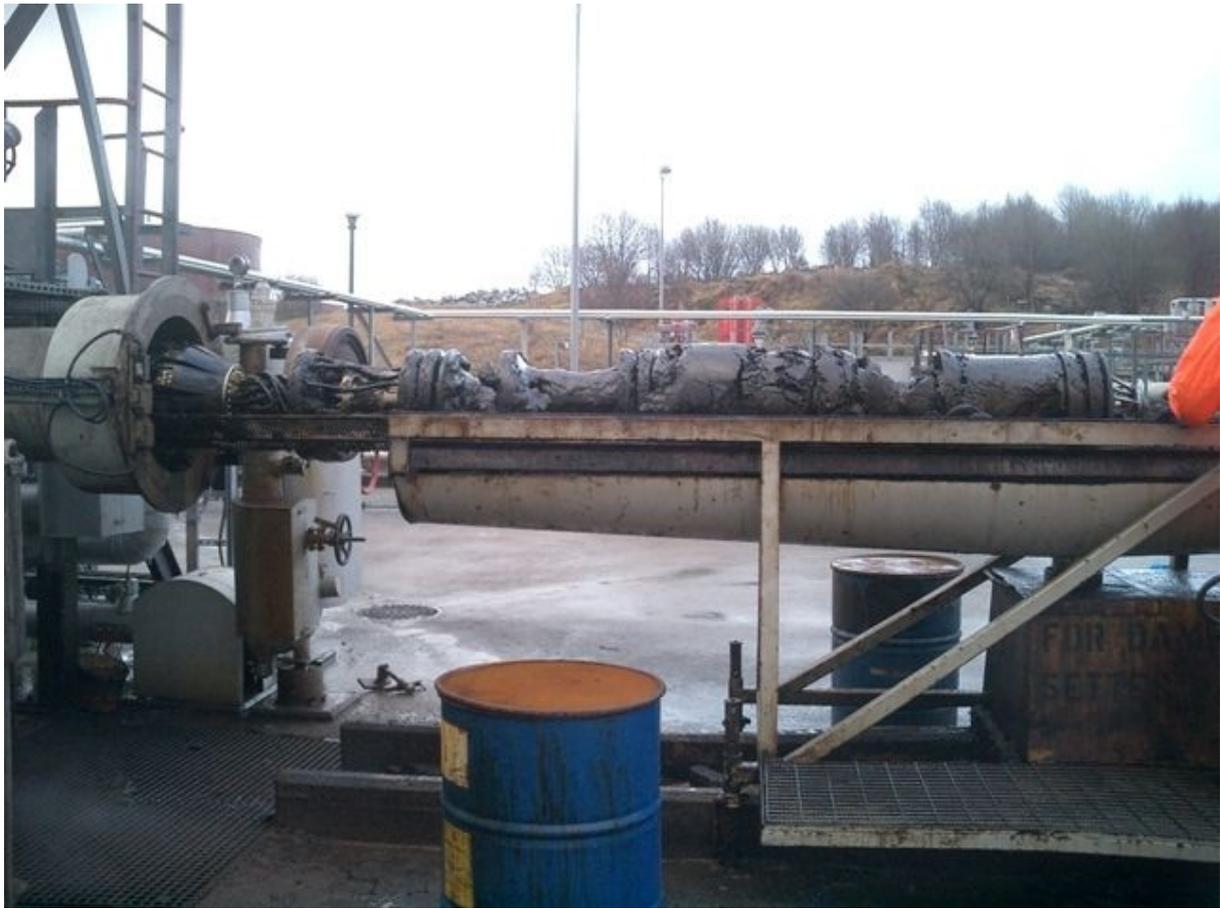
In 2006 Statoil experienced an unsuccessful inspection of the TOR1. When removing the inspection tool from the pig receiver, it was seen that the tool was covered by wax.

After analysing the inspection data, it became clear the odometer wheel had slipped, and after 18 km the odometer wheels started to slide. When the Odometer wheels are turning the inspection tool is collecting data as normal, but in this case the odometer wheels stopped turning and therefore also the data collection stopped.

The wax had also settled on the ultrasonic sensors, resulting in the ultrasonic pulses not being able to enter the pipe wall, hence no echo.

Receipt of not clean 16" Ultrasound- based ILI after un-successful inspection of TOR1 pipeline at Mongstad 2006

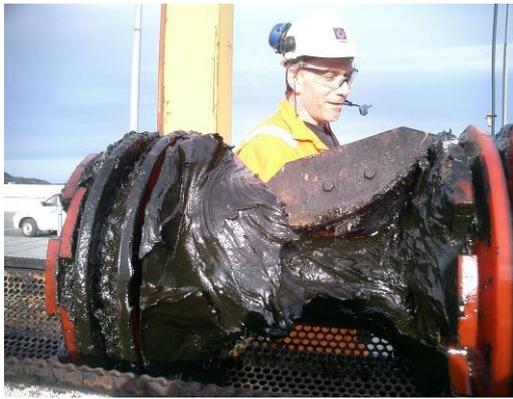
However, the appearance of wax varied significantly from very soft, the photo to the left below, and slimy to rather hard and pebble- like, the photo to the right below.

Soft wax on cleaning pig

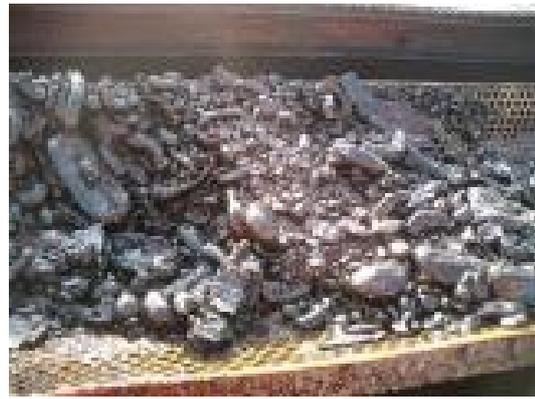
“Pebble- like” wax after cleaning run

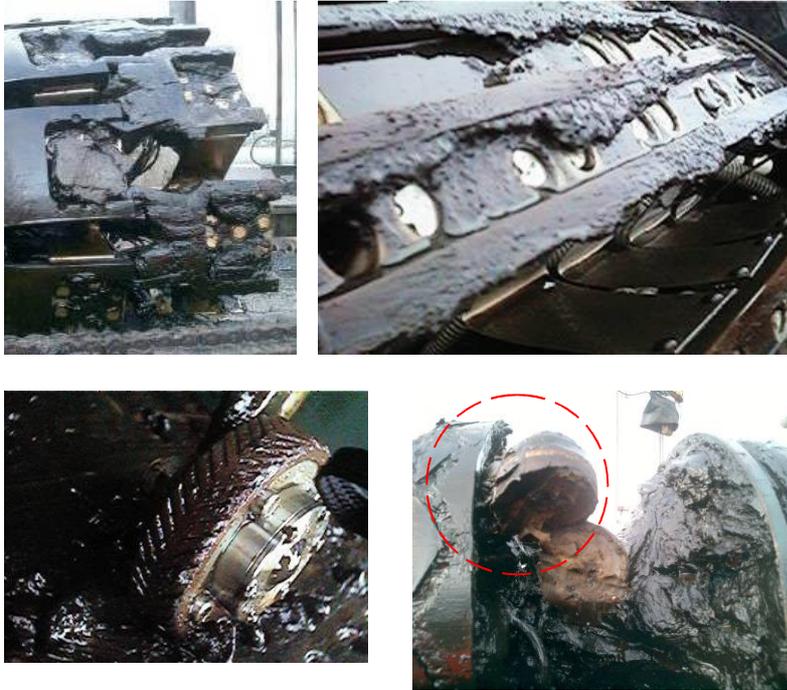
- Poor self cleaning ability of sensor carrier resulting in poor ultrasound signals and subsequent data loss of up to 80%, see group of photographs below top.
- Tendency of odometer wheels clogging in wax, resulting in interrupted signal triggering UT sensors, see group of photographs below bottom.
- Data recording dependency on proper odometer performance.

Example of wax covered sensor carriers on top and odometer wheel on bottom.

Modified odometer wheels with an increased diameter and optimised shape were designed. Further higher spring forces on the odometer arms were included in the new approach allowing for better traction of the wheel on the pipe wall. Additionally the odometer positioning on the tool train was changed from mid tool to the rear end of sensor carrier. This way wax accumulated between tool bodies would no longer lead to clogged wheels due to fill up of limited volume between tool units. Instead the chosen new position would allow for free “tail flow” of potential wax lumps. The inspection tool was also set up to trigger the measurements by time and not distance. Hence the UT inspection tool will be independent of the odometer wheel movement.

On the sensor carrier the results gained from modelling and subsequent wind canal tests, the liquid flow over the sensors could be increased. Also the area of the flow inlets to the sensor bars was increased. Both measures were intended to improve the carriers’ self cleaning ability particularly in handling heavier wax.

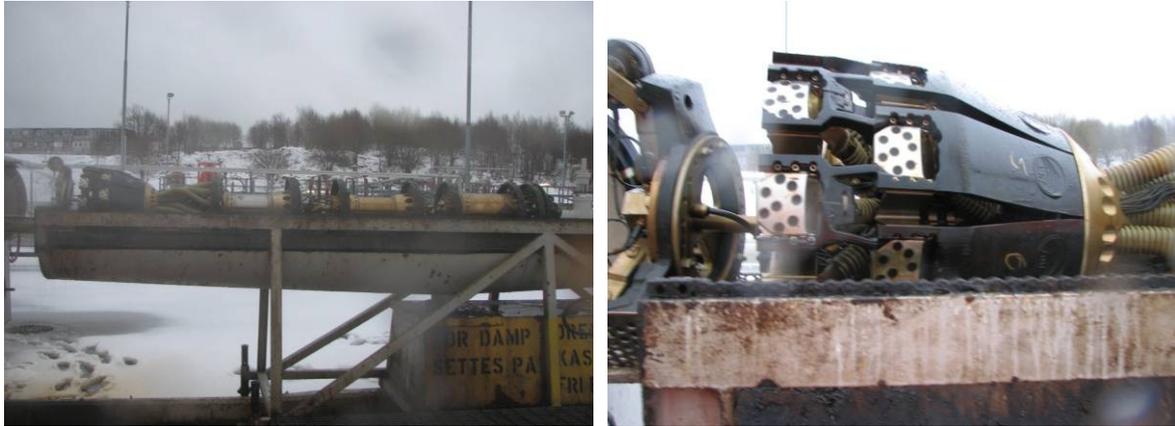
The evaluation of inspection data showed echo loss rates below 1 %. The inspection data covered the entire pipeline length and circumference. The quality of the inspection data were considered good. Photos after inspection tool run are shown below.

Receipt of clean 16" Ultrasound- based ILI after successful inspection of TOR1 pipeline at Mongstad
