A PIPELINE INSPECTION CASE STUDY: DESIGN IMPROVEMENTS ON A NEW GENERATION UT IN-LINE INSPECTION CRACK TOOL

By: Mark Slaughter, Weatherford International, P&SS, USA
Ing. Michael Huss, Adria – Wien Pipeline GmbH (AWP), Austria
Yuriy Zakharov, Weatherford International, P&SS, Russia
Andrey Vassiljev, Weatherford International, P&SS, Russia

This paper focuses on reviewing the latest design improvements for the new generation tools and presents a case study on a recent survey conducted on the Adria-Wien Pipeline (AWP). The pipeline sections inspected were the 30" x 4 kilometer and 18" x 420 kilometer pipeline. This paper is a joint collaboration between AWP (represented by Michael Huss) and Weatherford Pipeline & Specialty Services.

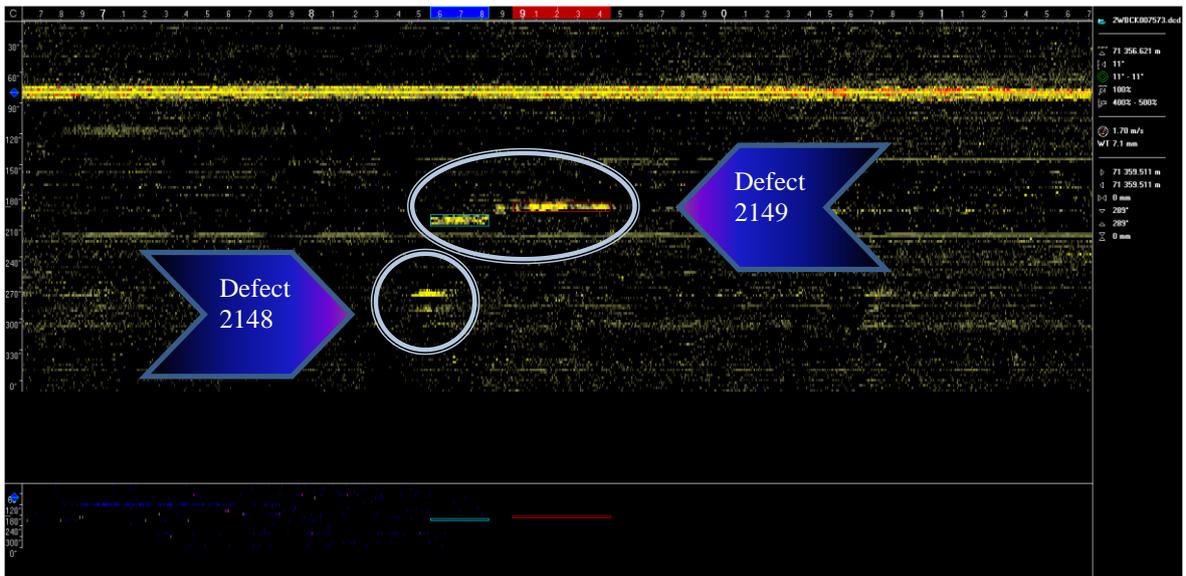
Figure 9 – i-View™ Screenshot of Anomalies 2148 and 2149

18" PS06 – PS09, 121.5 km Defect no. 2148			18" PS06 – PS09, 121.5 km Defect no. 2149		
Defect Parameters	ILI Results	Dig verification results	Defect Parameters	ILI Results	Dig verification results
Feature	Possible crack	Laminations and crack	Feature	Crack	Laminaations and surface cracks
Orientation	204°	210°	Orientation	191°	195°
Length mm	281	300	Length mm	507	500
Width mm	44	55	Width mm	36	75
Nominal wt in feature area	7.1	7.3	Nominal wt in feature area	7.1	7.3
Maximum depth mm	1.0	1.1	Maximum depth mm	2.0	0.9

Table 4 – Actual Versus Predicted - Anomaly 2148

Table 5 – Actual Versus Predicted - Anomaly 2149

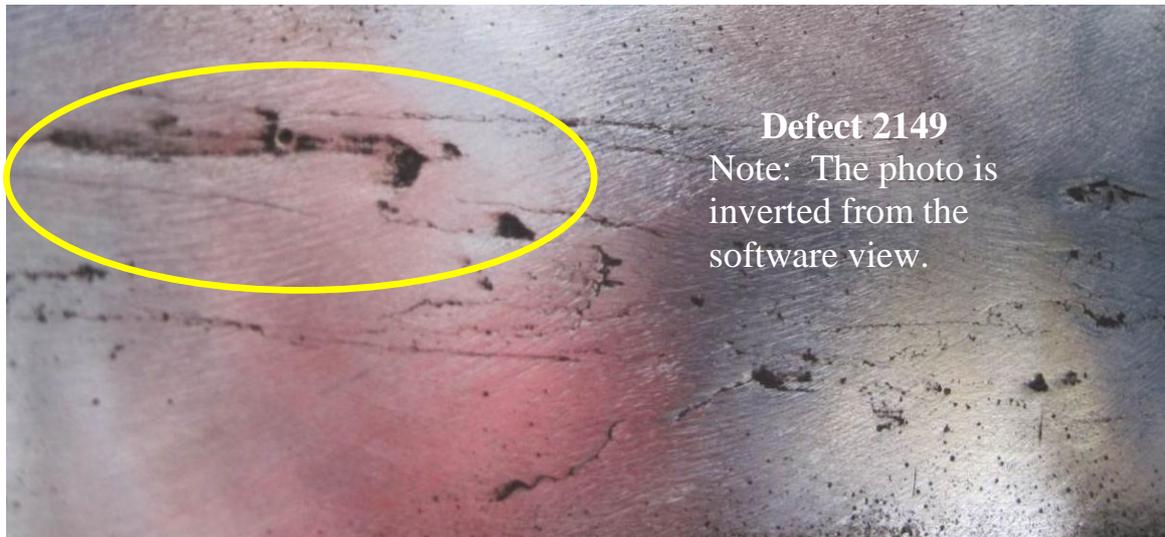
Figure 10 – Photo of pipe joint - Anomalies 2148 and 2149

ILI Predicted				Verification		
ILI	Def. #	Description	Depth mm	Description	Depth mm	Estimate of the convergence
18" PS01 – PS06, 169 km	31	external crack	2	internal crack	1.9	Possible inclined crack
18" PS06 – PS09, 121.5 km	2149	external crack	2	laminations and external surface crack	0.9	Possible the signal amplitude on data is increased due to a combination of crack + lamination.
18" PS06 – PS09, 121.5 km	2148	possible external crack	1	laminations and external crack	1.1	Satisfactory
18" PS09 – US02, 123 km	2348	poss. long weld anomaly	2	weld anomaly, linear slag inclusions	1.6	Satisfactory

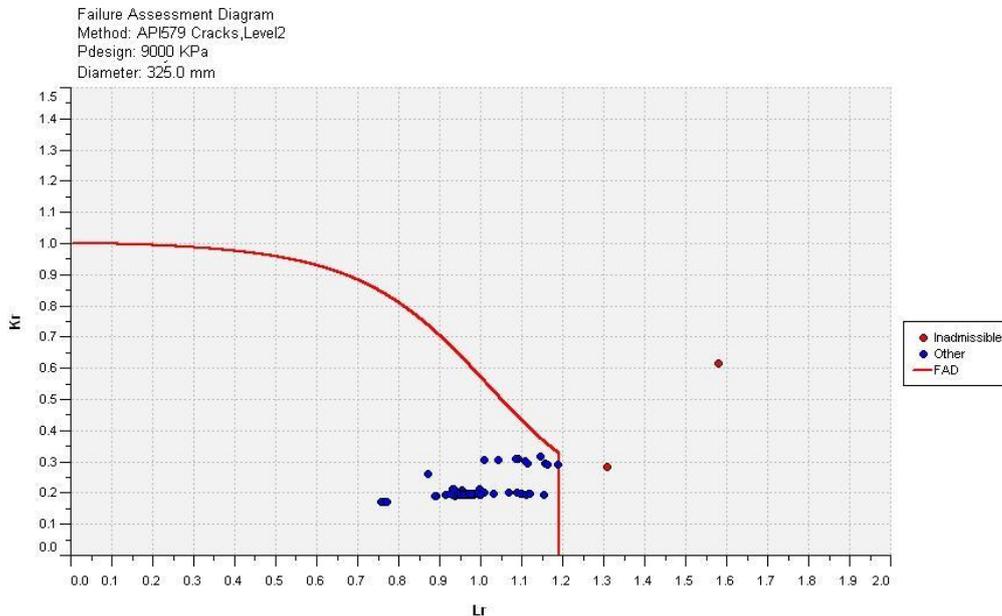
Figure 11 – Example of FAD diagram, API 579 Level 2

To assess the cracks, calculations were performed in accordance with API 579 methodology (LEVEL 2)⁶. Below is an example of a Failure Assessment Diagram (FAD) highlighting defects in red that fall outside the acceptable size for the pipeline section. The defects in red represent those that are > 1 for the defect acceptability factor (DAF) described in API 579.
