SHELL FLAGS INSPECTION CASE STUDY

J. Nonemaker, Solution Engineer, ROSEN
T. Steinvooorte, Business Development, ROSEN
R. Subramanian, Pipelines & Subsea Technical Support Engineer, Shell U.K. Limited

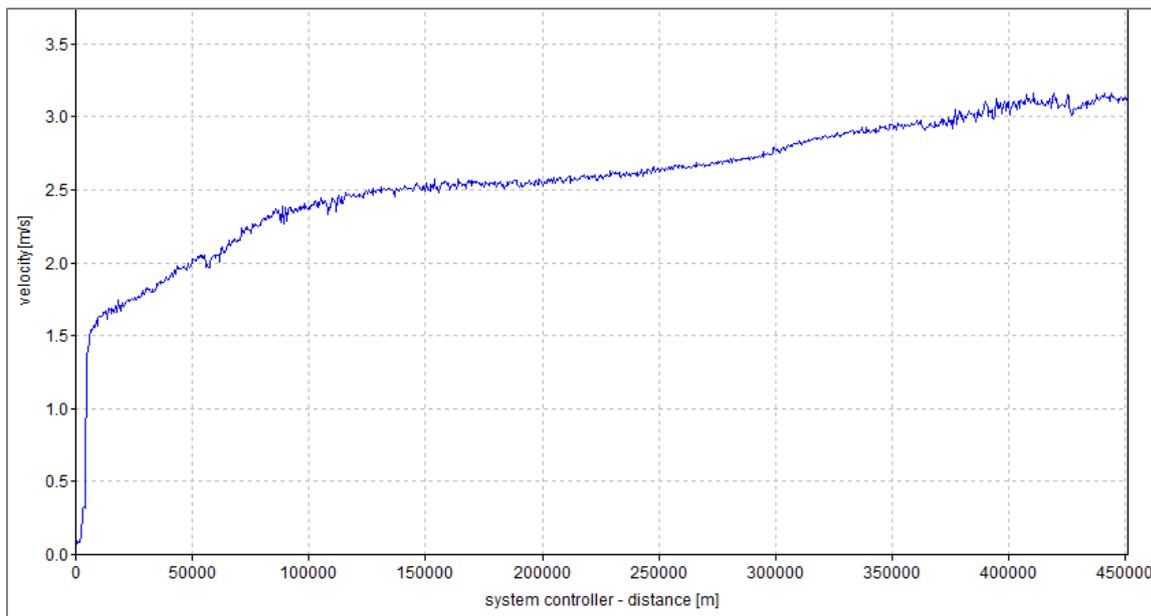
Figure 6: Tool velocity across pipeline

Figure 6 shows the MFL tool velocity profile along the full pipeline. The tool was initially in the low-flow pipeline section, as indicated in Figure 7. For the first two kilometers, the tool had an average speed of ~0.1 m/s, but then the velocity rose sharply at the HTT. After passing the tee, the velocity steadily increased as the pressure along the pipeline decreased.
