UNPIGGABLE PIPELINES – WHAT A CHALLENGE FOR IN-LINE INSPECTION!

By Dr. Rainer Schmidt, 3P Services, Lingen, Germany

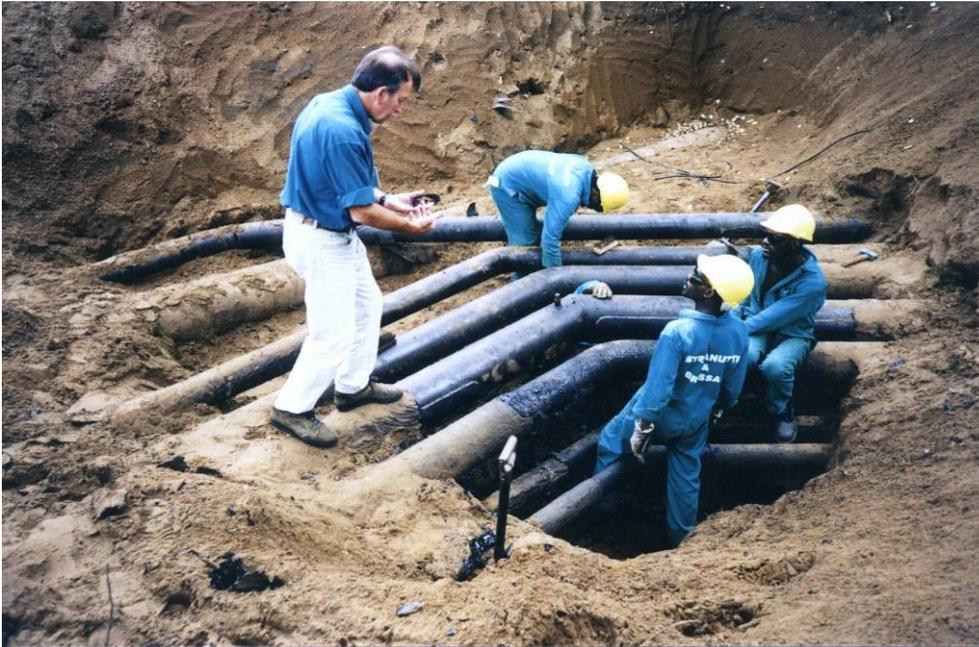
Why is it „un-piggable“? There are mitred bends present in angles up to approx. 50°. Numbers per line and locations were not known.

Result: The GEO inspection lead to the conclusion that mitre bends were present in the lines in a much smaller number than anticipated by the Client. Several of the pipelines did not have mitre bends exceeding 30°, so they could be MFL inspected without any pipeline modification. For the remaining pipelines with high angle mitre bends a minimum modification programme could be set up and executed on a relaxed schedule.

Fig. 1: (Case history no. 1) Excavation confirms some mitre bends, some radius bends

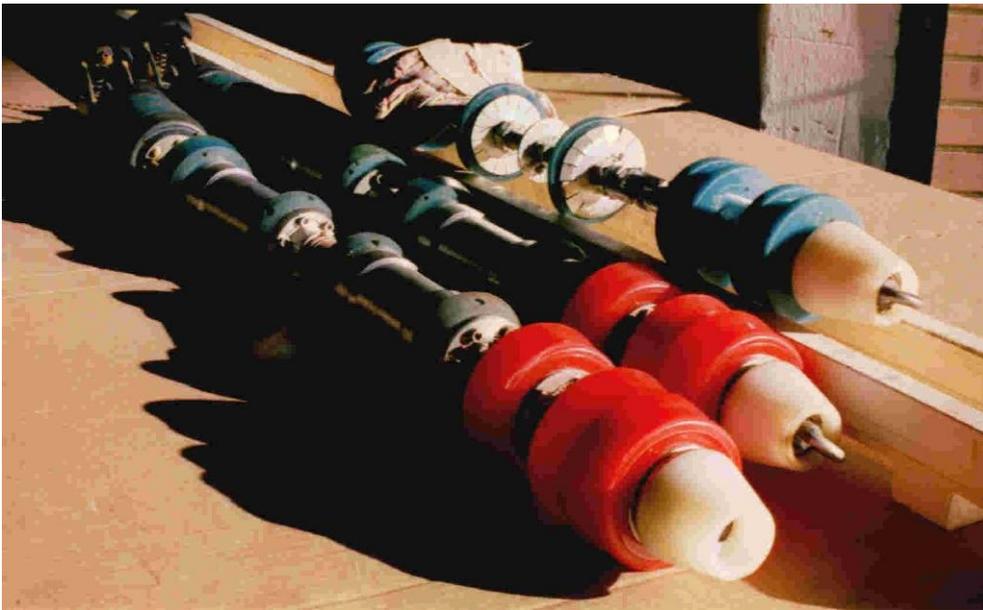
Performance: 3P Services received an order to conclude the development of the sensor, apply it on an in-inspection tools and inspect the flowlines. Two identical units, each carrying 32 DMR sensors were built and tested within only 4 weeks (see Fig. 3). Upon the final testing, the tools were approved by Shell Global Solutions Amsterdam for the Gannet project and mobilised off shore. The tools were propelled by stabilised crude which was available on the platform. The temperature was 70°C at the launch and approx. 40 to 50°C at the receiving end. Both units of the DMR inspection tool were run to achieve a double set of data.

Result: Both tools recovered complete inspection data that allowed an interpretation over the entire length of the pipeline. Internal metal loss like beginning pin holes having a diameter of 5 mm and 1mm deep was clearly identified at excellent repeatability. The operator's targets were achieved, budget and time schedule were met.

Fig. 3: (Case history no. 2) DMR inspection tools
