## **PIPELINE INTEGRITY ANALYSIS BASED ON INTERDISCIPLINARY COOPERATION**

This paper presents an overview of the validation process undertaken on a 51 km (32-mile) section of 457 mm (18-inch) pipeline. This pipe section was inspected in 1999 and again in 2003 by the same inspection company. This provided an opportunity to evaluate improvements in inspection technology, assess repeatability of performance and develop an engineering based approach to review, analyze, and validate high-resolution metal loss MFL data. Field verification and data validation included the use of several NDE techniques to acquire field measurements to overlay and compare to the ILI inspection data.

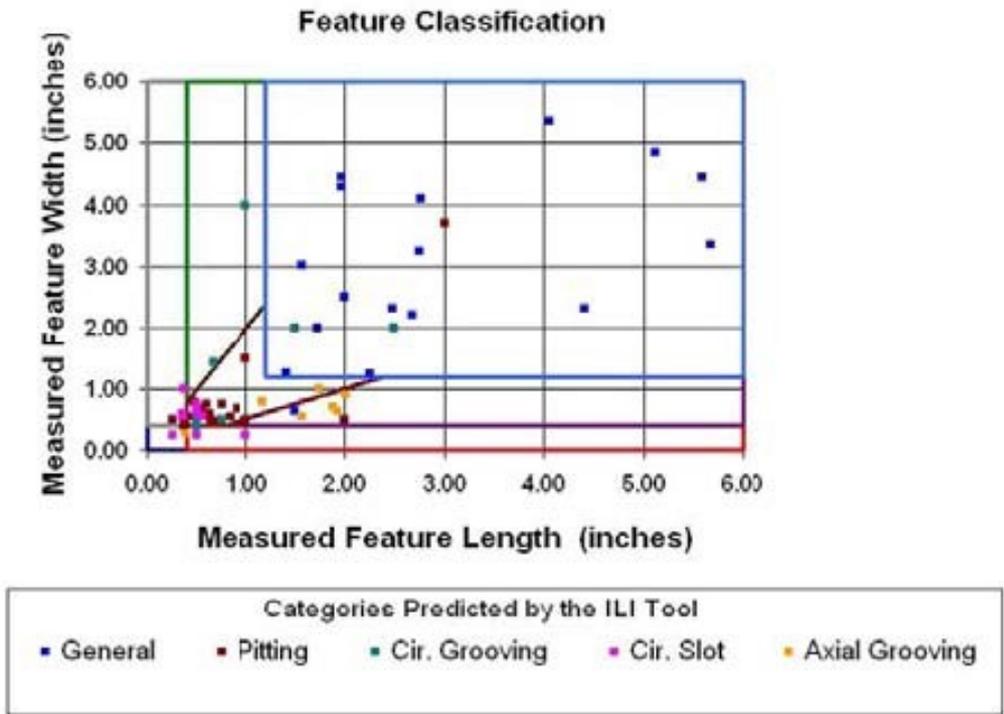
Figure 3 – Feature Prediction

The first task of the evaluation process was to determine if features were correctly categorized by the inspection tool. Although difficult to see, Fig. 3 – “Feature Prediction”, shows the feature categories predicted by the ILI tool for the “General” and “Pitting” categories are typically good but the tool give only a gross prediction for “Circumferential Slotting”, “Axial Slotting”, “Circumferential Grooving”, and “Axial Grooving” categories.

This is to be expected. The depth and length measurements that define feature categories in the POF document cannot be duplicated in the field. Length and width measurements are obscured by the fact that the tool will report dimensions based on the threshold-of-detection profile-line, (refer to Fig. 4 “Metal Loss Profile”), typically 0.05t, while the field measurement will be from the zero depth profile line. This can lead to significant differences as can be seen in Fig. 4 and reflected in the Feature Prediction graph.

For MFL tools, it is best to limit the number of categories into which features are classified. From the experience gained in this case, circumferential grooving and slotting categories should be grouped as a single category as should the axial slotting and grooving categories. This still allows an Operator to make integrity decisions on based on feature geometry but does not overly complicate the process.

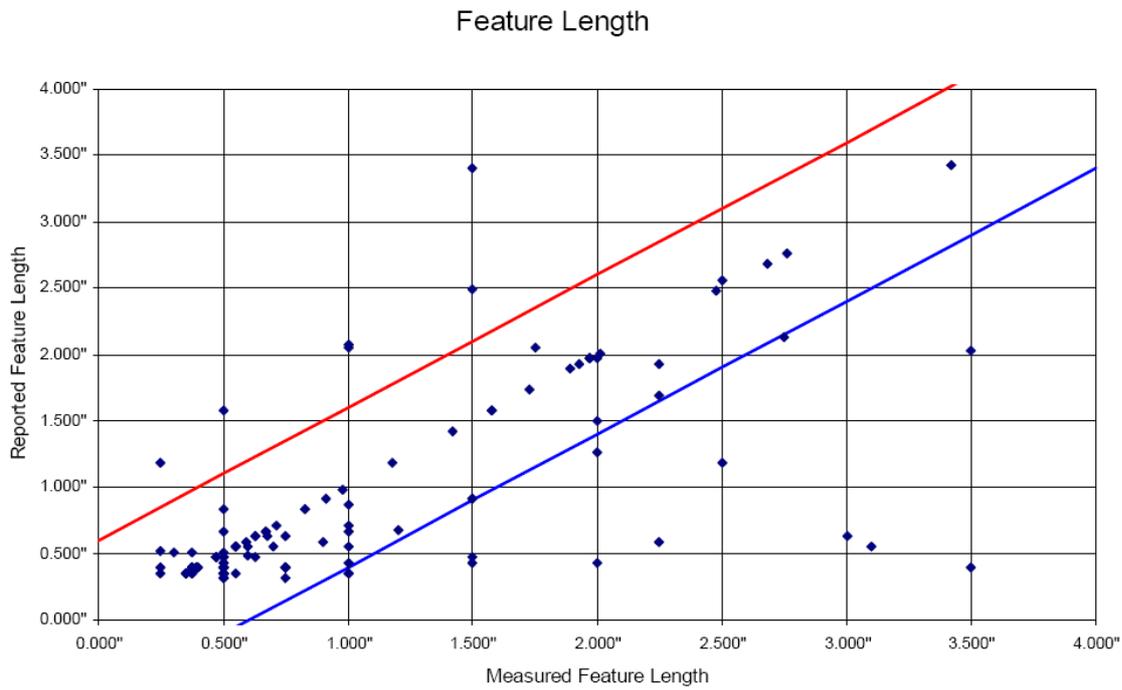
Figure 5 – Feature Length Accuracy

Fig. 5 “Feature Length Accuracy”, shows the reported length vs. actual field measured length of 123 features. In this case, the tolerance for all reportable feature categories is  $\pm 15$  mm ( $\pm 0.60$ -inches). Features with a measured length greater than the predicted length are likely a result of the reporting threshold and threshold-of-detection of the tool and do not necessarily represent an error in tool accuracy (refer to Fig. 4 “Metal Loss Profile”). It is very difficult to validate length predictions, but in general terms, the feature lengths predicted by the tool are reasonable. In this case, taking just the raw data without correcting for the reporting threshold or threshold of detection, the tool was within tolerance 86% of the time.

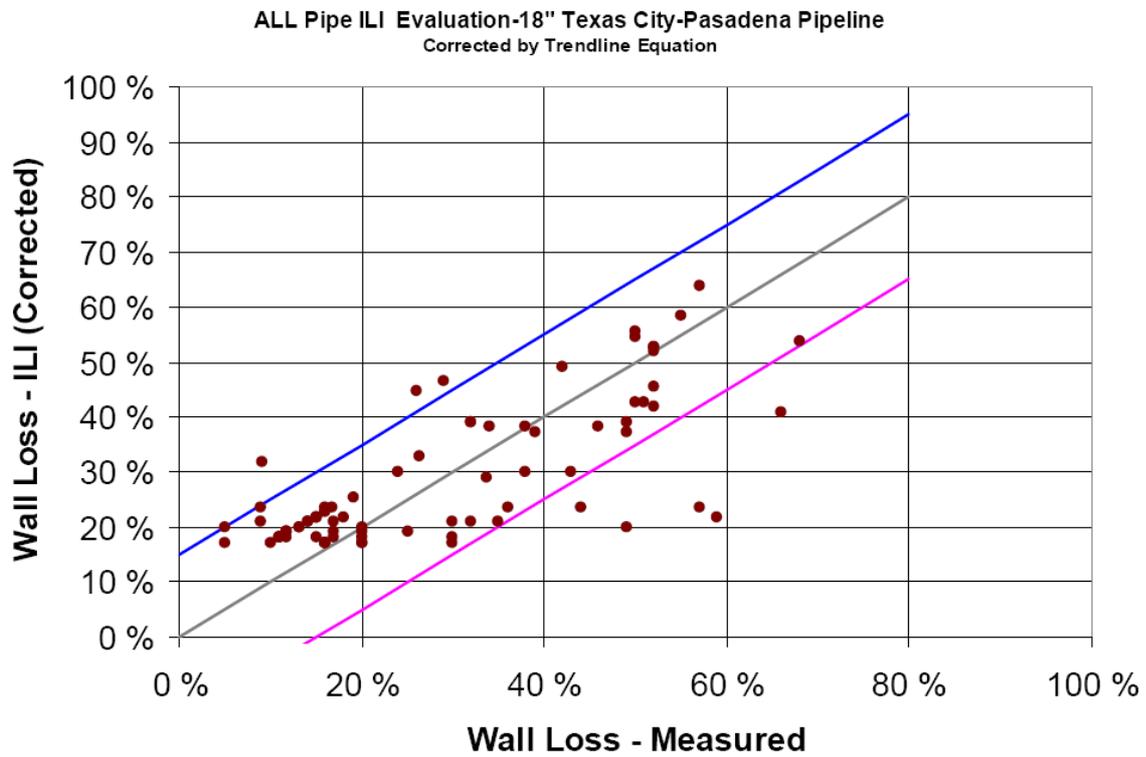
Figure 6 – Feature Depth Accuracy

In this particular inspection, the feature depth accuracy for the 123 features was  $\pm 0.15t$ , 84% of the time. Using a simple trend line correction, the accuracy increases to  $0.15t$ , 93% of the time. The trend line equation shows a tendency to under call features by 8%. This was then used in subsequent integrity decisions to ensure that all significant features were addressed. This corrected depth data is shown in Fig. 6 –

This graph shows predicted feature depth versus the feature depth measured in the field. The field measurements will contain a measurement tolerance which must be understood if this data is to be used for integrity assessment decisions. RTD Quality Services used qualified personnel and written, qualified procedures, to acquire the field data so that the effects of measurement tolerance would be minimized. In addition, the ILI Service Provider reviewed the field procedures and accepted the acquired field data with confidence in its accuracy. This is the key issue in the overall integrity program; it must be a cooperative effort of all involved parties.

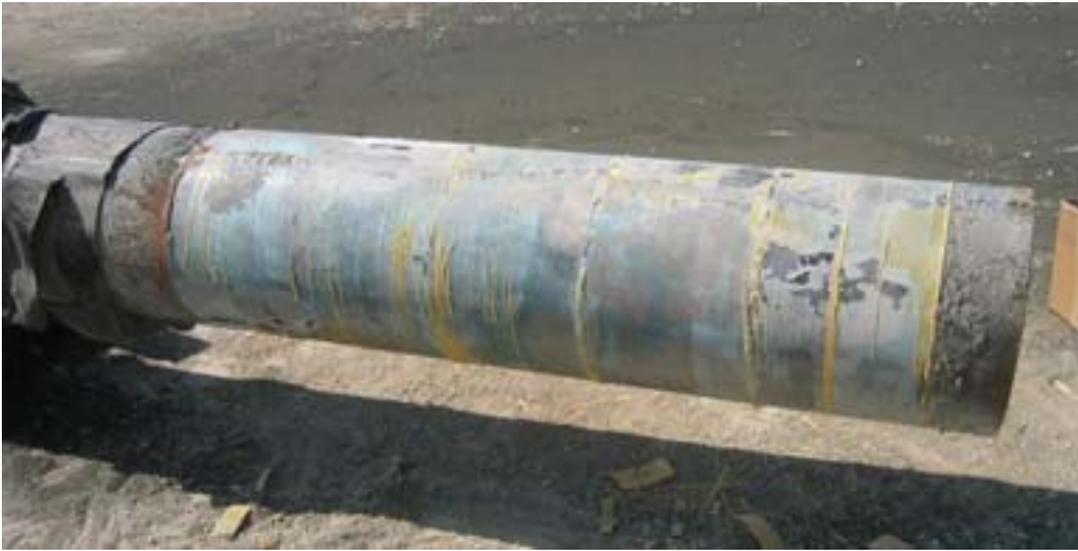
Figure 8 - Section of Clock Spring Removed by Sandblast

To confirm that the Clock Spring sleeves had protected the pipe from further corrosion, this section was removed from the pipeline after the 2003 inspection. When the pipe was repaired in 1999, the surface was sand blasted to a clean, bare finish. Five Clock Springs were installed, side-by-side. The repair was then over wrapped with a CANUSA heat shrink sleeve to protect the repair location and pipe from corrosion. Fig. 8 shows the pipe surface after the Clock Springs were removed.

After four years of service, the Clock Spring repairs were effective in all respects. Defects repaired with Clock Spring can be used to validate subsequent inspections.

Based on the results of the 1999 inspection, an anomaly located at 43+95 feet, consisting of multiple isolated pits and general corrosion and covering 142 cm (56-inches) of pipe was investigated and repaired with Clock Spring. These sleeves do not affect the performance of an MFL inspection tool and, when properly installed, will prevent further corrosion growth. If detailed defect measurements are acquired at the time of the repair, then the repaired defect can be used to validate subsequent MFL inspections.
