CLEANING & ILI OF HEAVY WALL SUBSEA PIPELINE WITH IMPROVED DIFFERENTIATION BETWEEN DEBRIS AND CORROSION

Author: Johannes Keuter, 3P Services GmbH & Co. KG, Germany

An 18", North Sea, heavy wall, offshore wet gas flowline with known debris interference, had to be inspected. The total length is circa 300km with up to 27.3mm nominal wall thickness. Potential corrosion had been detected in a previous 3rd party in-line inspection. However, the POI was limited and no clear differentiation between corrosion and debris was possible. Hence, the previous inspections were not fully successful, and the data couldn't be used for a full evaluation of the clients' problems. 3P Services was asked to perform a metal loss inline inspection of the pipeline as soon as possible. Following on from a specific cleaning program, 3P proposed an 18" GEO/MFL/DMR combo tool. This tool combines a heavy wall magnetizer with a geometry measurement segment and special DMR sensors, wall guided as well as in a stand-off configuration. The combination of these different sensor technologies allows an optimized differentiation between debris, internal corrosion, or internal corrosion with debris. This information was

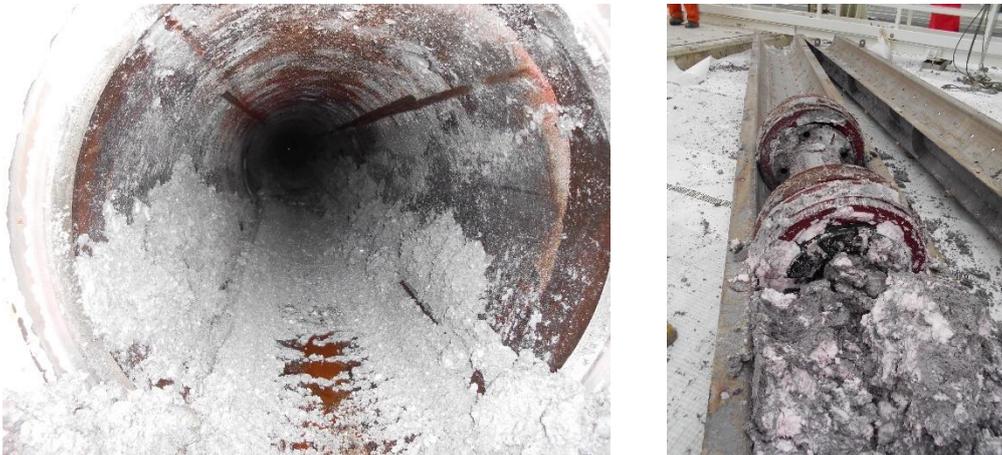
Figure 1-2: Examples of previously removed debris

The pipelines had several cleanliness challenges. There have been several pigging operations between 2016 and 2020 in which dewaxing pigs and debris mapping tools were used. However, the data from the debris mapping tool and debris observed after cleaning did not assist with the decision to run a 3rd party MFL inspection, nor help interpret the compromised data received. The probability of identification (POI) was limited and no clear differentiation between corrosion and debris was possible. Hence, the previous inspections were not fully successful, and the data couldn't be used for a full evaluation of the clients' problems.

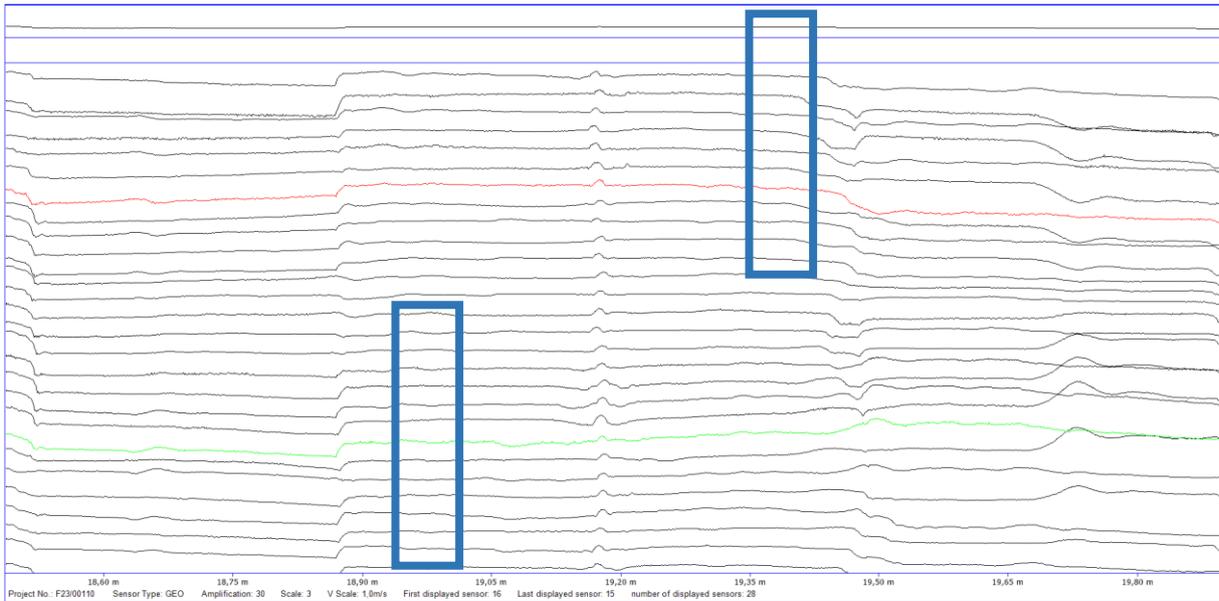
Figure 8: GEO data – blue rectangle shows anomaly location (red/green sensors = 12h/6h)

The characteristics of this spool piece were used to reflect situation "D" as part of the large-scale tool testing. The combined ILI tool was pulled several times through the pull test line and data sets of the introduced four (4) different measurement technologies were recorded. The first data screenshot below shows the geometric (GEO) data of the ILI tool. Each line represents a sensor. The debris within the internal metal loss didn't exceed the inner pipe wall and didn't cause any ID reduction. Accordingly, the GEO sensors don't show any reaction and show no ID reduction. Instead, they show a constant ID. The location of the anomaly is marked with a blue rectangle.

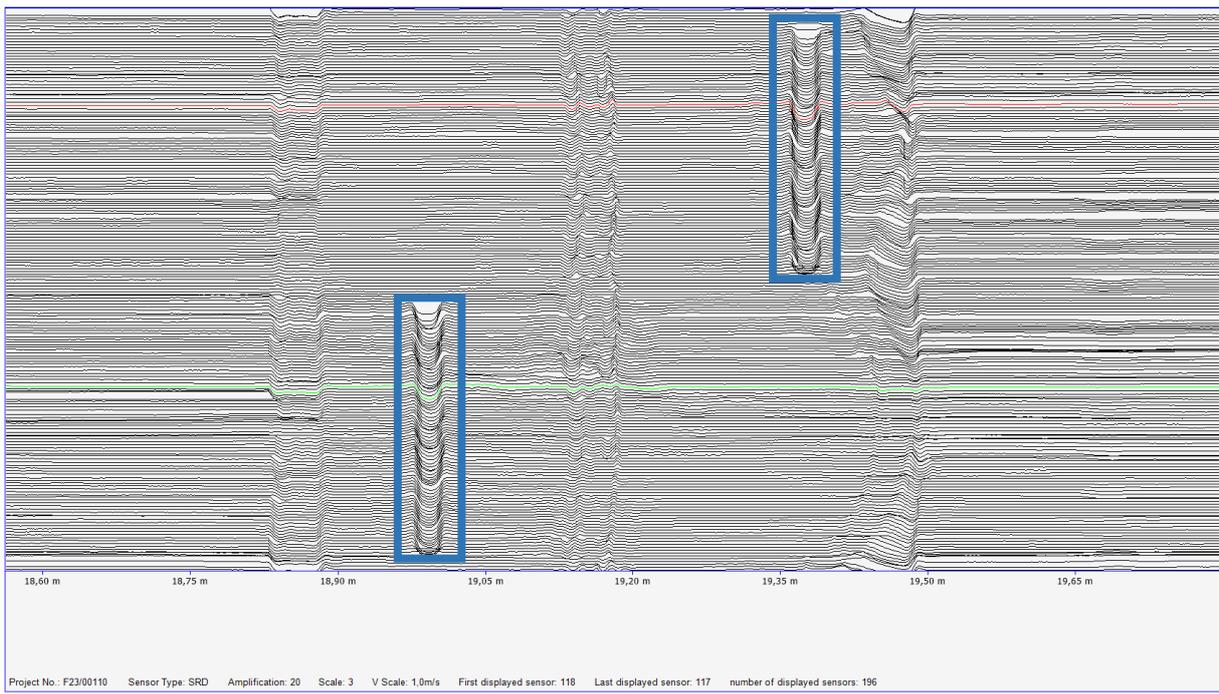
Figure 9: wall-guided magnetic sensors data – blue rectangle shows anomaly location (red/green sensors = 12h/6h)

In contrast to the GEO sensors show the wall-guided magnetic sensors clearly the internal metal loss. These sensors measure through the artificial debris.

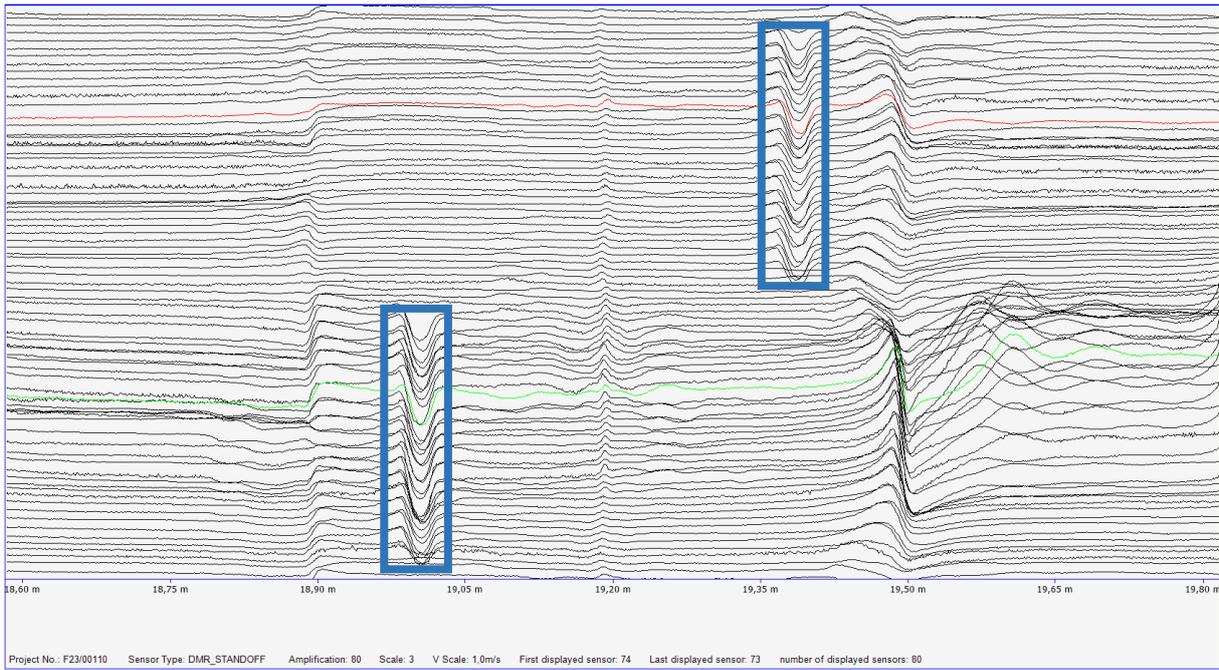
Figure 10: stand-off magnetic sensors data – blue rectangle shows anomaly location (red/green sensors = 12h/6h)

The same behavior can be observed on the stand-off magnetic sensors. These sensors ignore the debris and measure clearly the internal metal loss.

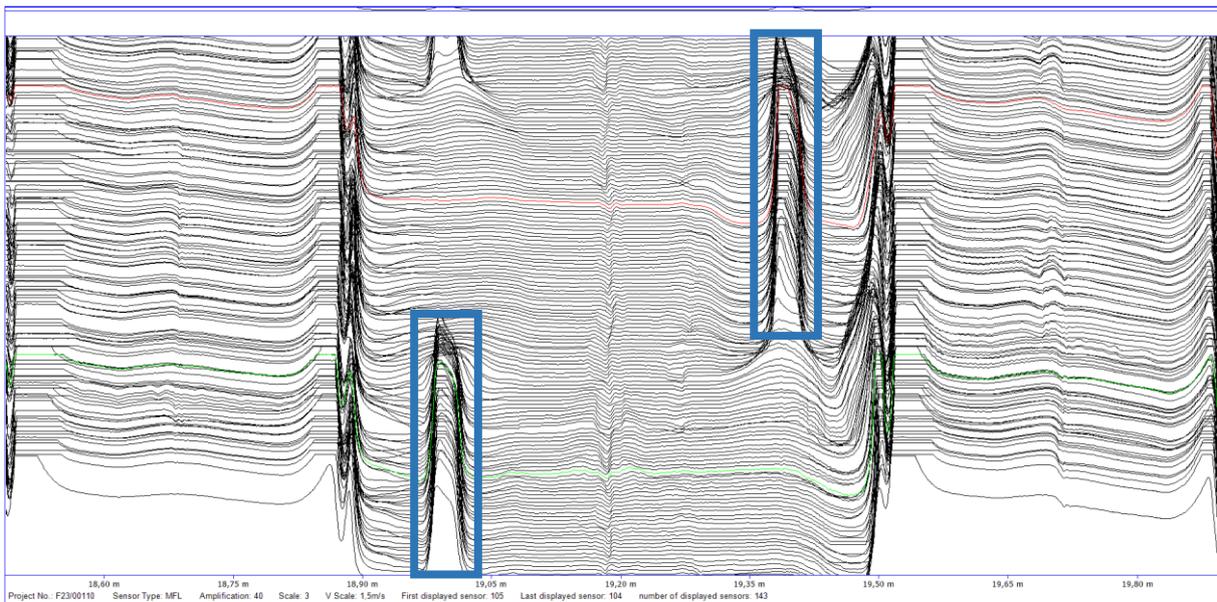
Figure 11: MFL sensors data – blue rectangle shows anomaly location (red/green sensors = 12h/6h)

The heavy wall MFL magnetizer was able to magnetize the 27.3mm wall thickness and clearly detect and size the internal metal loss anomalies. The internal debris did not influence the magnetic field and the sizing of the metal loss worked according to performance specifications.

AS BUILT				ILI RESULTS		
No.	Axial length	Circ. width	Depth	Axial length	Circ. width	Depth
1	28mm	556mm	47,4%	34mm	545	50%
2	28mm	556mm	43,1%	34mm	558	49%

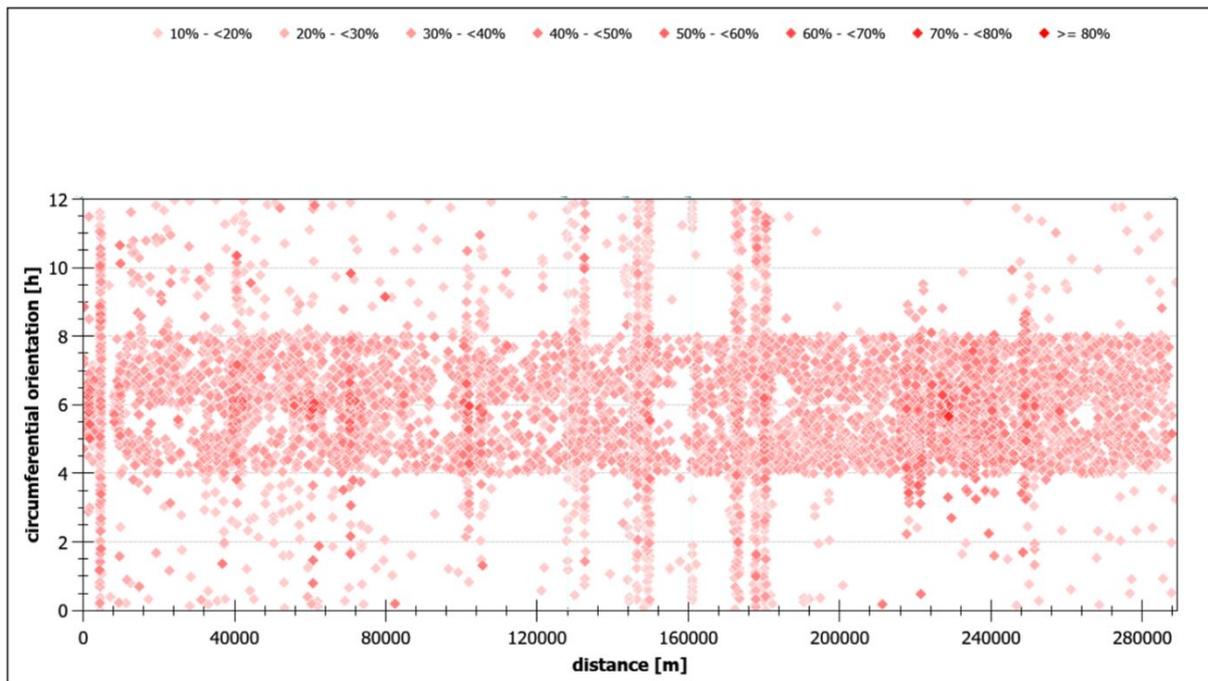
Figure 13: Distribution of metal loss over the pipeline length and circumference

Prior to the project an extended preliminary reporting time of four weeks was agreed, which was recommended due to the size of gathered ILI data. The preliminary report was sent accordingly and fourteen (14) metal loss indications equal to or above 60% were reported. Correspondingly to the operations report, the preliminary report re-confirmed that there is no debris-based influence on the data.

A typical 6 o'clock pattern of internal metal loss anomalies over the pipeline length and circumference can be seen. 3P Services did additionally perform an estimated repair factor (ERF) calculation according to ASME B31.G to provide the operator further data for their integrity assessment. These results are visualized below.
