DEEPWATER, HIGH-PRESSURE AND MULTIDIAMETER PIPELINES A CHALLENGING IN-LINE INSPECTION PROJECT

Dr. Hubert Lindner, ROSEN Technology & Research Center, Lingen, Germany

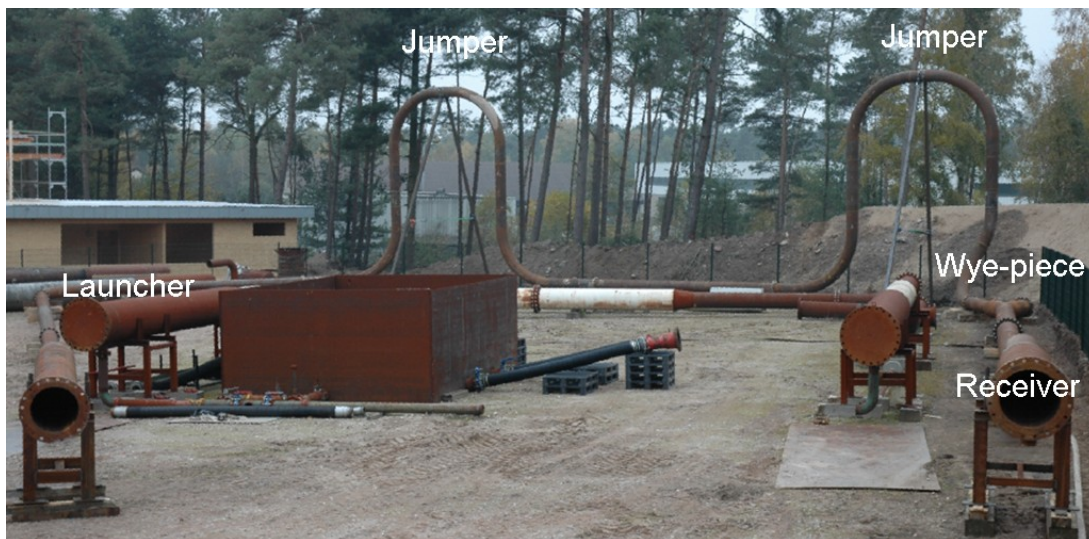
Figure 6: The 14"/18" test loop

The most important tests were, of course, the pump tests in the special 14"/18" test loop (Figure 6). During these runs both tool and pipeline flow and pressure data were measured to evaluate tool performance and optimize the behavior.

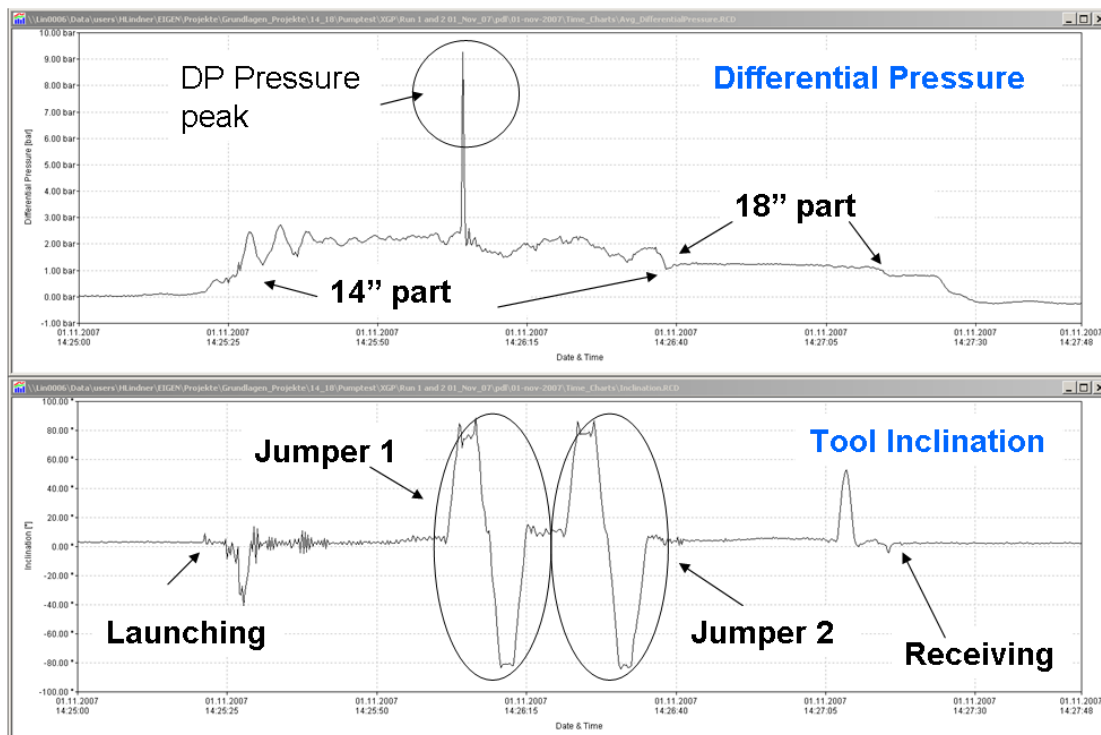
Figure 7: Results of pump test with RoGeo Xt (Top: dp, Bottom: tool inclination)

Figure 7 illustrates the differential pressure (dp) along the RoGeo Xt tool as measured by an on-board PDL during a pump test. The dp is about 2 bar in the 14" and 1 bar in the 18" section. The bottom diagram shows the inclination of the tool during the run. The inclination is a good indicator for the tool position resulting from the two jumpers as shown very clearly in Figure 7. The swan necks of launcher and receiver too are plainly visible. The pressure diagram also shows a distinct peak of nearly 10 bar. This peak reflects damage to the pull unit including missing wheel support. In combination with the synchronized display of the inclination it was possible to identify the reason for the peak and corrective design actions could be made. The subsequent tests did not show any similar effect.

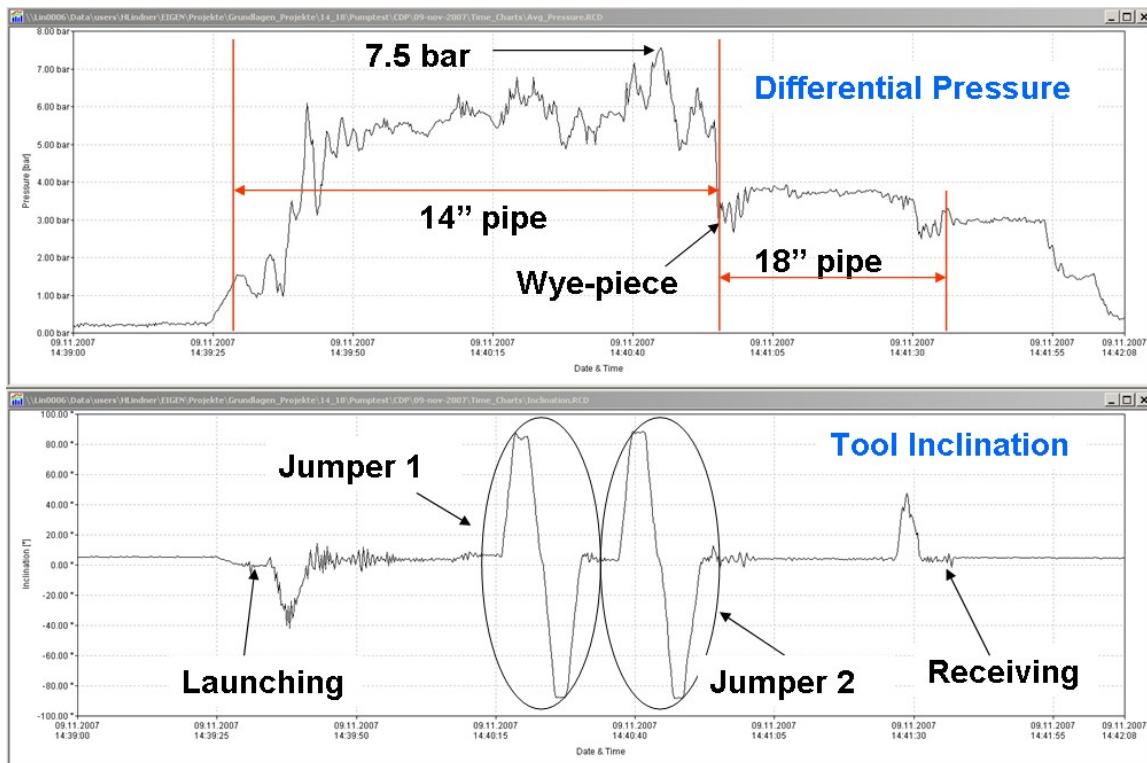
Figure 9: Results of the pump test with the CDP tool (top: differential pressure, bottom: tool inclination)

PDL measurements of a MFL test run can be seen in Figure 9. Again the lower diagram shows the tool inclination in support of the information provided by the upper graph. The MFL tool needs a higher dp than expected: it is between 3.8 bar in an 18" and 5.5 bar in a 14" straight pipeline segment. For the passage of the jumper bend combination, a slightly greater differential pressure is required (up to 7.5 bar). The passage of the wye-piece was performed without stop and shows only little effect on the measurement.

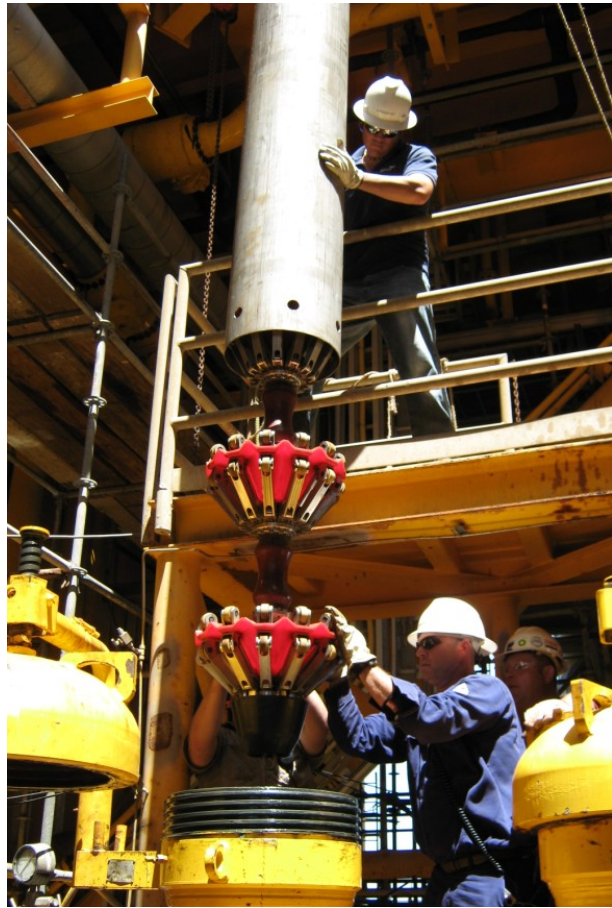
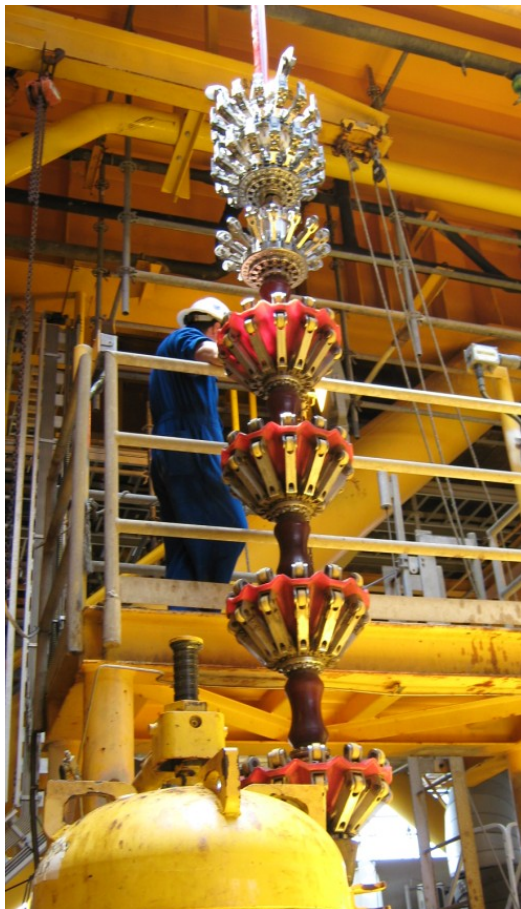
Figure 10: Vertical launching of the geometry and MFL tool

The geometry tool (Figure 10: left) was launched without any problem and arrived within the calculated time. The data collected during the geometry run was complete and of very high quality. The same evening initial data analysis was performed by the on-site team and data was transferred to the ROSEN Data Evaluation Department. One extreme measurement was observed and isolated for detailed evaluation. Because of the known pipeline layout, it was clear that the signal was recorded in the check valve between the jumpers. The evaluation of the data revealed the internal geometry of the check valve (Figure 12). In the RTRC, this information was carefully compared to the tool design and decided that it is just as expected and therefore no critical installation, though the MFL tool could be launched.

Because of the length of the launcher barrel, the two segments of the driving unit had to be pushed into the reduction for a certain distance. Additionally, a launching tube was used to keep the magnet units away from the wall to reduce the required pushing forces. As this was also tested on a dummy launcher with original measures, the launching procedure worked perfectly. Again, the tool was received within the allocated time and with complete data of high quality.
