# Multidisciplinary Pipeline inspection project

# Inspection of 12" pipeline, never been inspected

# Challenging project

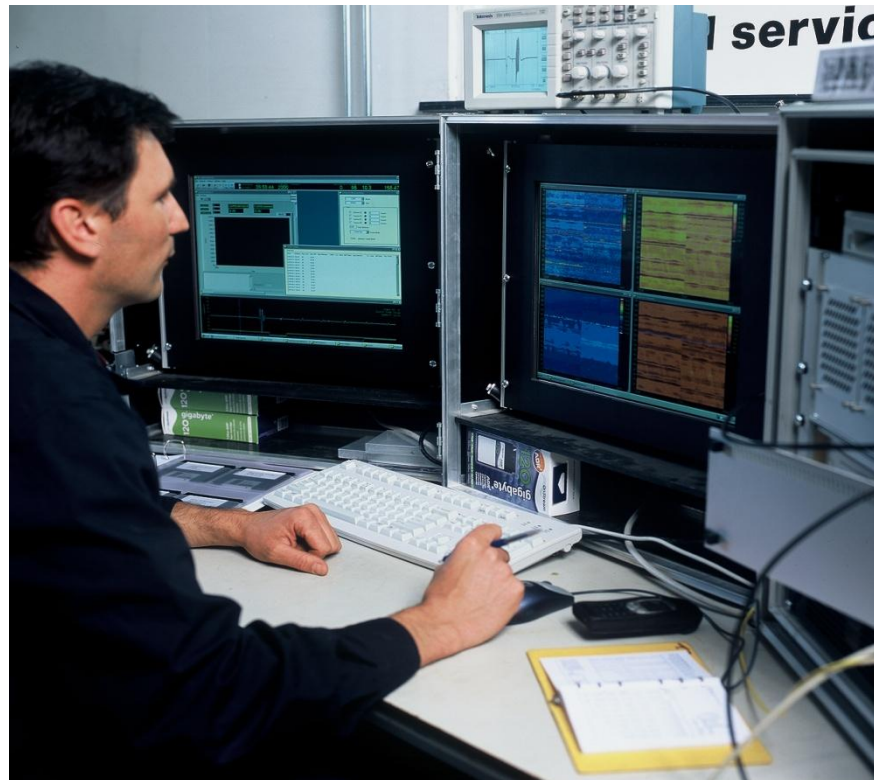
# Data Acquisition Unit

On-line inspection data

AVG. Coverage: **99**    AVG. Thickness: **13.0**    Distance: **3541.60**

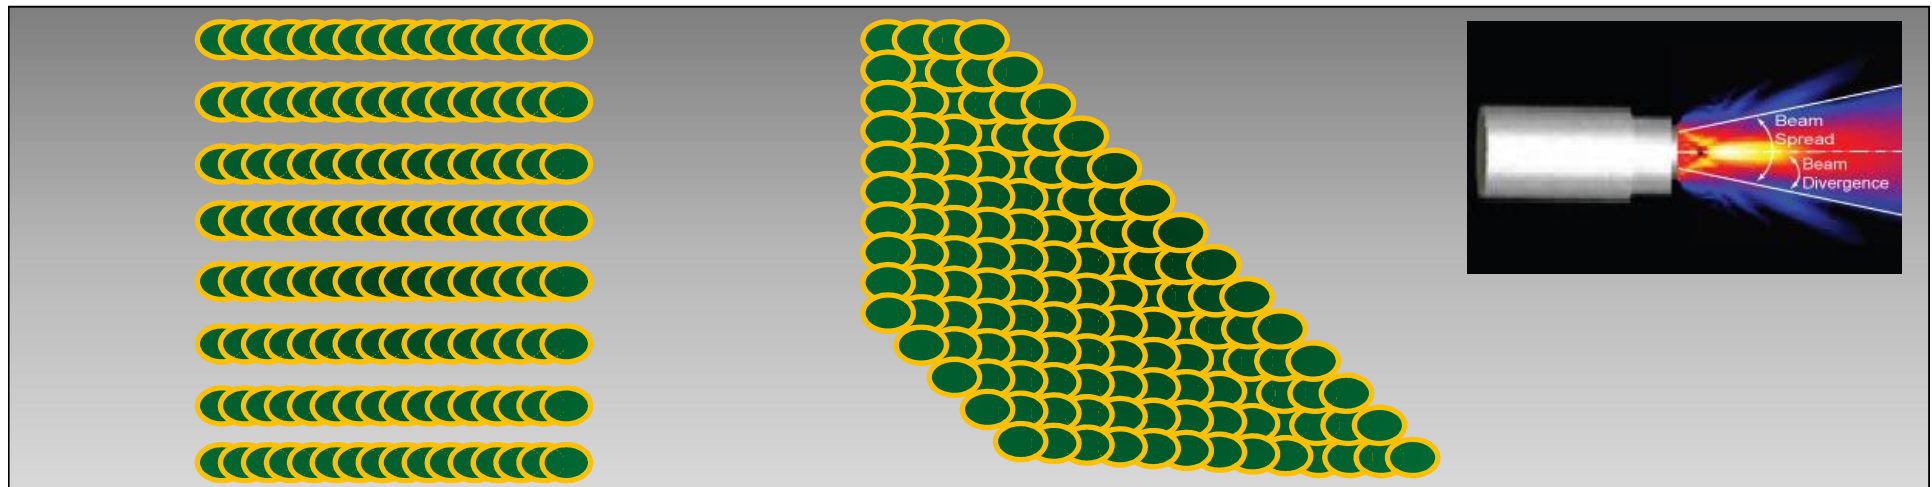
Flow direction

Fixed transducers

Rotating transducer

Axial direction , coverage depending on speed (Pulse repetition frequency)

Circumferential direction , coverage depending on:

- amount of transducers
- beam spread (depends of crystal diameter/frequency)

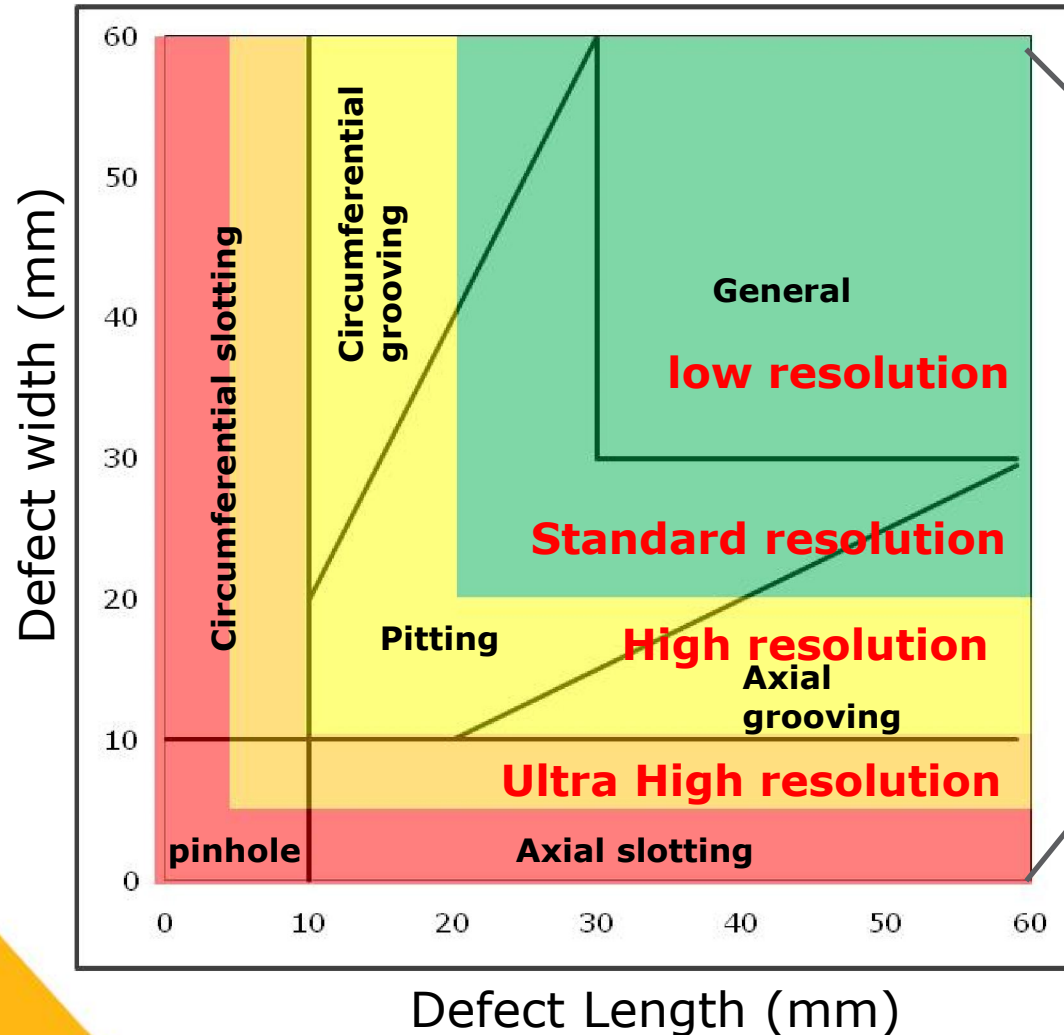
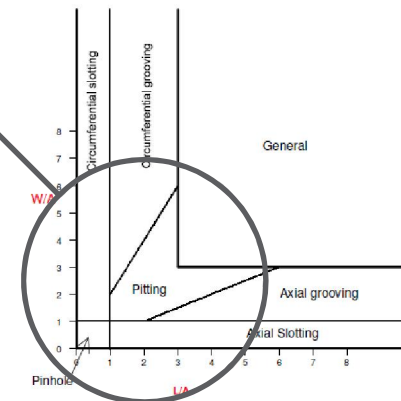
The geometrical parameter A is linked to the NDE methods in the following manner:

- If  $t < 10$  mm then  $A = 10$  mm
- If  $t \geq 10$  mm then  $A = t$

Figure 2. Graphical presentation of metal loss anomalies per dimension class.

Low resolution	3Tx3T
Standard resolution	2Tx2T
High resolution	1Tx1T
Ultra High resolution	0.5Tx0.5T

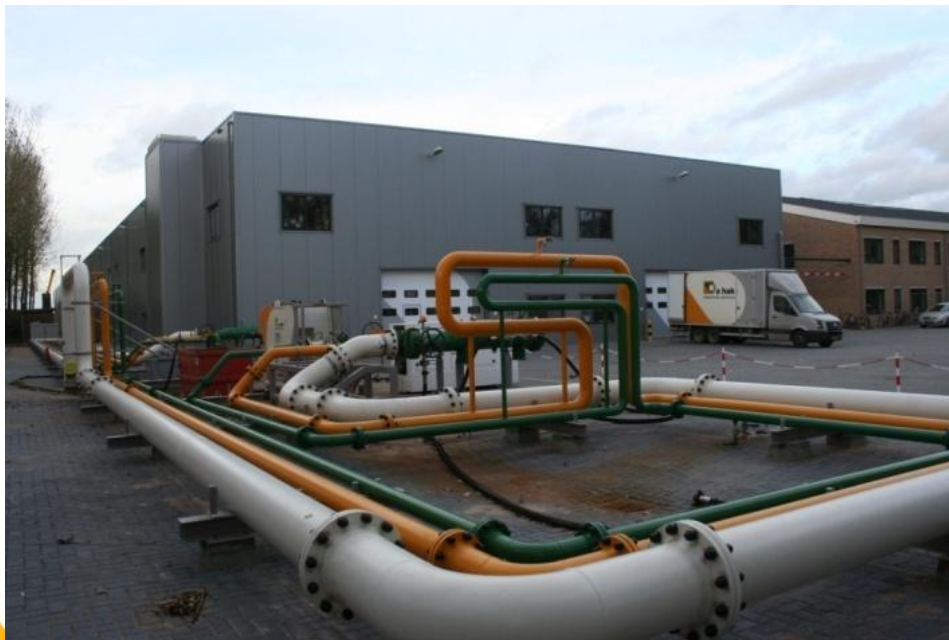
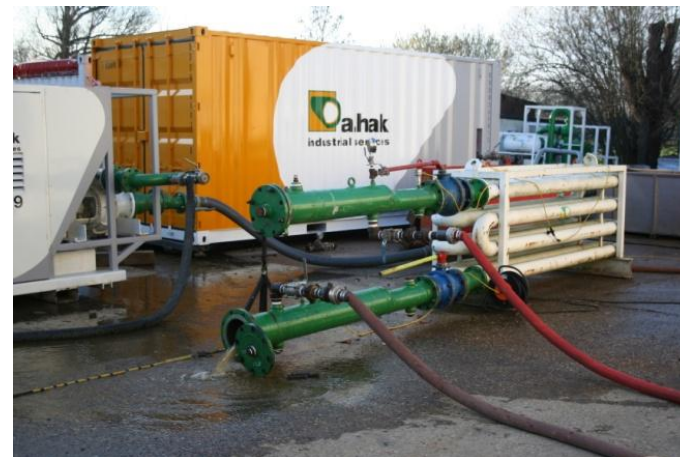
## Test-Facilities:

- Test loop's +/- 200m: 4", 6", 12", Flanged
- Various Mock-up on clients demand
- Furnace 4",5", 6" & 8", multiple 1D bends

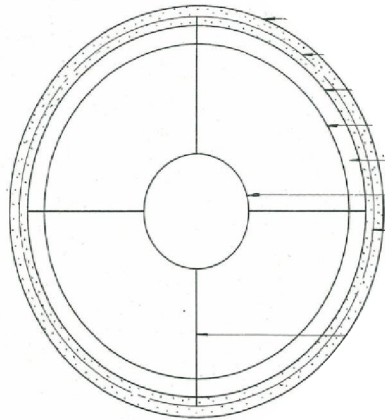
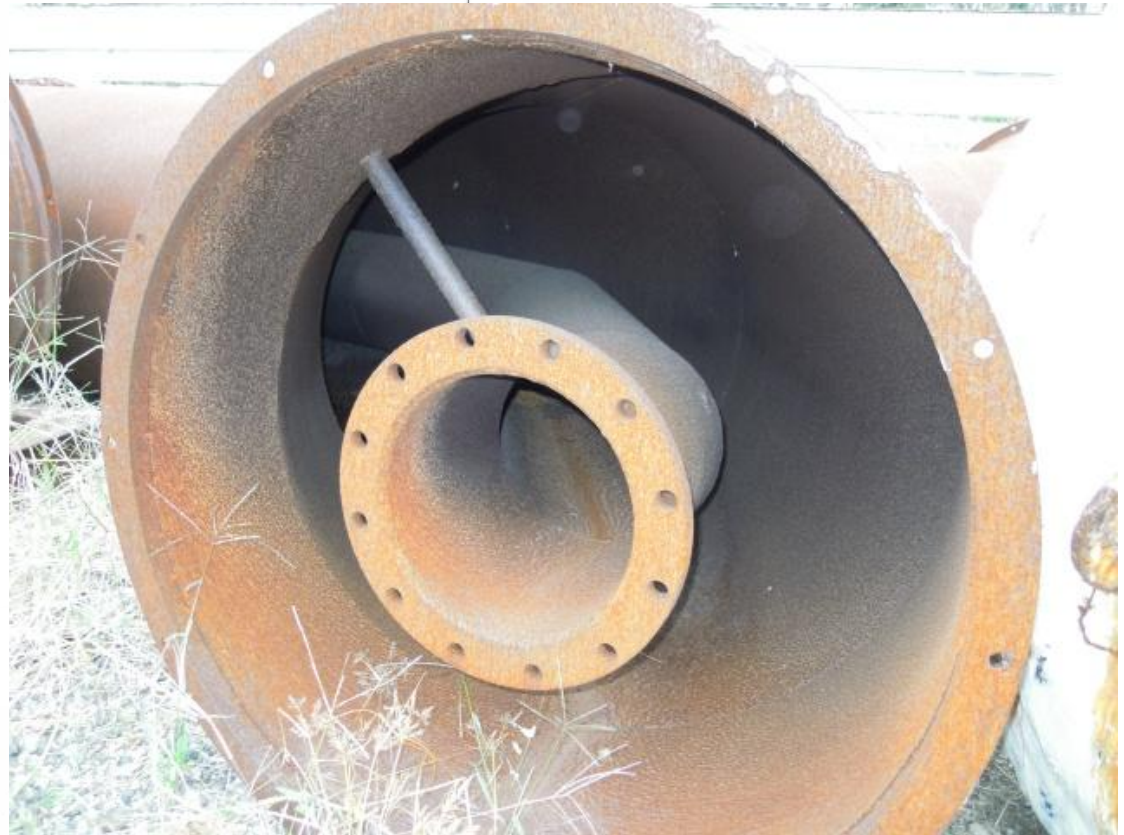
[Standard Section View]

As you see, the pipeline is a triplex structure.

The one we need to inspect by pigging is the Pipe 1 only.

- (1) Size : OD=323.2 mm and 318.5 mm
- (2) Length : about 3.1 km
- (3) Wall thickness : 14.3 mm and 10.3 mm
- (4) Bend radius : Please refer to the attached drawing
- (5) Fluid transported : Crude oil or Sea water
- (6) Operating pressure : 0.5 - 0.6 MPa
- (7) Temperature : Ambient
- (8) **Pipeline structure Double pipes consisting of 12" inner pipe and 38" outer pipe**

As you can see in the attached drawing, there are bend restrictions such as **forged bends(<1.5D)** and **mitre bends(R=1448mm)**.

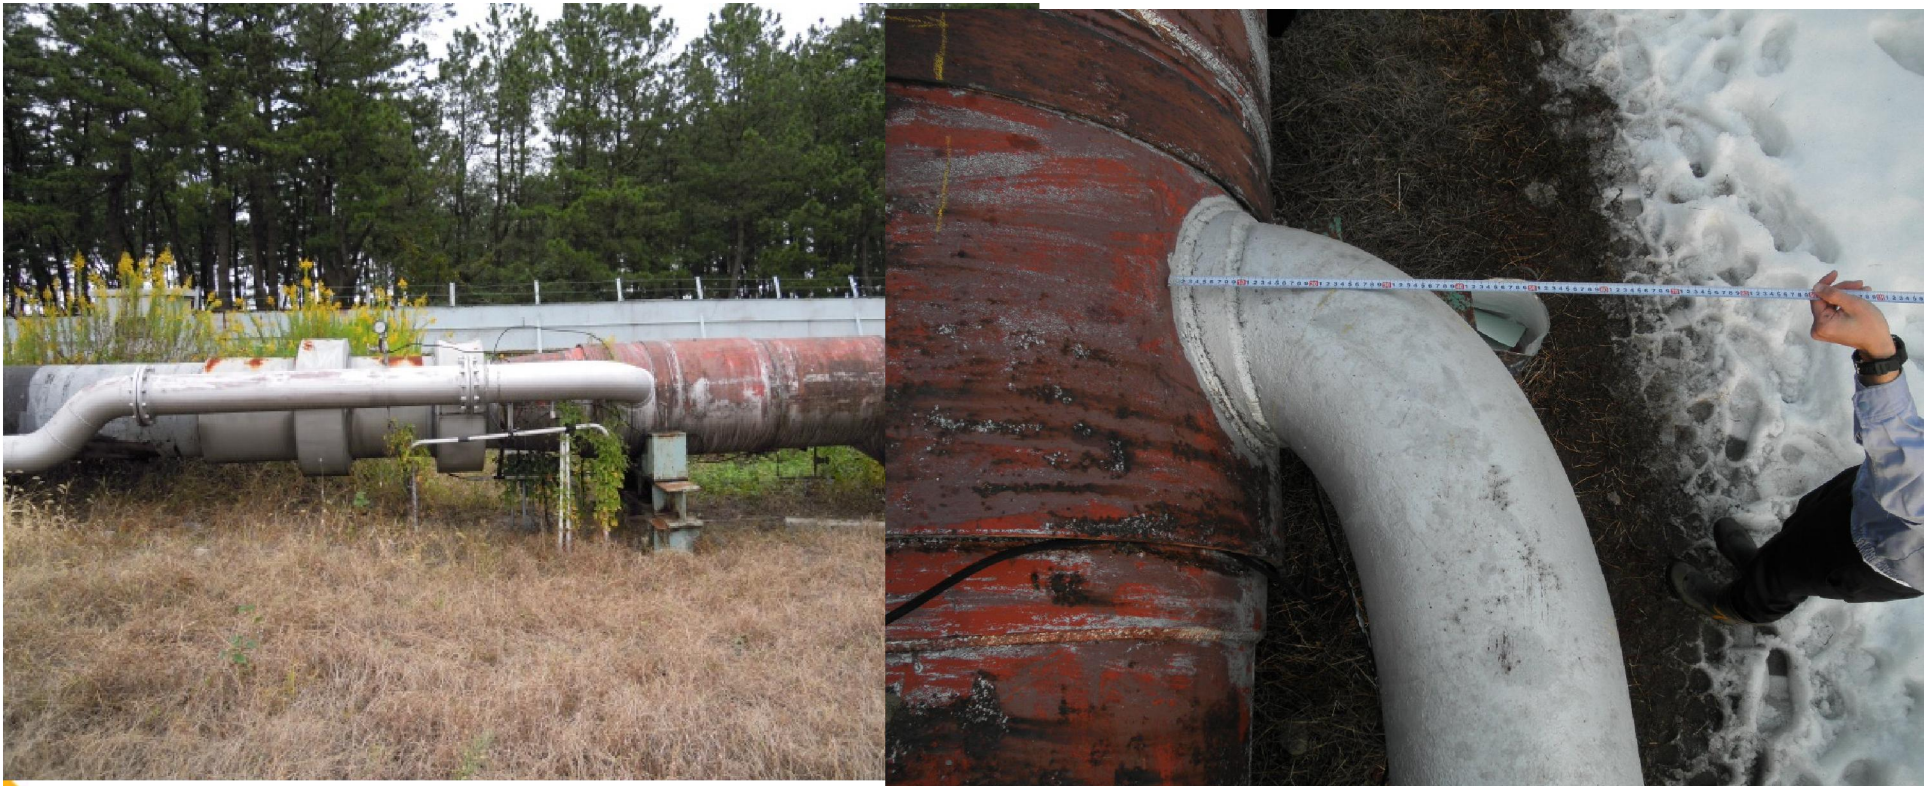
# Photograph location

(Case 7)

Pink line shows the path of pigging.

Launcher/receiver in one.

(Land area)

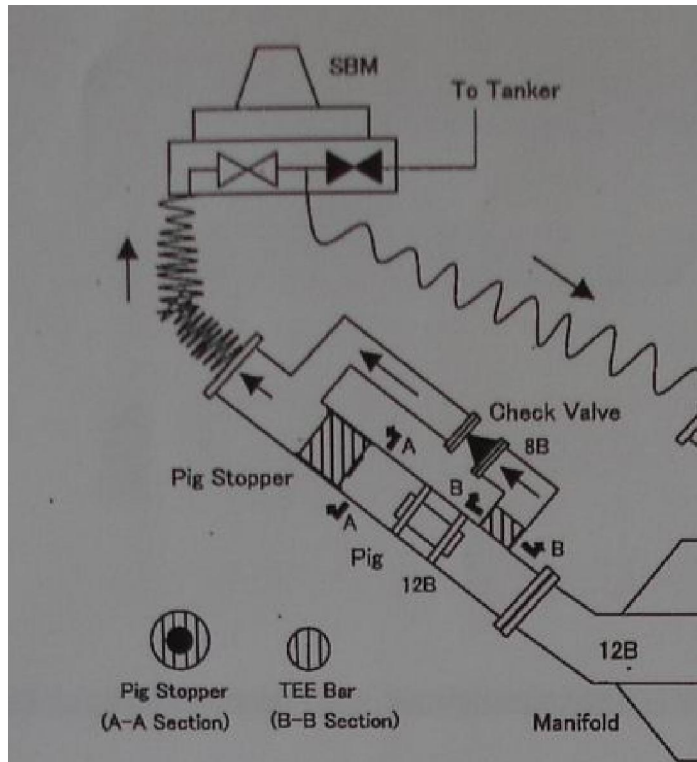
Fig 3. When Pig Is Stopped During Pigging

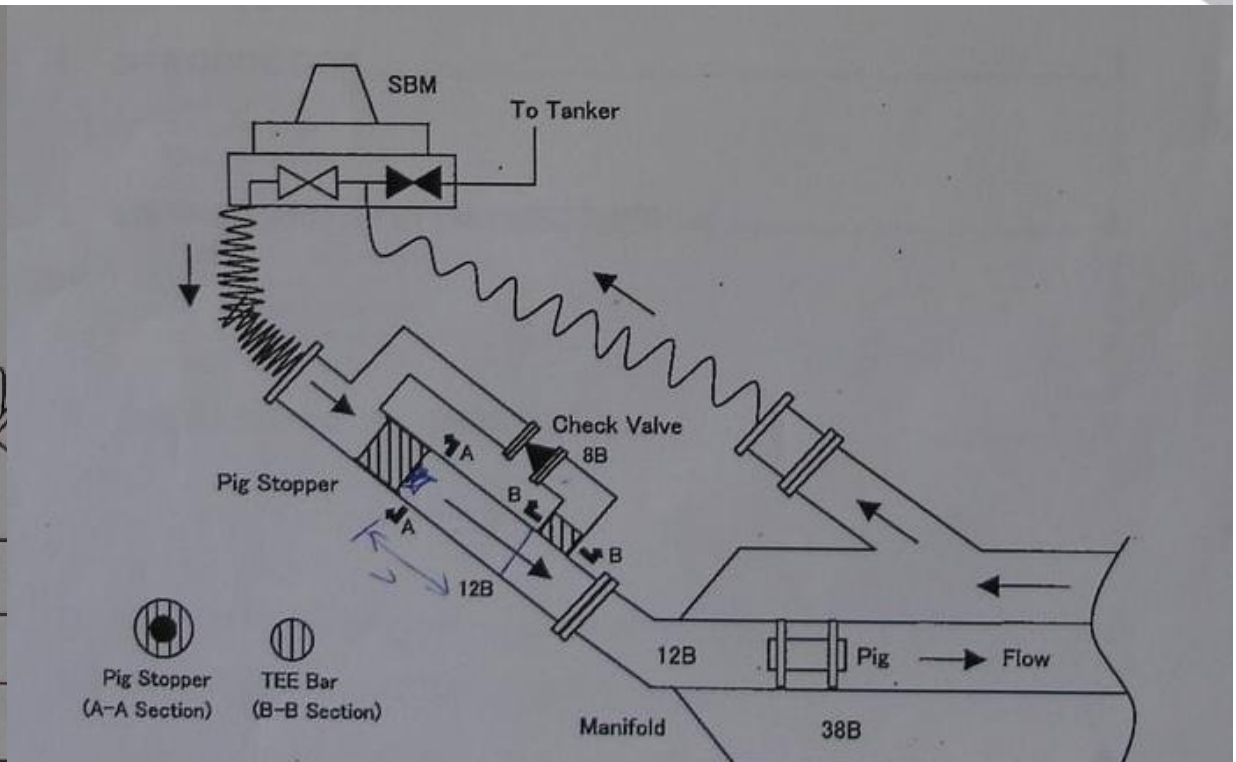
Fig 4. Pigging Operation in the Reverse Direction (from Sea to Land Area)

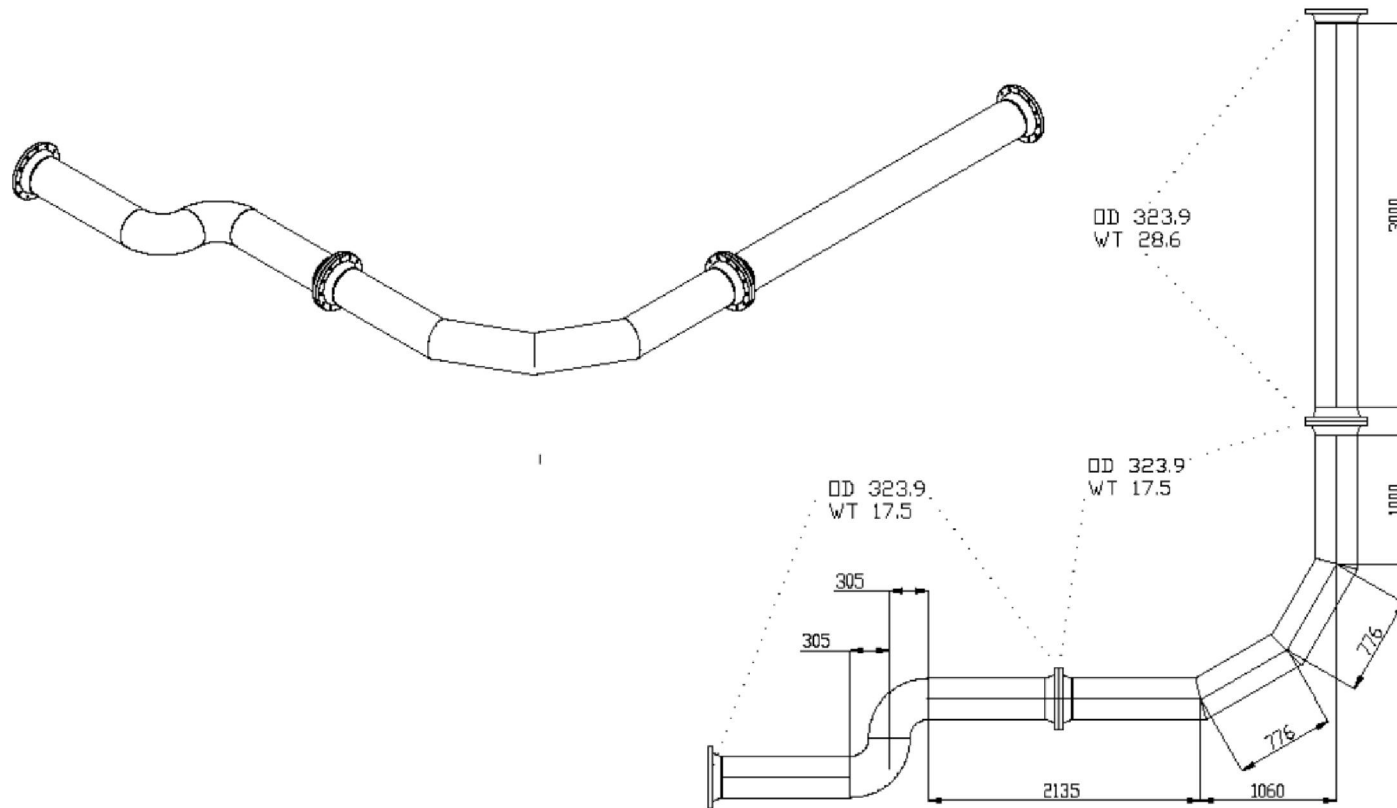
# Drawing Mock-up

DRAWING: Mock up 12" 1D

DESCRIPTION: Mock-up
