**PIGGING PRODUCTS &
SERVICES ASSOCIATION**

WIDE BAND ULTRASOUND IN LINE INSPECTION

PPSA Annual Seminar, 2017

Craig Hall, Rolf Sporkel, Willem Vos

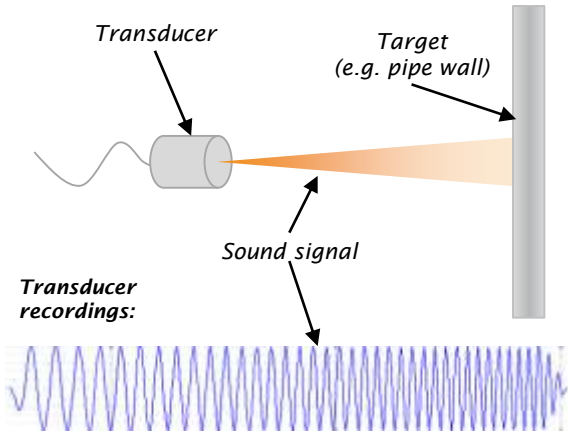
Emitting sound signal towards a target (e.g. pipeline wall)

- Transducer shooting a broadband (multiple frequency) sound signal towards a target
- Signal duration is sufficiently long to generate oscillations in target

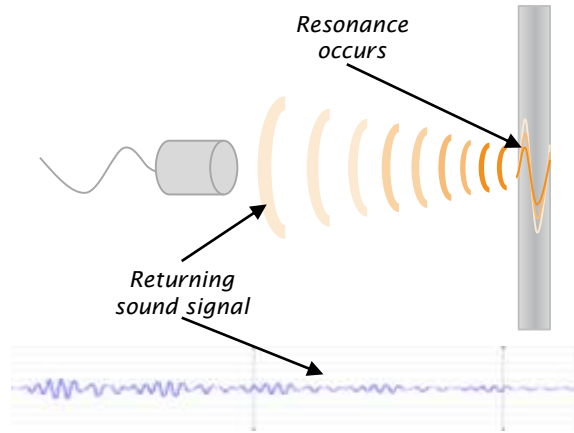
Listening

Resonance occurs in target - returning sound signal recorded

- As the oscillating target continues to be struck by the sound signal, resonance occurs in the target i.e. oscillations are greatly amplified
- These resonating frequencies are characteristic of the thickness and material of the target
- The tool records the returning sound signal

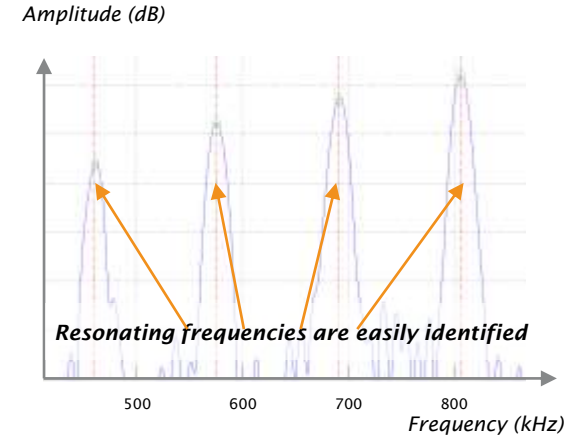
Interpreting

Identifying resonant frequencies allows for direct measurement of target thickness

- Direct measurement of thickness is revealed in the returning sound signal
- The frequencies that resonate (i.e. become amplified) are used to calculate the thickness of the steel
- time-of-flight (TOF) measurement allows for accurate caliper/geometry measurement

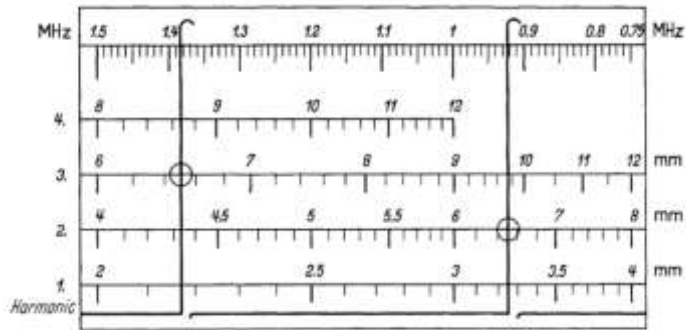
Fig. 11.3 Simplified scale of Vidigage for frequency range 0.75 to 1.5 MHz, with the 1st to 4th harmonic, resonance reading of a thickness of 6.5 mm at the 2nd and 3rd harmonic.

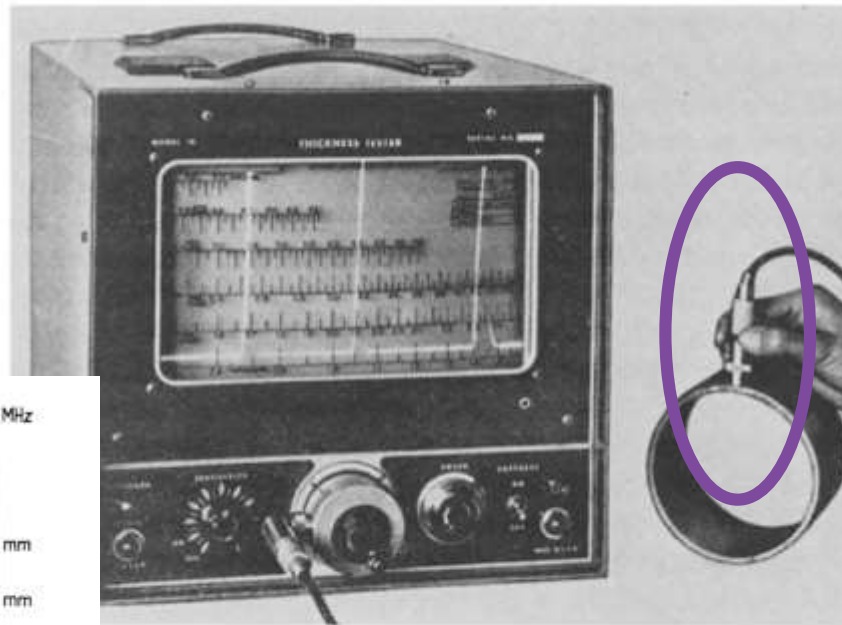
gauge, model 14 (Branson), showing the wall thickness measurement.

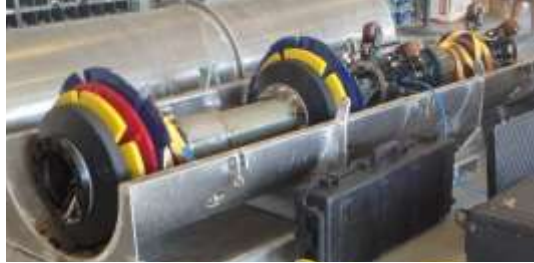
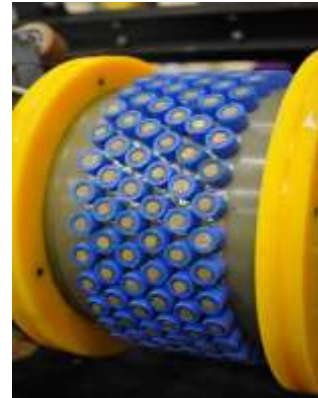
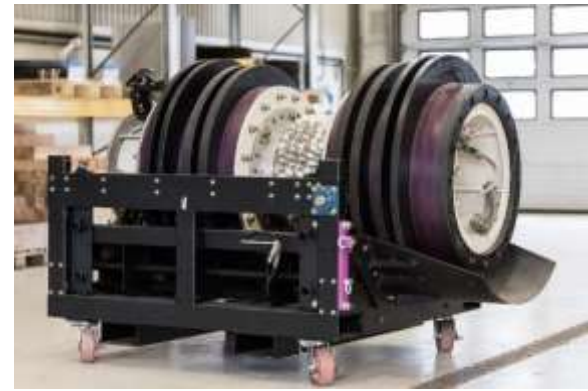
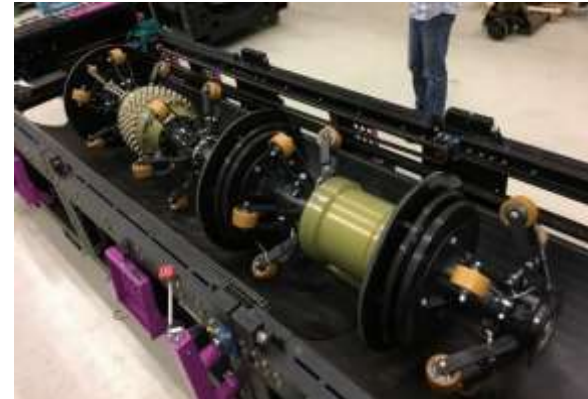
- 16 – 26 inch (128 channel)
- 24 – 30 inch (192 channel)
- 28 – 42 inch (192 channel)
- **36 – 48 inch (512 channel) Q3 2018 NPI**
- **48 – 56 inch (624 channel) Q3 2018 NPI**
- Wall Thickness: more than 100 mm
- Speed range: 0.1 – 5 m/s
- 3 odometers & IMU (gyros & accelerometers)
- Intrinsically safe, pressure and temperature recording, ELF pig tracker
- Reporting done in-house, to POF specs.

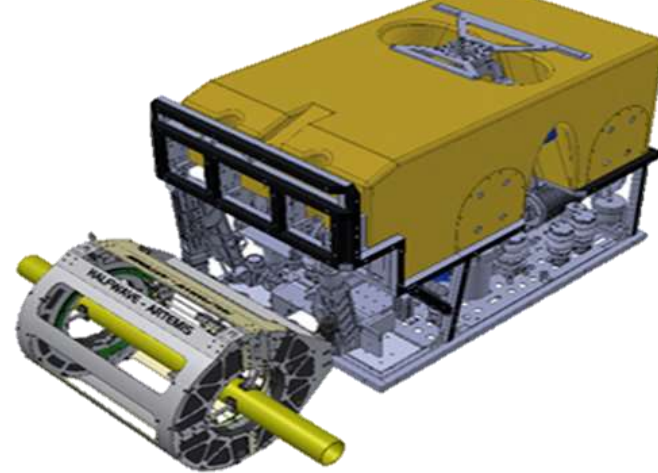
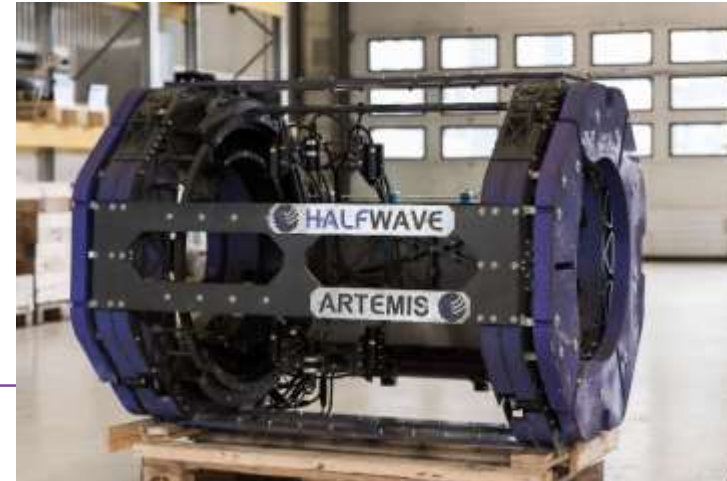
- **Depth rating:** up to 3,000 meters
- **ROV:** Compatible with all types and makes of ROV
- **Weight tooling:** 150 kg / Neutral Bouyancy
- **Spread:** 2 containers (1.2m x 1.5m x 1.5m, 250 kg)
- **Communications:** Fiber through ROV umbilical
- **Pipe diameters:** 6 to 17 inch
- **Data visualization:** Real time
- **Inspection applications:** Rigid and flexible piping
- **Inspection techniques:** TOF & ART
- **Inspection capabilities:** X- 1mm step, Y-1mm step
- **Steel thickness:** 10-100 mm
- **Personnel:** 2 man team for offshore operations
- **USP:** Scans Pipe Through the Coating.

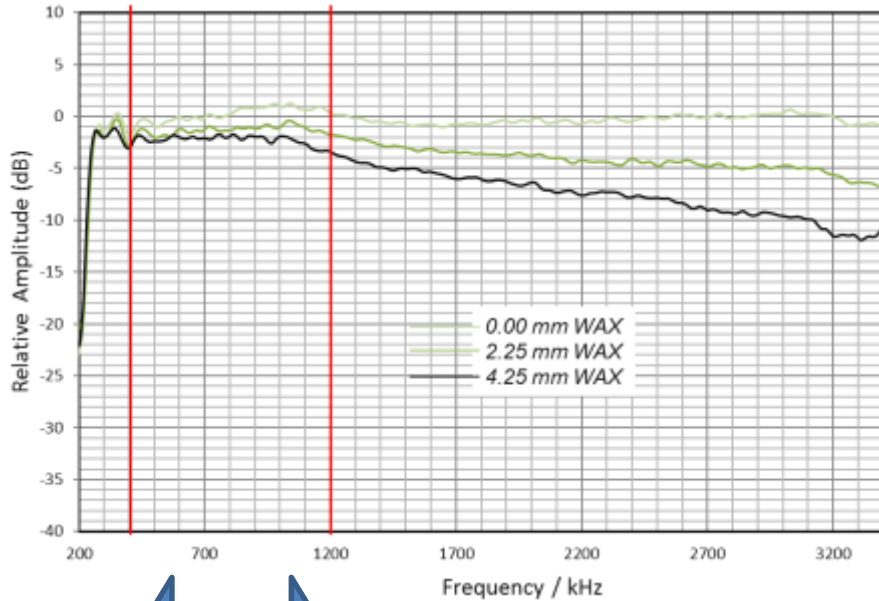
- Chart shows attenuation of sound through wax at different frequencies
- Low attenuation 400kHz to 1,2 Mhz bandwidth (ART Domain)
- ART measures wall thickness through wax
- ART also measures thickness of wax layer
- Traditional ultrasound operates at frequencies of 5 MHz and higher

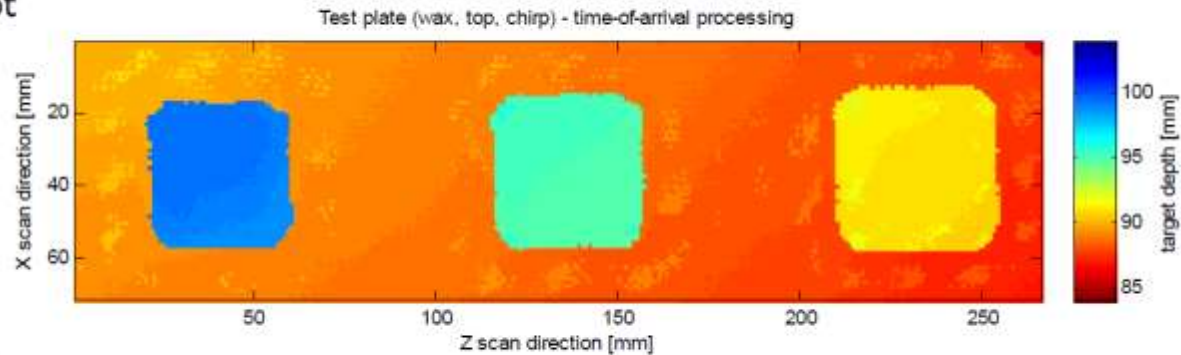
toa plot

With wax, chirp, top

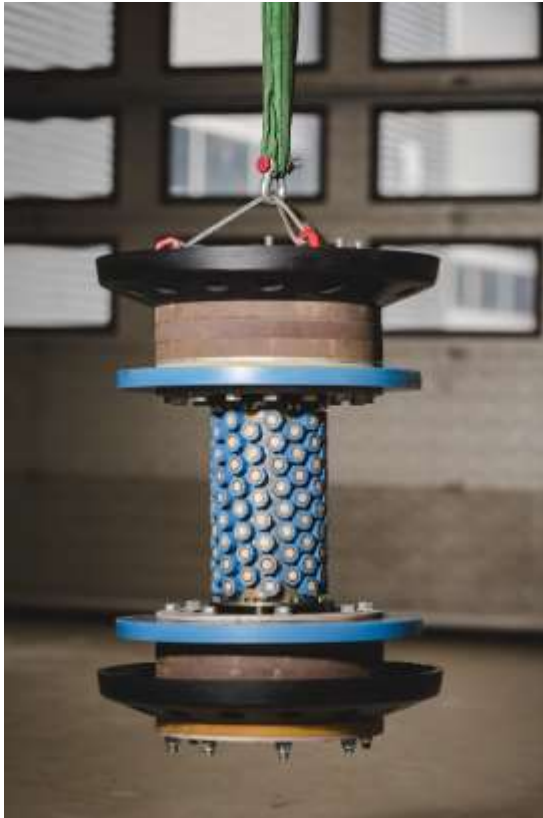
24" Crude Line Gulf of Mexico

- 24" x 132,5 km
- Inspection in Crude Oil > 300'000 BPD
- Offshore vertical launch onshore receive
- Challenging Wye Passage (from 3 to 8 ft/s)
- Non Return Valves
- 12.4mm – 27mm wall thickness
- Inspection performed July 2016

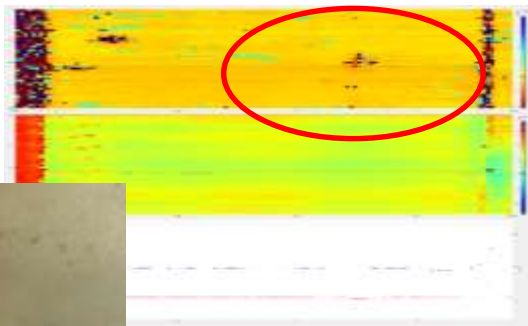
Excavated Feature (II)

- Corrosion Feature under pipe support detected
- Field Verification
- Nominal WT: 0.985 inch
- 6 o'clock metal loss feature called
- Support removed
- Feature depth verified in field

| | ART Scan | Field verification |
| Nom WT [in] | 24.9 mm | 25.0 mm |
| Depth [in] | 1.4 mm (5.5%) | 1.6 mm (6.2%) |

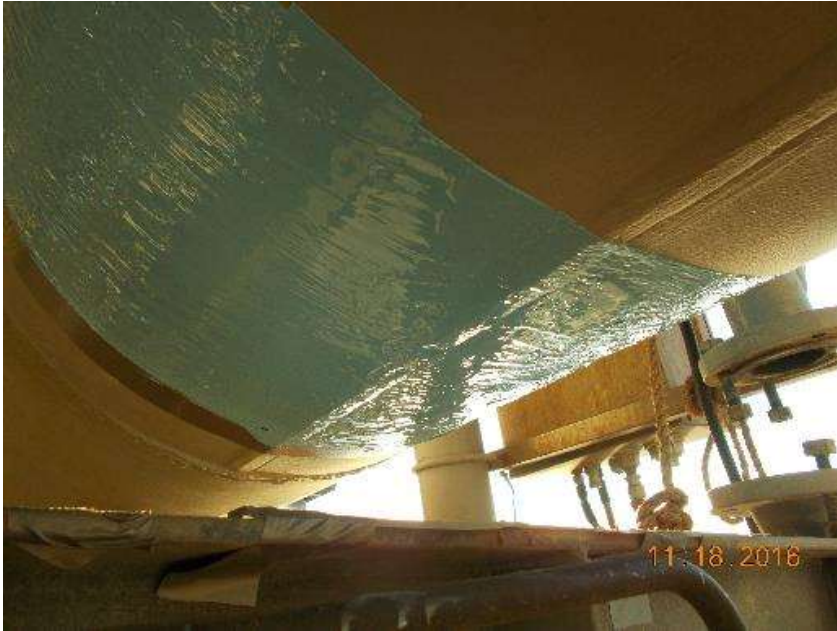
Verified Feature (II)

- Corrosion Feature under pipe support detected
- Field Verification
- Nominal WT: 0.985 inch
- 6 o'clock metal loss feature called
- Support removed
- Feature depth verified in field

| | ART Scan | Field verification |
| Nom WT [in] | 24.9 mm | 25.0 mm |
| Depth [in] | 1.4 mm (5.5%) | 1.6 mm (6.2%) |

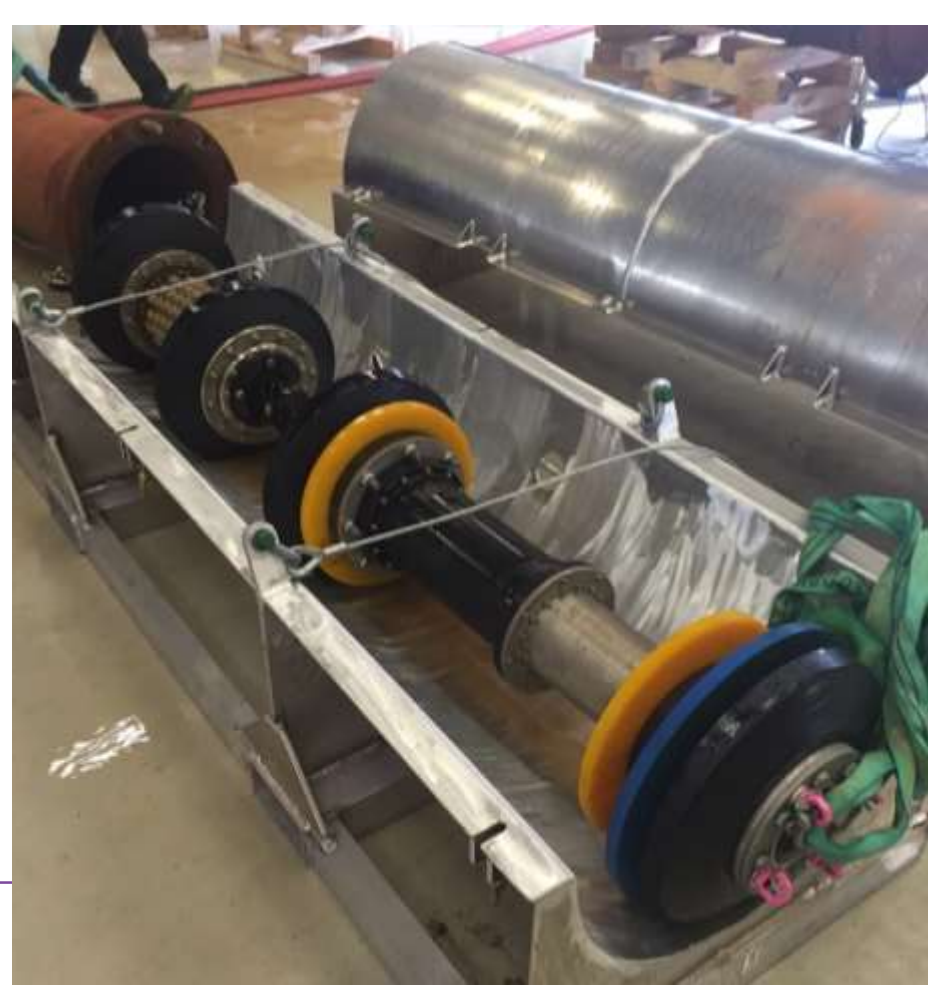
Crude Line in North Sea

Several challenges

- Low flow speeds
- Wye passage
- Wax deposition
- Plus side: Highly Experienced Operator

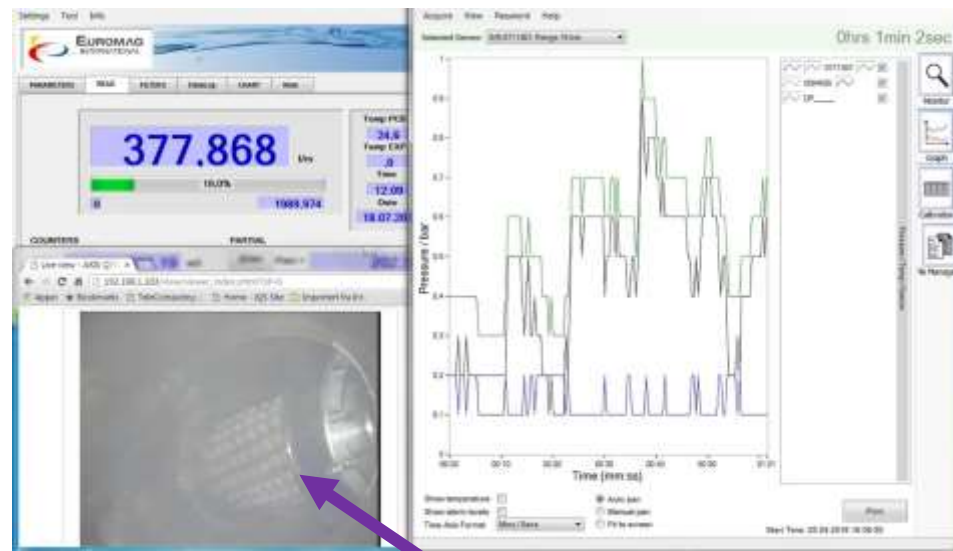
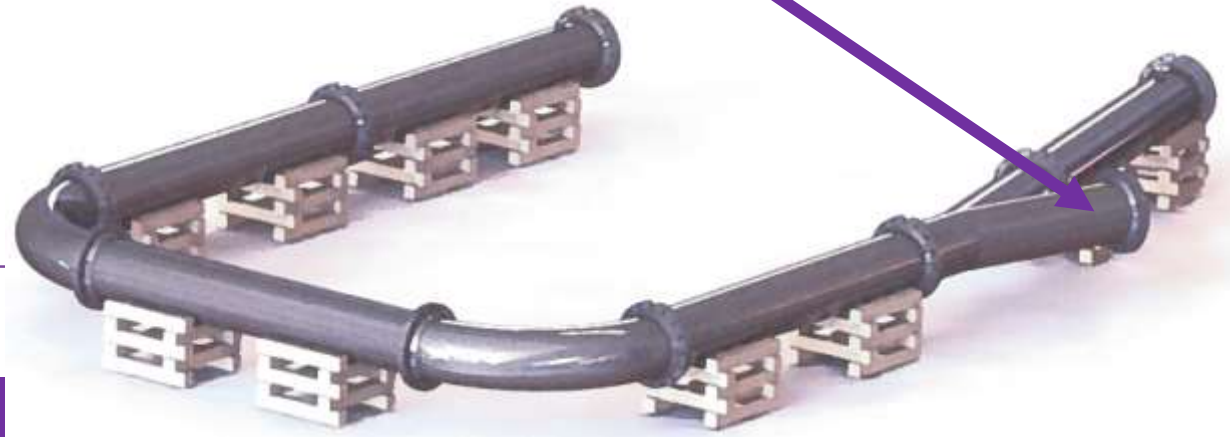
- Piggability Study
- Pigging Loop Constructed, Pigging Trials Performed
- Camera Installed
- Over 20 runs performed
- Speeds down to 0.04 m/s

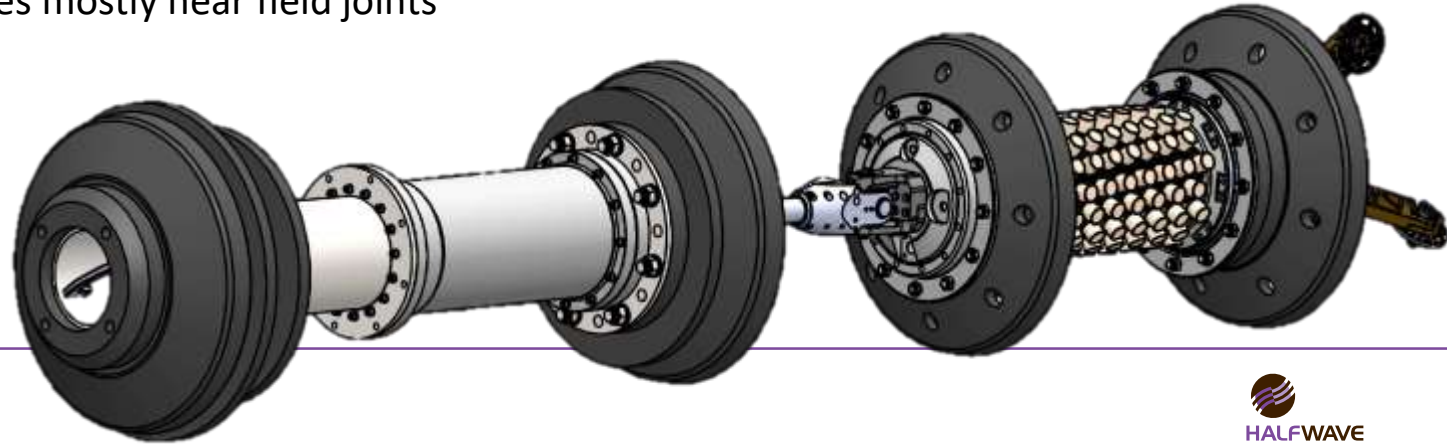
- Wax detected ~250 m into the line, mostly near 6 o'clock
- Typically about 200 mm wide, narrows to the end of the line
- Several metal loss features found, even under wax
- Internal Features mostly near bottom
- External Features mostly near field joints
