THE NORTH SEA RISER INSPECTION PROJECT

Jonathan Hoare, CNR & Tom Steinvorte, ROSEN · PPSA Aberdeen · 20-11-2019

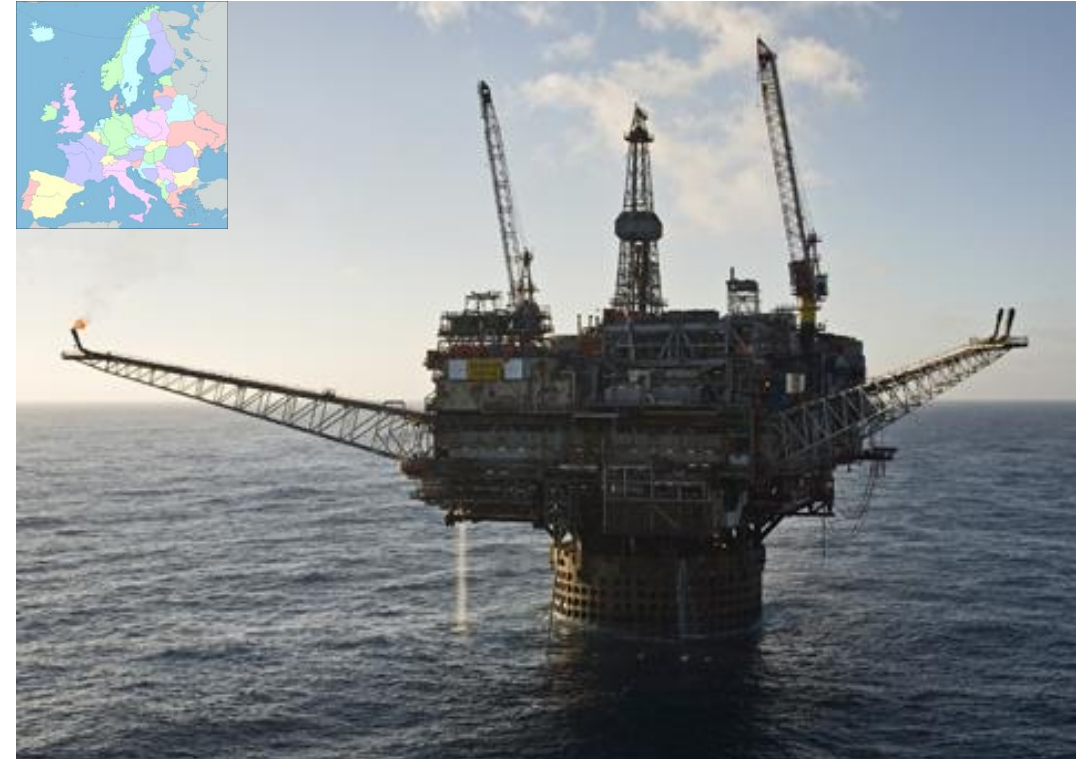
CNR operates a pipeline (25km, 130 barg) that imports gas to the Ninian Central platform operating as a hub in the Northern North Sea, around 386 km north-north east of Aberdeen.

The hub platform, together with another connected platform is used for production as well as processing and commingling of oil coming from surrounding fields.

The imported gas provides fuel for power generation systems, which in turn provide electric power for the platform.

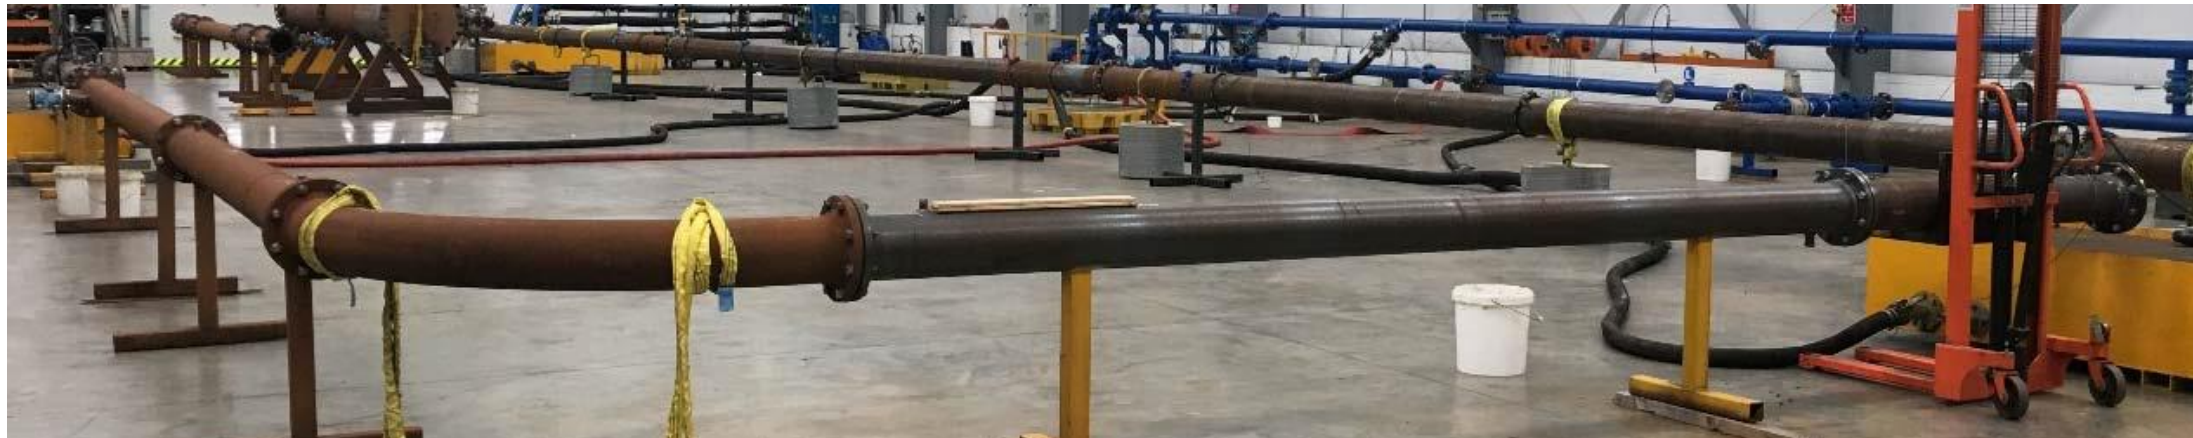
TESTING

Cleaning Tool:	UT ILI Tool:
<p>Launch pressure ~ 1.5 barg Flip pressure in 200mm ID straight section ~ 2.6 barg Flip pressure in 187mm ID 5D bend ~ 2.3 barg Running pressure 200mm straight ~ 1 barg Running pressure 187mm straight ~ 1.8 barg Running pressure 187mm 5D bend ~ 2.5 barg Running pressure 182 mm 6D bend ~ not tested</p> <p>Forward speed – 0.1 m/s Reverse speed – 0.1 m/s</p>	<p>Launch pressure ~ 2.0 barg Flip pressure in 200mm ID straight section ~ 3 barg Flip pressure in 187mm ID 5D bend ~ not tested Running pressure 200mm straight ~ 1.5 barg Running pressure 187mm straight ~ 3 barg Running pressure 187mm 5D bend ~ 5 barg Running pressure 182 mm 6D bend ~ 7 barg</p> <p>Forward speed – 0.1 m/s Reverse speed – 0.2 m/s – 0.5 m/s</p>

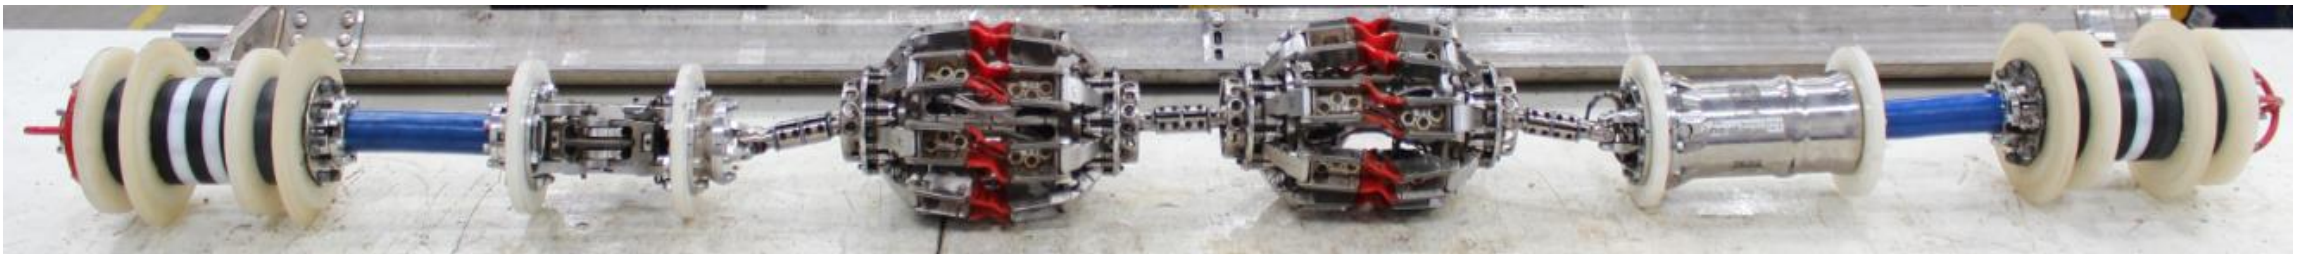
In order to ensure the majority of the riser could be expected whilst minimizing the risk of the front sealing pig or worse the UT tool entering the flexible, the running procedure was formalized using bore maps and drawings of the riser and then optimized and calibrated by performing multiple runs in the riser.

After each intermediate UT tool recovery the data would be downloaded from the tool and uploaded to ROSEN server to determine the tools stop position.

- Compare recorded tool distance with the volume pumped.
- Compare signals in welds and bends with the riser drawings.
