# WHEN BOTH SHALL MEET: MANAGING INTEGRITY FOR H<sub>2</sub> AND CO<sub>2</sub> CONVERSION

Neil Gallon (ROSEN, Newcastle upon Tyne, UK)

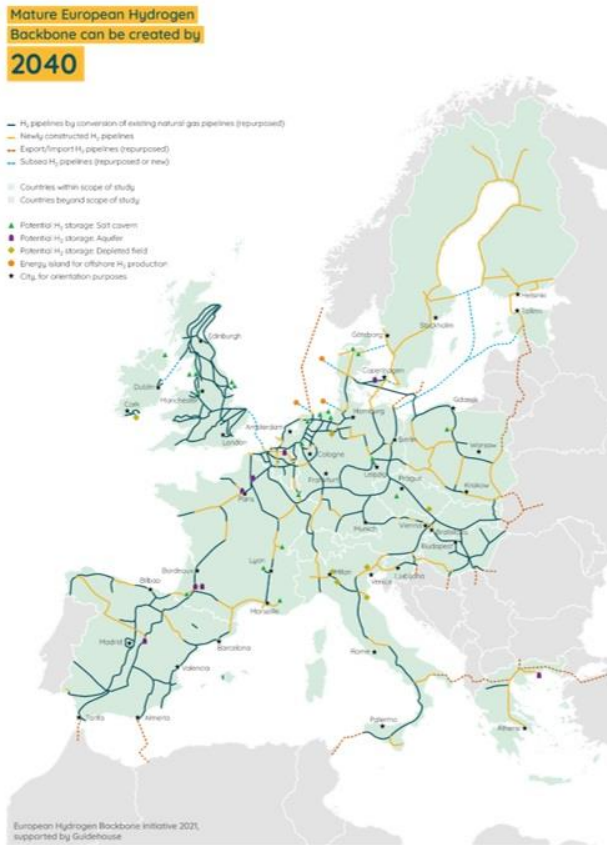
Figure 1 – Proposed European Hydrogen Backbone in 2040

European Hydrogen Backbone which envisages a network of almost 40,000 km of hydrogen pipelines by 2040, of which 69% (c. 27,000 km) will be repurposed existing lines.

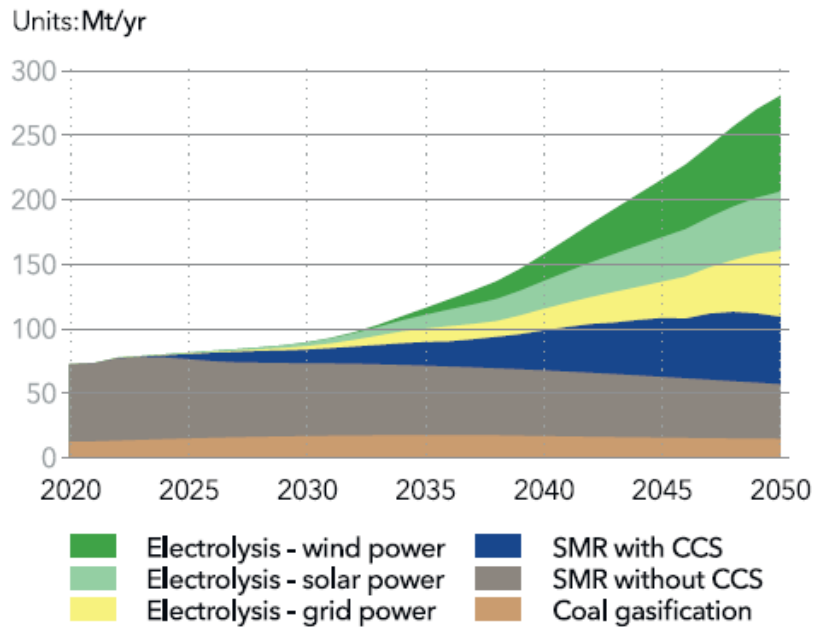
Figure 2 – World Hydrogen Production by Source

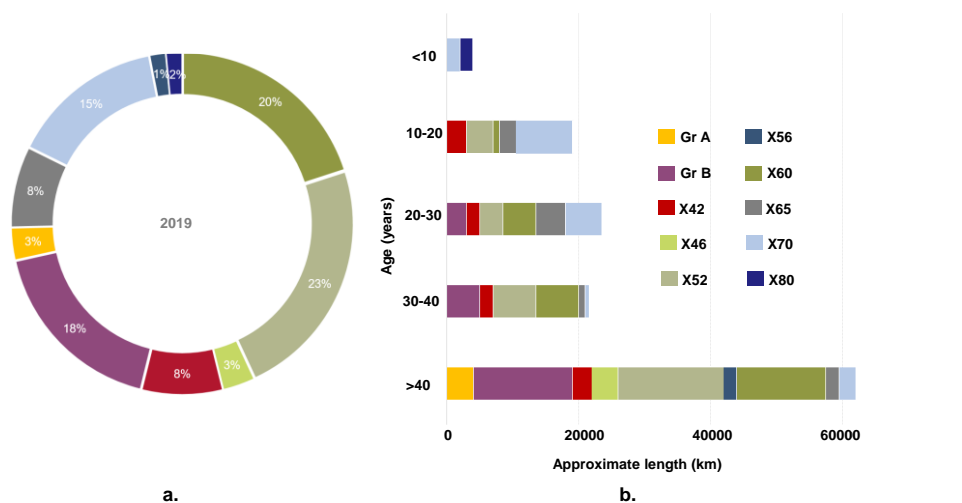
Figure 3 – Steel Grades<sup>3</sup> in NG Transmission Lines in Europe (a) 2019 Distribution; (b) Versus Age [1]

While CO<sub>2</sub> and hydrogen pipelines could be purpose-built [2][3][4] to address the range of applicable integrity concerns, it is very likely that a major proportion of the future transmission network will revolve around the integration of existing Natural Gas (NG) or other hydrocarbon infrastructures. Hydrogen and CO<sub>2</sub> pipeline design codes<sup>2</sup> tend to be more constraining or restrictive than that for hydrocarbons. For example, typical hydrogen standards will limit the use of steels up to API 5L X52 (L360) to tackle hydrogen embrittlement issues, while over 45%<sup>3</sup> of the European NG system is designed with higher steel grades (see Figure 3).

<sup>3</sup> The grade only refers to the Specified Minimum Yield Strength (SMYS), the Actual Yield Strength (AYS) could be higher. It is common for material nominally supplied as X52 to have an actual strength, which would meet X60 or even X65 requirements. Thus the percentages of pipelines designed with grades above X52 can be actually much greater than 45%.

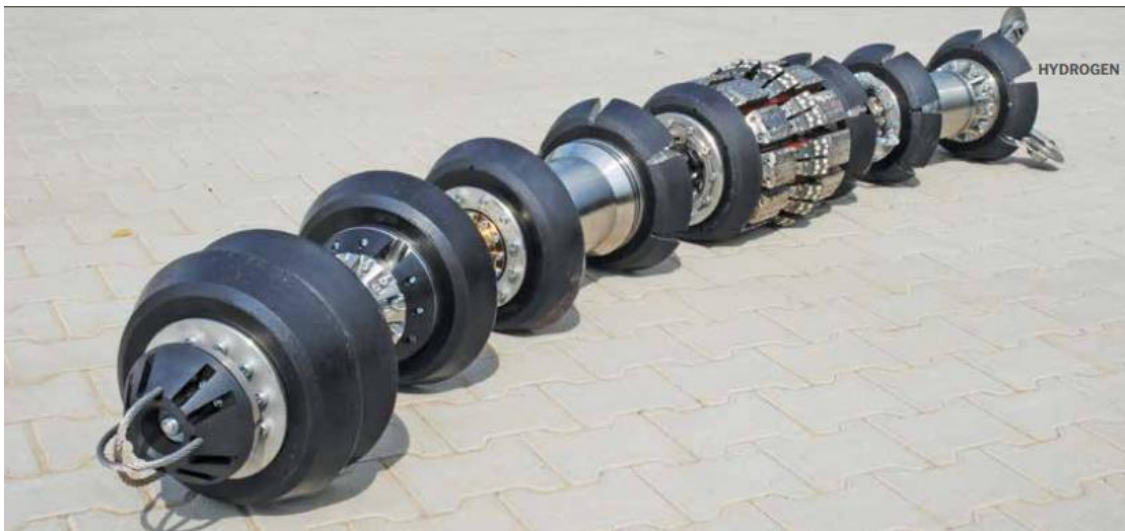
Figure 4 – ATEX Compliant MFL ILI Tool

This pipeline was originally installed in 1996 and set up for the transport of hydrogen. At the time, the only way to inspect hydrogen pipelines was by utilizing water as the propellant which was costly and time consuming. In 2015, the operator approached ROSEN for a method to safely inspect the line using a combination of geometry and magnetic flux leakage (MFL) technologies, and requested whether the inspection could be performed in hydrogen. Following a detailed study, it was concluded that this was possible and could be done safely. Initially the tool was set up in accordance with the European Union’s ATEX directives, which included providing a flameproof enclosure for the components, having a pressurized enclosure for the electronics and utilizing intrinsic safety with voltage-restricted electrical circuits. The tool was also set up with non-standard cups (different hardness) to lower the risk of static electricity, resist decomposition and allow for proper resistance to uneven wear. The magnet circuits were also protected to avoid the possibility of hydrogen damaging the magnets themselves. Finally, the flow conditions were assessed. For a standard tool set-up a minimum pressure of 435 psi is typically requested, however this was not considered feasible for the hydrogen pipeline, instead a pressure of ~270 psi and a flow rate of 11 MMscfd was required. In order to reduce excessive velocity from pressure build-up in installations while still providing enough seal to propel the tool through the line, various bypass holes and notches were applied to the design (see Figure 4).

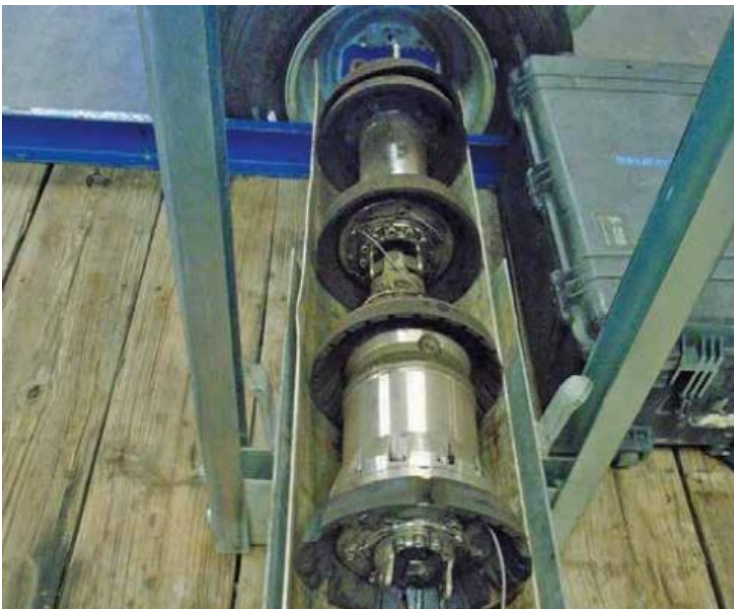
Figure 5 – Tool on Arrival at Receiver

Once these adjustments had been made to the tool, the line was initially inspected in January 2017. The resulting data showed 100% sensor coverage for both geometry and MFL, and magnetization levels, although some velocity spikes were noticed in installation areas the overall data quality was acceptable for evaluation. The tool was inspected after extraction and there was no evidence of any damage to tool or components, with the cups showing minimum wear (see ).

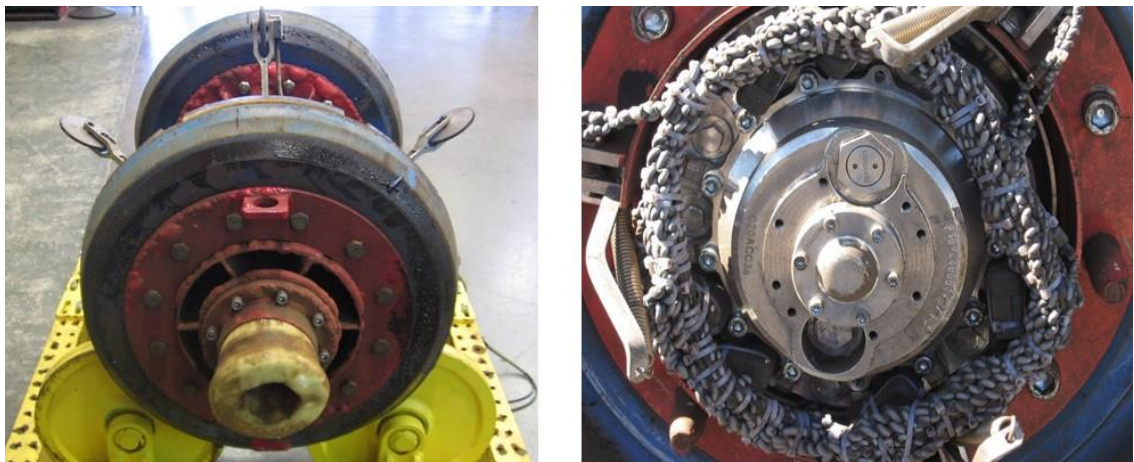
**Figure 6 – Post-run Images of EGP tool (left) and MFL Tool (right)**

Diameter	Pipeline length	Pressure	Temperature	Tool deployed	Observations post-run
24” OD	116 km	131 bar	16 degC	Geometry (Electronic Geometry PIG: EGP)	Run successful; no damage was reported.  Several hours later in the workshop, the plastic and rubber parts of the tool began to show signs of bubbling. The cups and discs were not severely affected, with no bubbles being identified while the buffer showed signs of swelling and bubbling. This was attributed to the different materials used, with the buffer being softer (65 Shore hardness) than the cups and discs (85 Shore hardness), see Figure 6.
				Magnetic Flux Leakage (MFL)	Run successful; tool showed no extreme wear on the cups and the disc.  There was a visible difference in appearance of a high number of cables a short time after receiving, with excessive swelling being noted, see Figure 6.
24” OD	120 km	134 bar	-	Geometry (Electronic Geometry PIG: EGP)	Similar to above
