Experiences with ultrasound in wax rich pipelines

PPSA seminar 17. November 2010 Roger Hunsbedt – Statoil pigging and in-line inspection

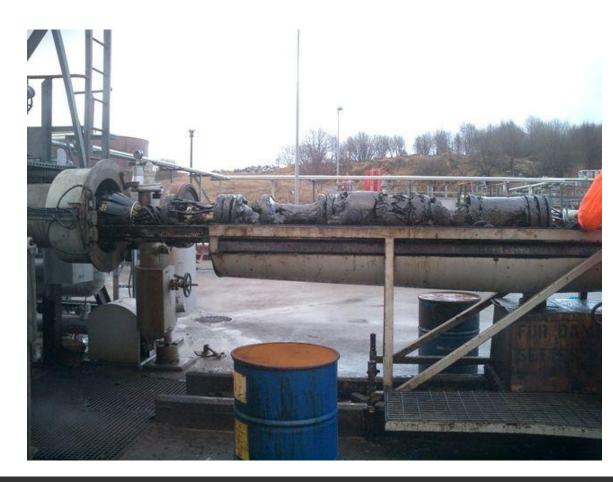
2006 UT inspection

- UT tool
- First 18 km inspected out of 89 km.
- No data from landfall tunnel
- Odometer wheels sliding
- Sensors covered by wax

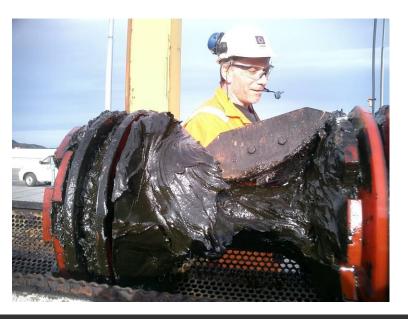
Type of wax?

- 8 cleaning pigs sent
- Pebble like wax in front of pig
- Amount of wax varies

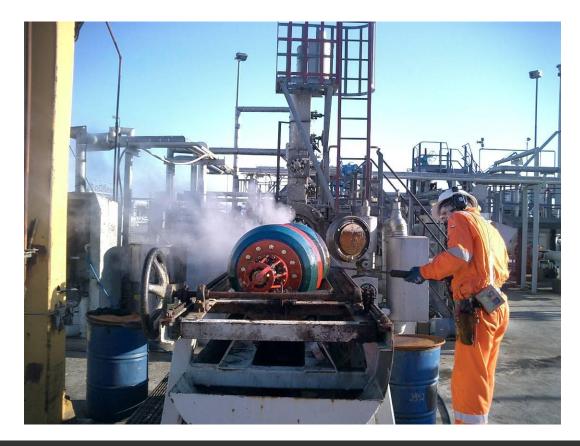
How much wax?

- Run an Eddy Current based
 geometric tool
- Not possible to quantify amount of wax in pipeline

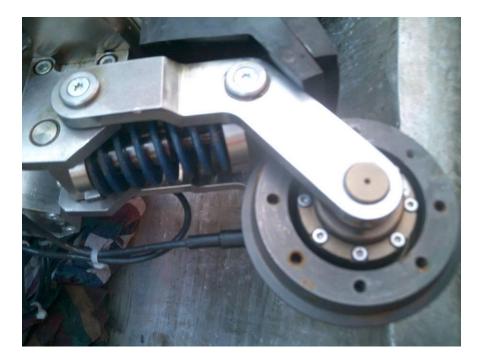
Improvements - odometer wheel system

- Increased diameter
- Increased spring force
- Positioned in "wax free" rear end
- Time trigger mode introduced
