ASSESSMENT OF THE EFFECTIVENESS OF CLEANING PROGRAMMES

By: David Russell, Project Manager, Research and Development, Pipeline Engineering
Chris Marshall, Project Manager, Pipeline Engineering

Abstract

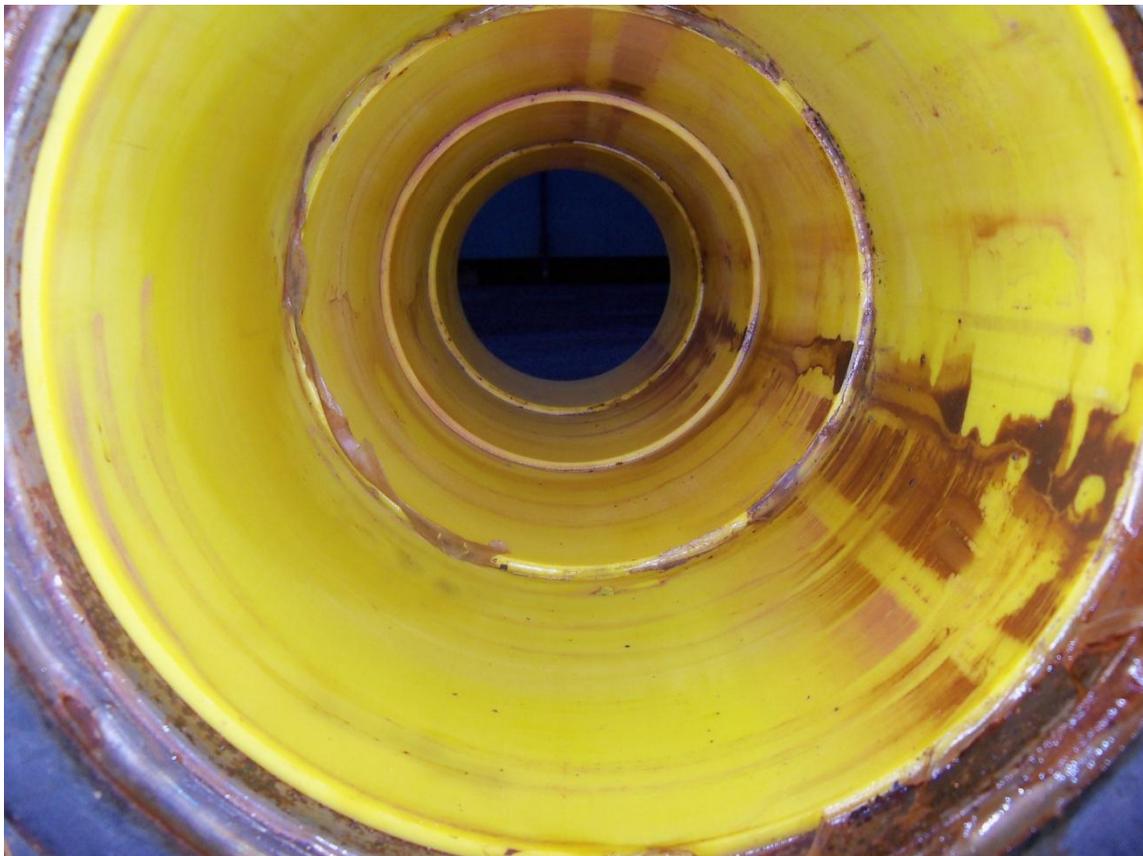
Figure 1 - Offset Test Section

Two test spools were prepared for use in pull-through testing on PE's Catterick site. The first of these consisted of two short, flanged 10" pipe sections, each only 500mm in length. These had moulded polyurethane inserts the thickness of which varied from 5mm to 20mm in steps of 5mm (Figure 1). This section was intended to provide a test of the ability of the tool to accurately measure arm lift-off from the pipe-wall.

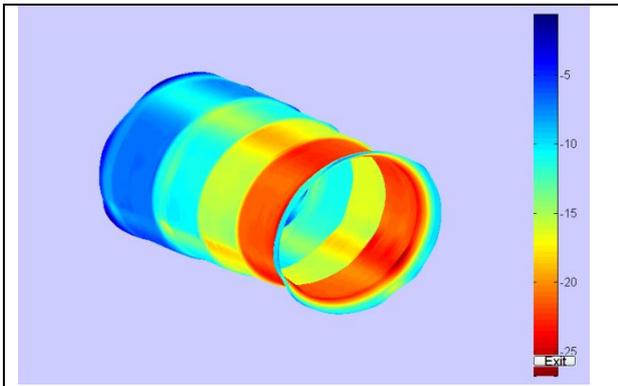
Figure 2 - Test Section 1, Pull-Through Test

The PECAT tool was built up and pulled through the test section using a winch. Speeds in the range 0.5 – 1.0 m/s were achieved. The 10" spider was observed to give acceptable centring of the tool as it travelled through the pipe. The test was repeated a number of times in order to provide baseline data on repeatability of measurement.

Figure 2 to Figure 7 show results from the pull-through tests. Outcomes are seen to be inline with expectations.

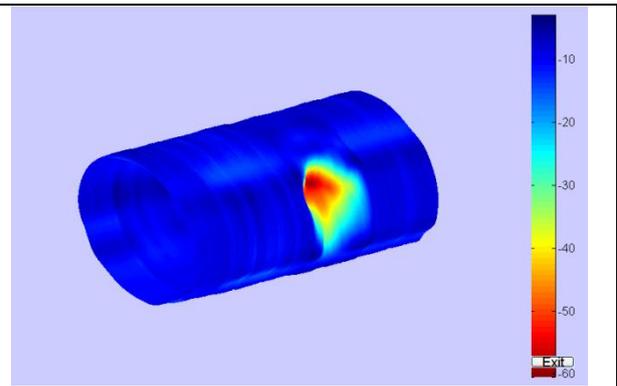
Figure 3 - 25% Dent, Pull-through Test

The second test section consisted of a 4m long 10" pipe spool with five simulated dents, ranging in size from approximately 2% of ID up to 25%. These were created by heating the pipe before deforming it. This spool was intended to test the caliper functionality of the tool, and give information on its ability to discriminate between dents and offsets due to the build up of non-ferrous material on the pipe interior.

Video monitoring of the pig motion showed that the arm springs were sufficient to centre the sensor spider in the pipeline. As it passed through the test section, the largest (25%) dent was seen to push the spider over to one side, as expected. This is in line with the expected design behaviour to permit the tool to pass large obstructions by dividing the required displacement between opposite arms.

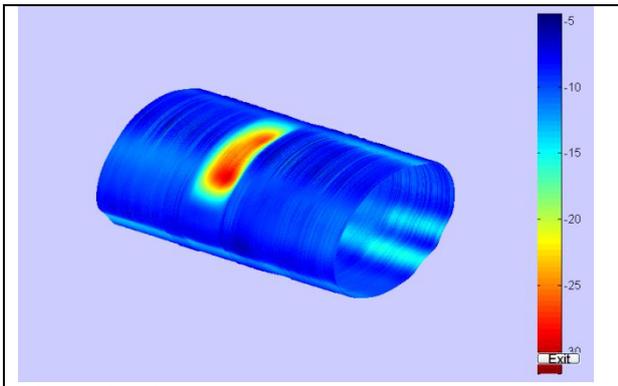
Figure 4 - 12% Dent, Pull-through Test

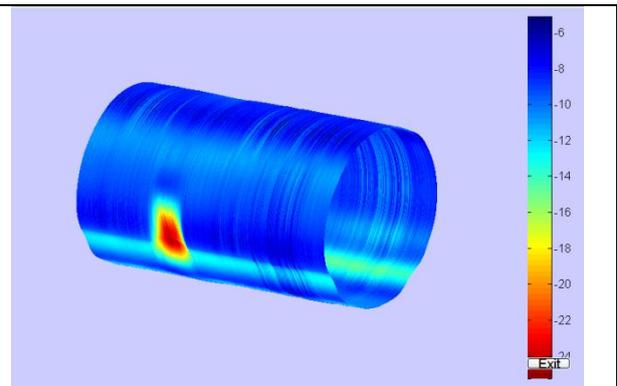
Figure 5 - 6% Dent, Pull-through Test

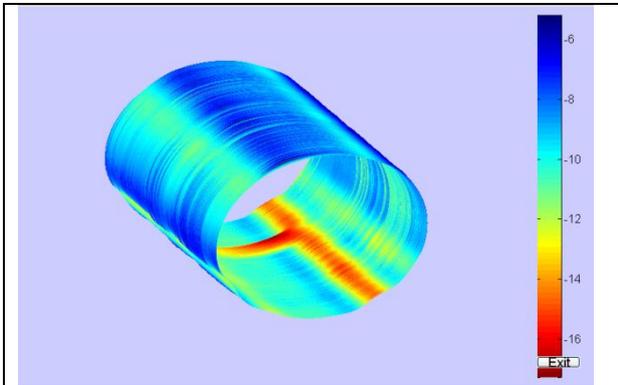
Figure 6 - 3% Dent, Pull-through Test

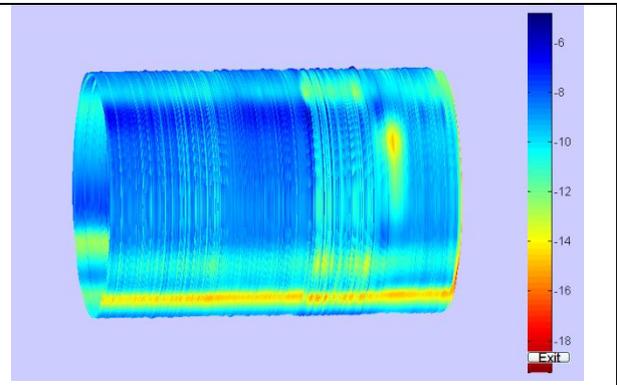
Figure 7 - 2% Dent, Pull-through Test

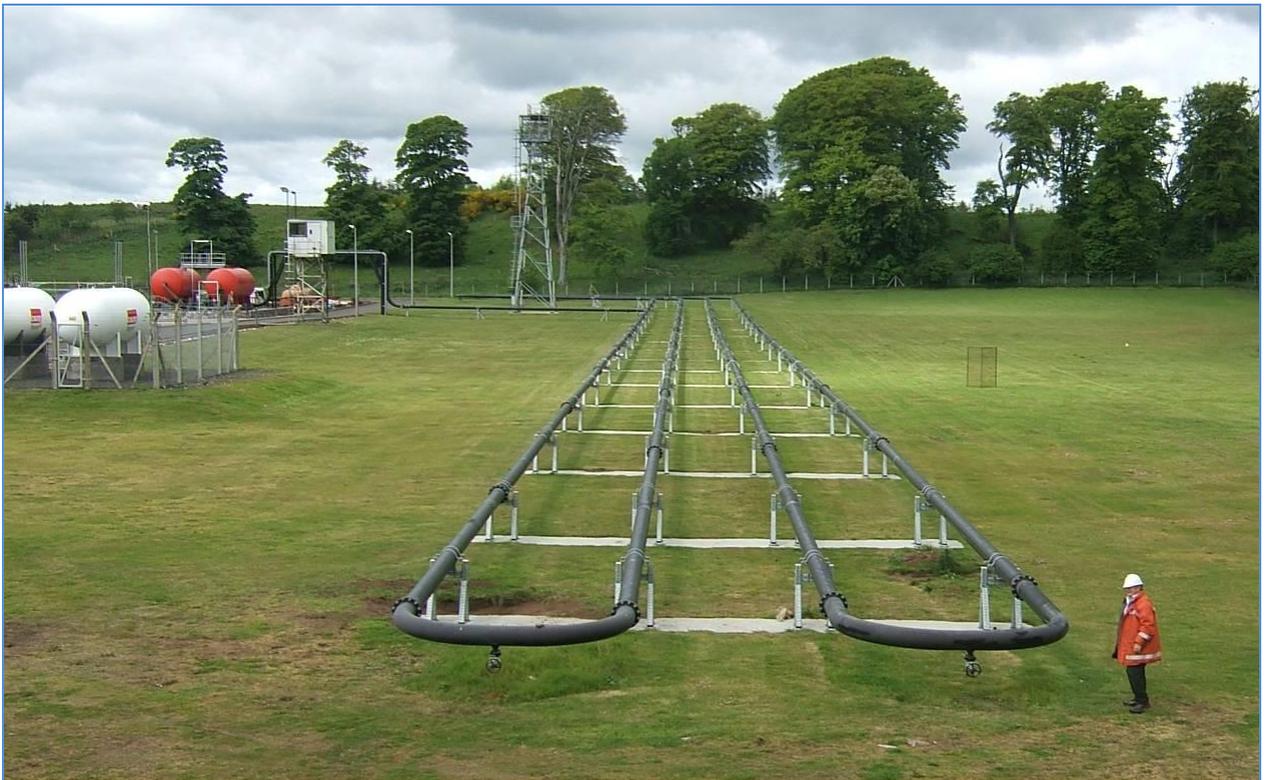
Figure 8 - Montrose Test Facility

A further set of pigging tests were performed at Petrofac's Montrose facility. Figure 8 shows the test loop, and

Parameter	Unit	10" Pipeline
OD	m	0.273
WT	m	0.0078
ID	m	0.2574
Length of Pipeline	m	1000
Unit Volume	m ³ m ⁻¹	0.052
Total Pipeline Volume	m ³	52.035

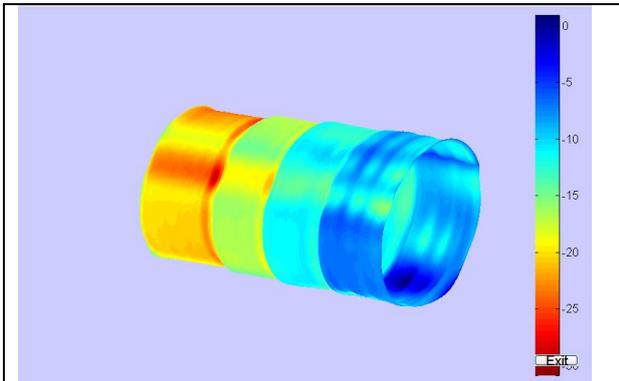
Figure 9 - Pig Trials, Test Section 1

The same test spools as were used with the facility as had been used during the Catterick pull-through tests. The spools were orientated with the coated section first, with the thinnest coating at the upstream end. Pigging speeds from 0.25m/s up to 1.2m/s were tested. The overall aim of testing was

Figure 9 to Figure 14 show sample results from the loop trials. These were generally in line with the expected performance of the tool; however a number of issues were identified which required further engineering.

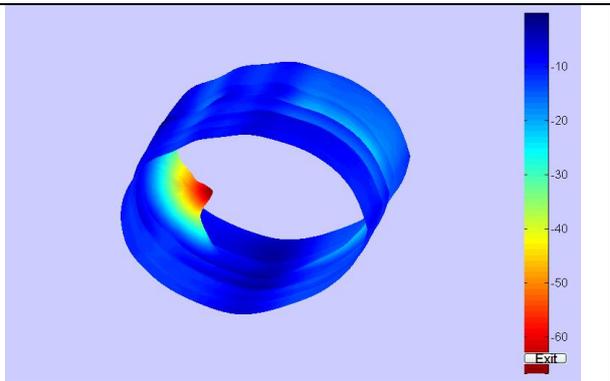
Figure 10 - Pig Trials, 25% Dent

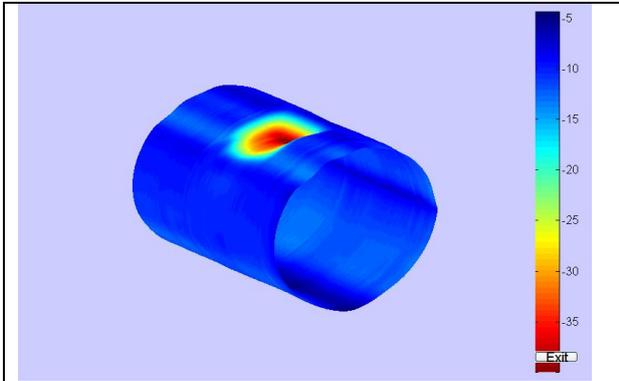
Figure 11 - Pig Trials, 12% Dent

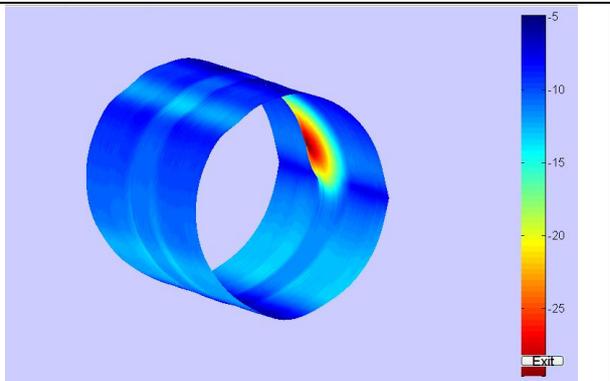
Figure 12 - Pig Trials, 6% Dent

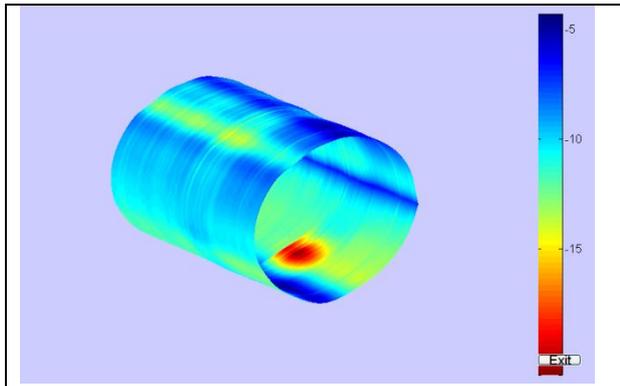
Figure 13 - Pig Trials, 3% Dent

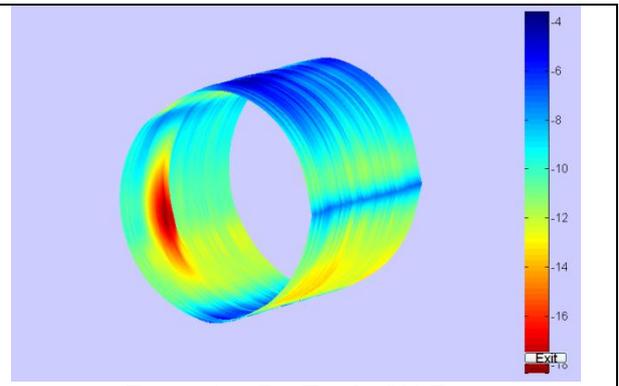
Figure 14 - Pig Trials, 2% Dent

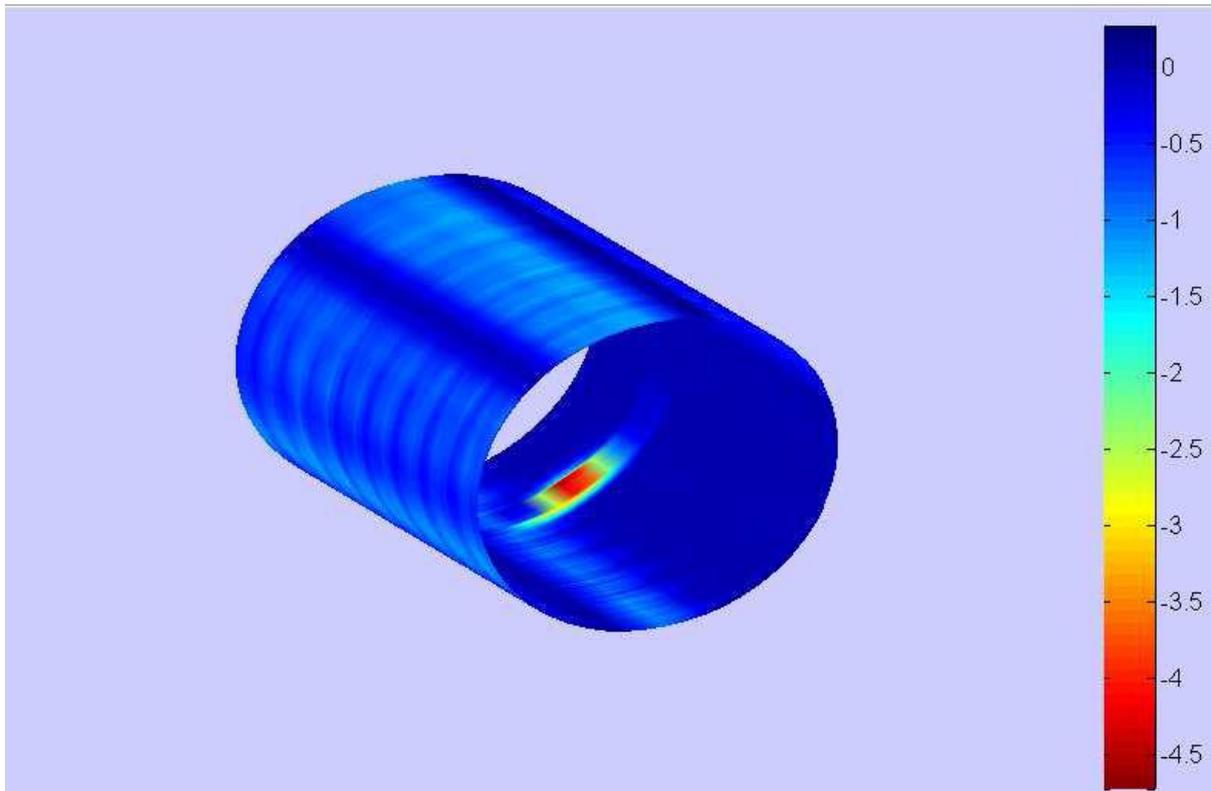
Figure 15 - Lift-off Anomaly

Figure 15 shows the offset measurement for the only significant short-range feature found in the line. This is an approximately square feature 250mmx250mm and 4mm deep. Apart from being non-ferrous, the nature of this obstruction is not clear. The calliper measurement also detected this intrusion into the line, perhaps suggesting a foreign object.

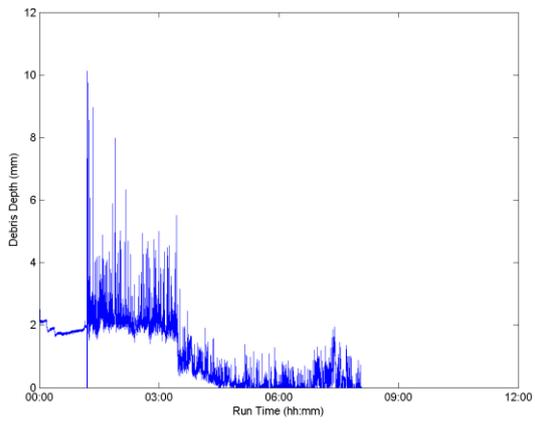
Figure 16 - Typical Arm Data - Run 1

The initial survey showed significant quantities of debris present, particularly in the first few km of the line, at thicknesses up to 2mm. There was also evidence of some intermittent very large deposits of material. Estimation of total volumes of debris present from this type of tool are subject to uncertainties, but it was clear that a significant amount of wax was present, of the order of 10 cu. m. Following a six week cleaning programme PECAT was run a second time. Significantly smaller quantities of wax were detected on this second run, amounting to no more than a quarter of that previously detected.

Figure 16 and Figure 17 show some typical arm data for the two surveys, with the second survey indicating only residual quantities of wax present in the line.
