ASSESSING MECHANICAL DAMAGE USING MULTIPLE DATA SETS IN ILI

Abel Lopes
Market Development Manager EH
14th November 2012

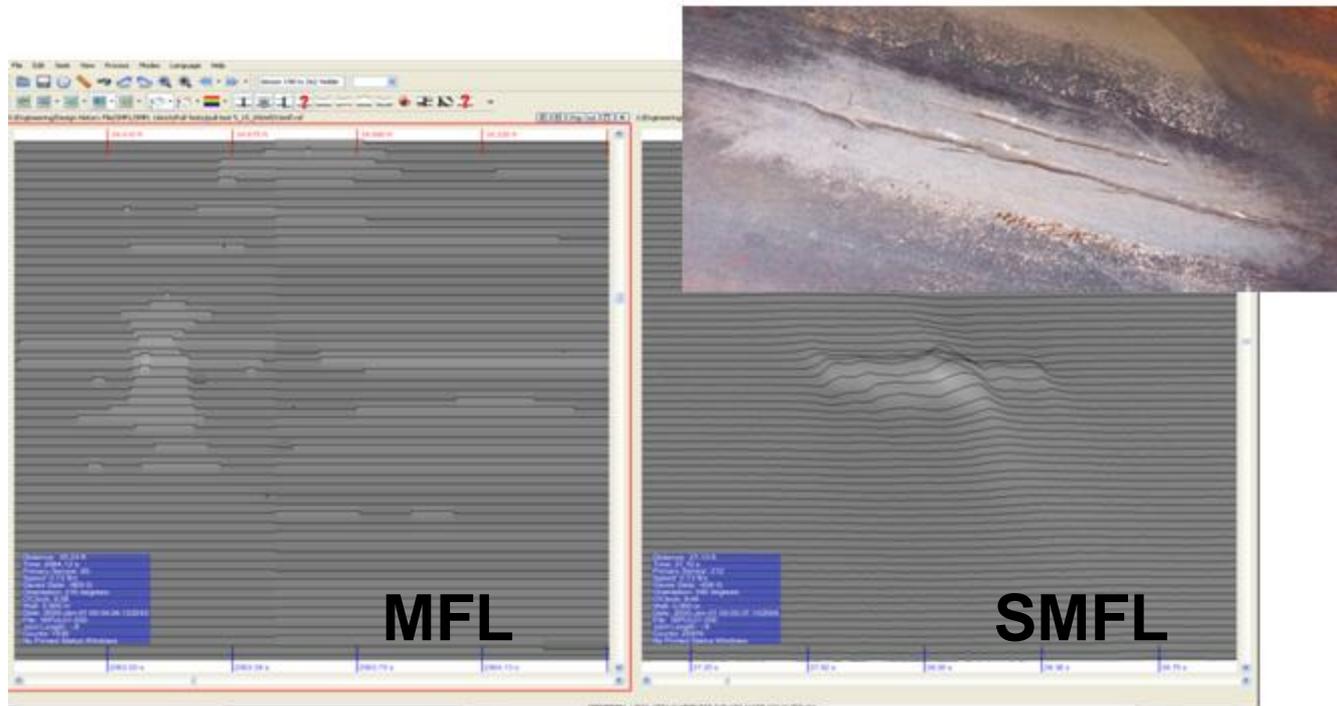
- 16-inch inspection tool runs indicated that SpirALL™ MFL technology successfully identifies narrow axial defects that normally would not be reported by axial MFL alone.

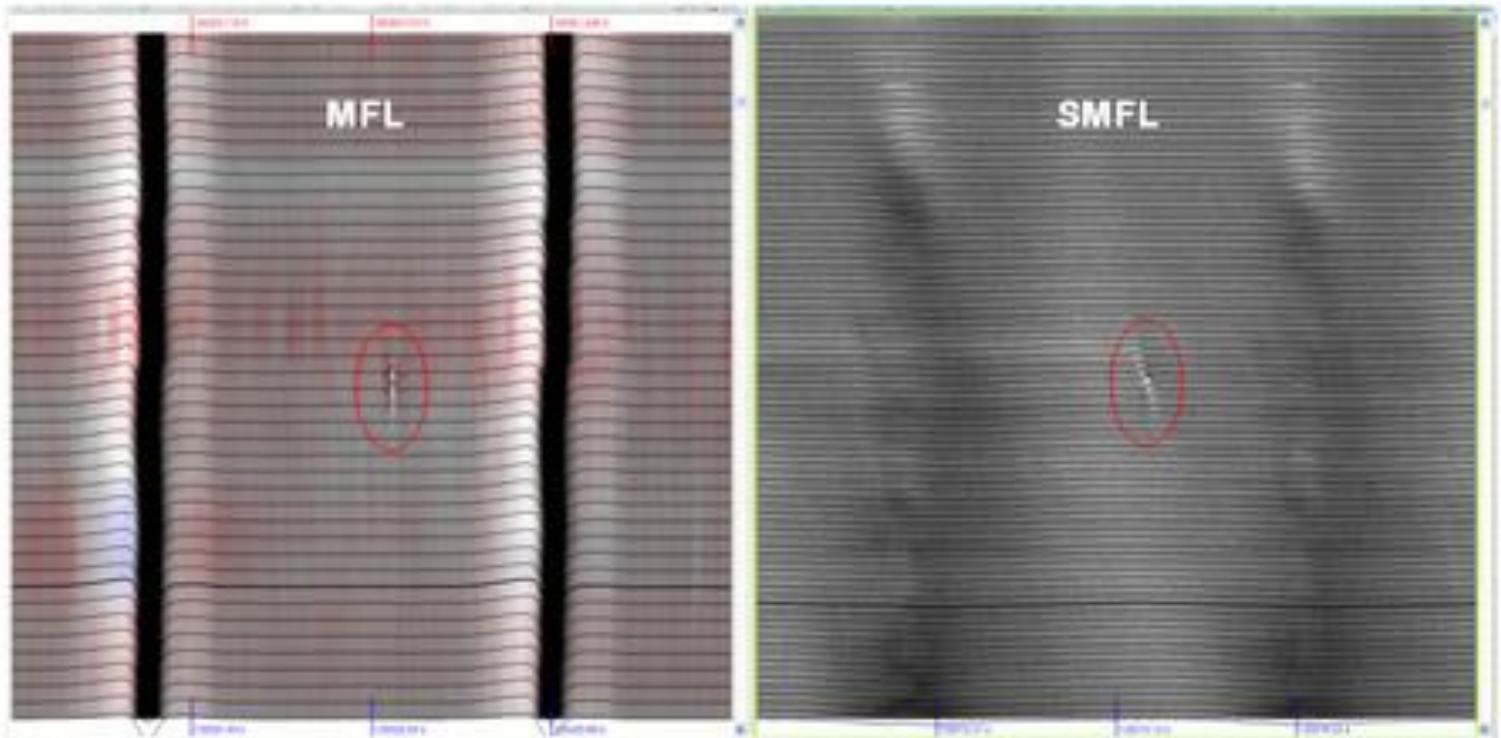
- By combining axial MFL with SpirALL™ MFL in the same run, it becomes possible to identify the anomaly as a metal loss feature that happens to be in the seam weld instead of a crack-like feature in the seam

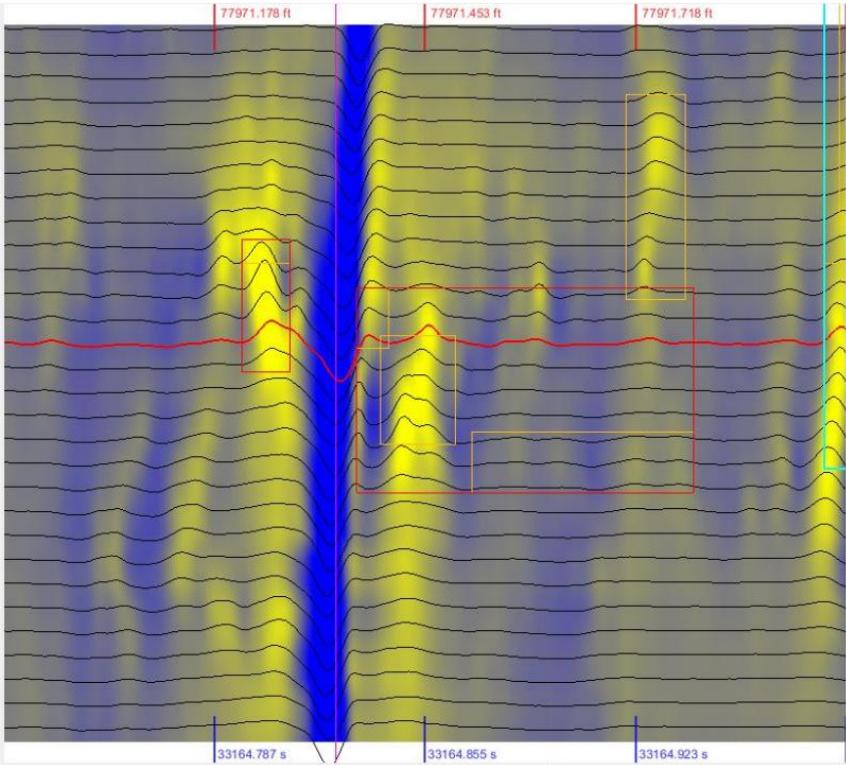
MFL

Metal Loss crossing and within a girth weld

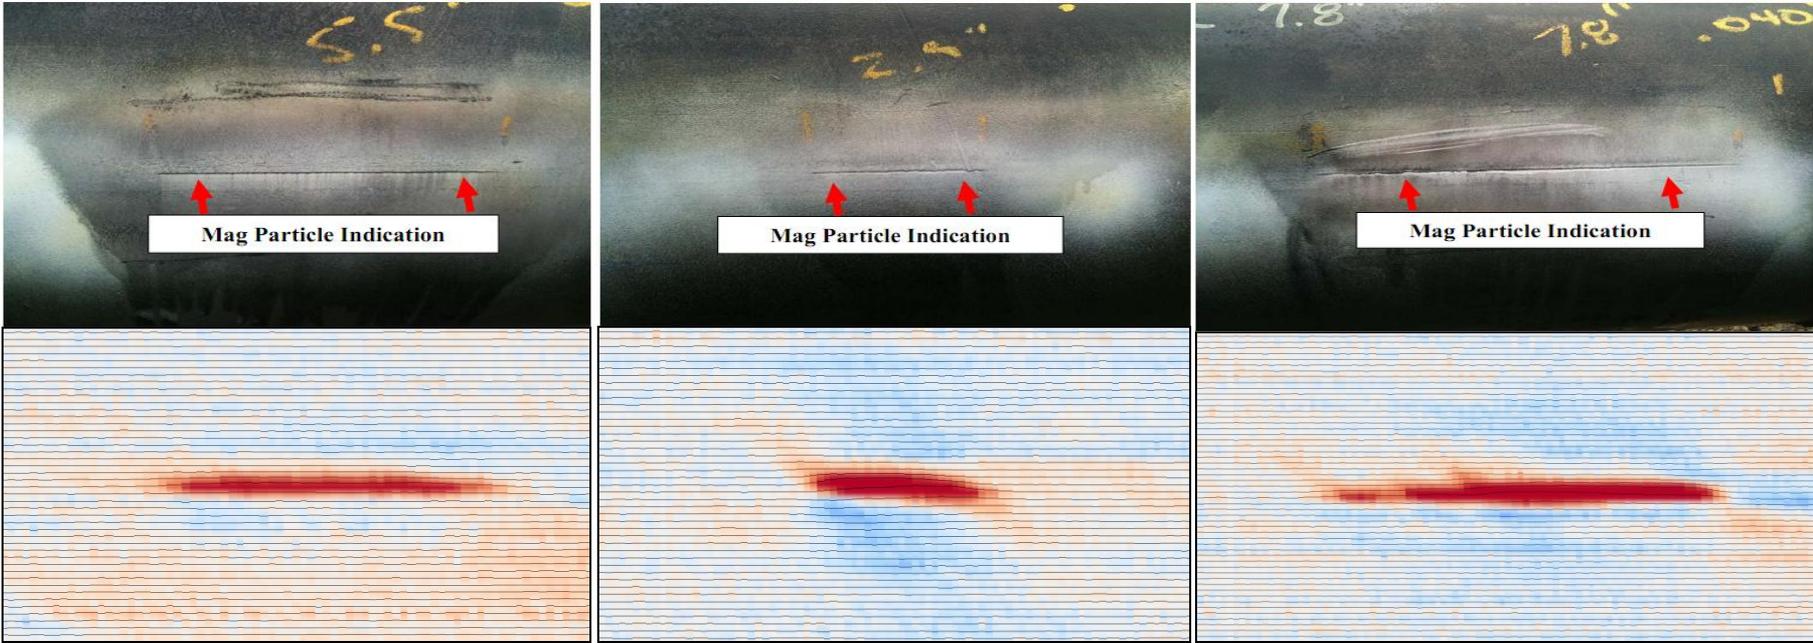
Anomaly 1, 2 and 3 (left to right): zoomed in SMFL screenshot with dig photo

#	Descr.	ILI %	Field %	ILI Length (mm)	Field Length (mm)	ILI Width (mm)	Field Width (mm)
1	Planar	19	16	109	140	1.3	Linear
2	Planar	29	14	61	73	1.8	Linear
3	Planar	15	16	188	198	2.0	Linear

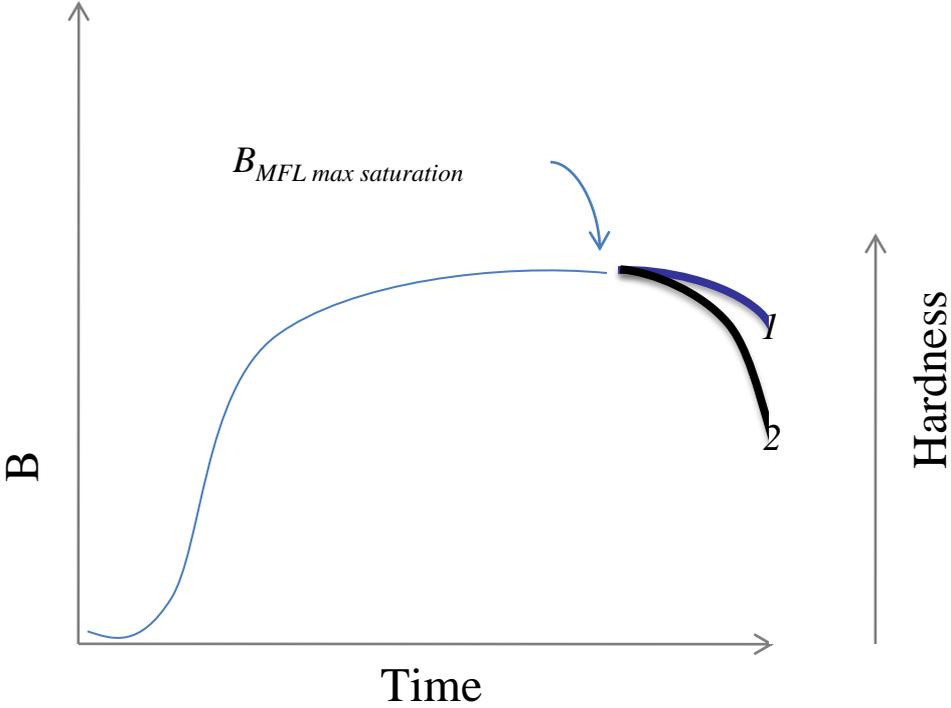
- *Two different steel lattices will produce two different residual measurements (1,2)*
- *This happens with hard spots, heat affected zones, and stress.*

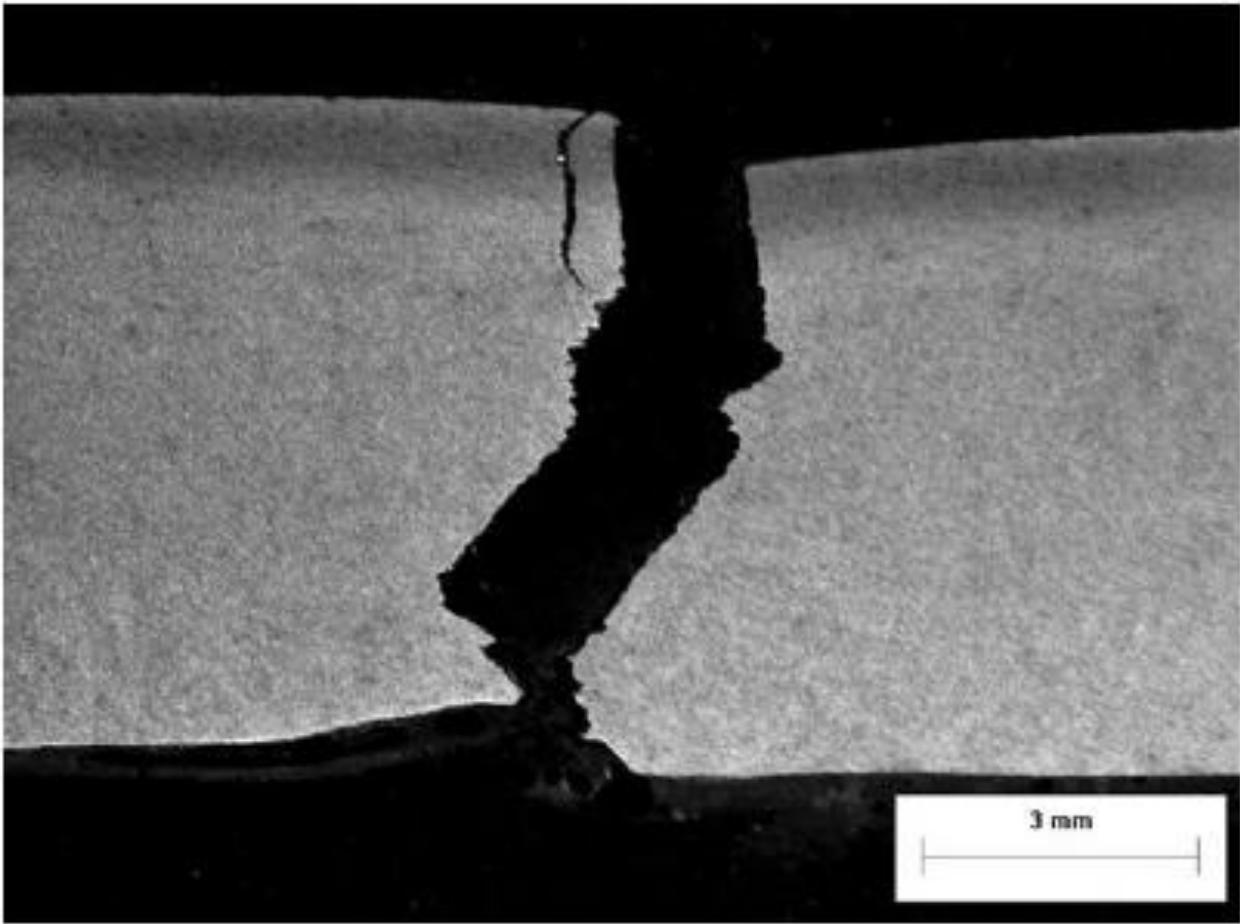
Figure 11. Photomicrograph of cracking initiating in a **hard spot**.

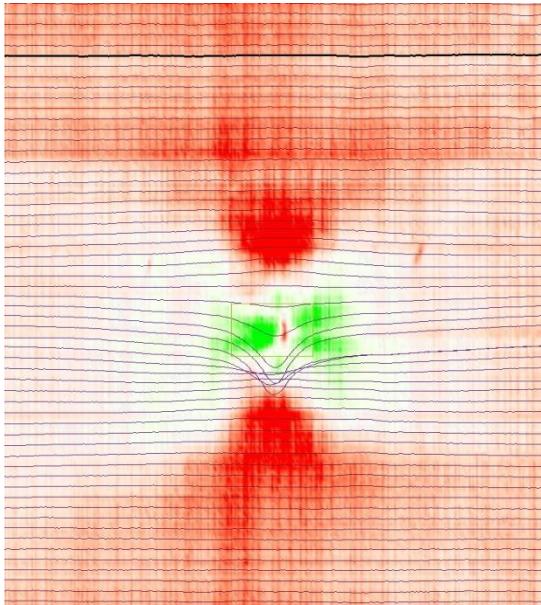
Re-rounded dent signature

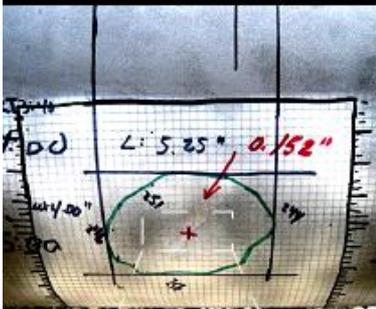
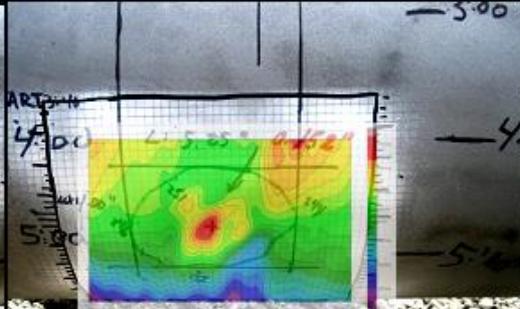
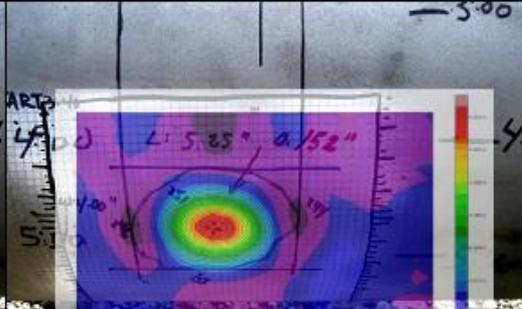
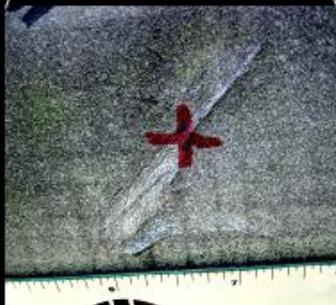
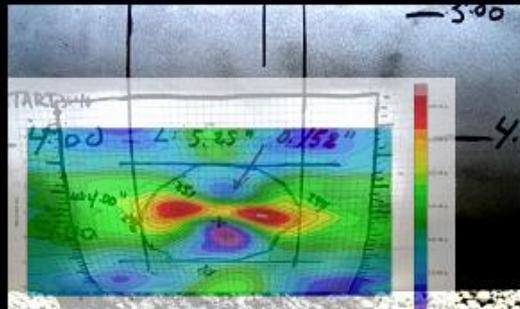
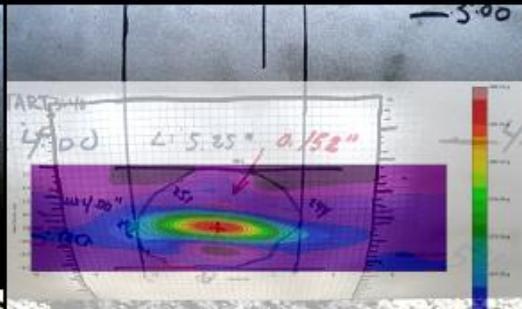
Dig 12-0160 with 0.95% dent, gouging and cracking

SMFL

DEF

LFM

MFL
