IN-LINE INSPECTION OF PIPES USING CORROSION RESISTANT ALLOYS (CRA)

M.Sc. Johannes Keuter
Rosen Technology and Research Center GmbH, Rosen Group
Am Seitenkanal 8
49811 Lingen
Germany
jkeuter@rosen-group.com

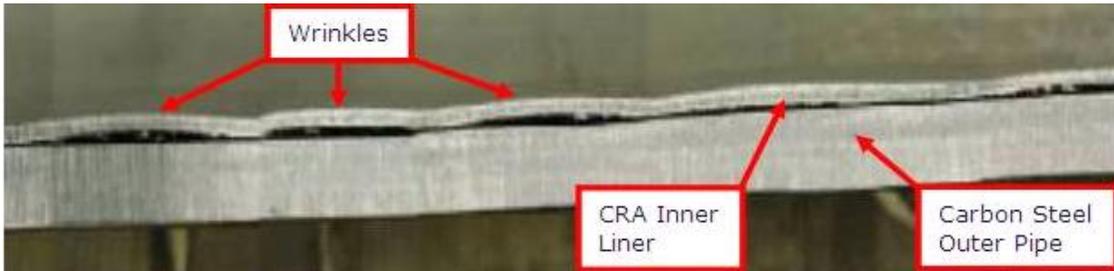
Figure 6: CRA Pipeline with defects (2)

Moreover there could be cracks within the stainless steel or carbon steel and pitting features in the corrosion resistant alloy. Also geometric deformations like dents, wrinkles or buckles, especially in lined pipes, and other defects like bonding flaws can occur. For this purpose Figure 5 and 6 show the possible defects of the carbon steel in corrosion resistant alloy pipe materials. Due to this it is necessary to inspect corrosion resistant alloy pipelines. Inline inspection technologies provide a solution for this need.

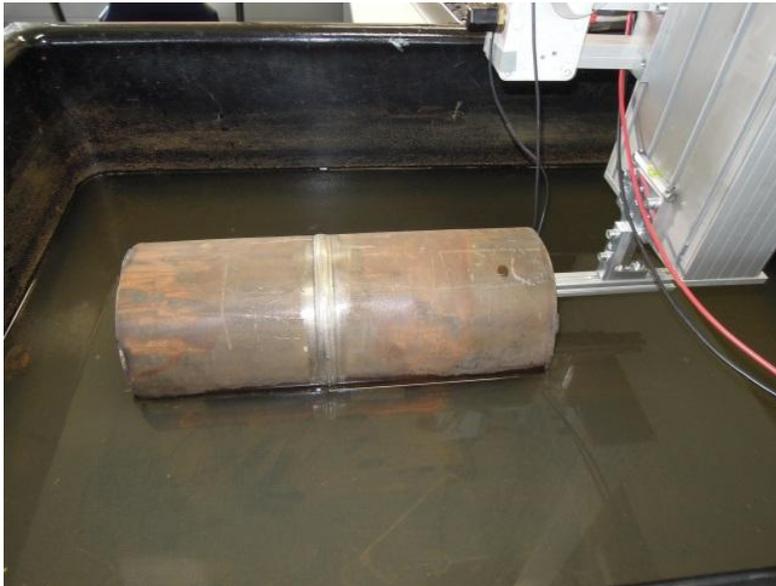
- 06 in spool
- 0.5 meter length
- Lining with Inconel alloy 825
- 15.9mm wall thickness of carbon steel
- 5.0mm wall thickness of CRA
-

Figure 26: Test setup for test with ultrasonic sensors

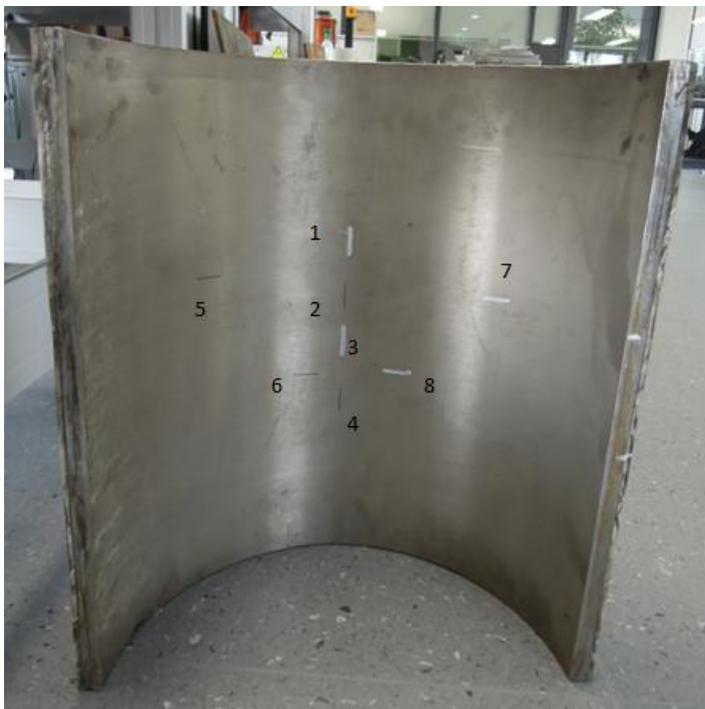
With this test setup a crack detection test was performed as well, illustrated by the following Figure.

Figure 30: UT crack detection test setup with 16in pipe spool
