NEW TECHNOLOGIES OF “SPETSNEFTEGAZ” MAGNETIC IN-LINE INSPECTION

*By: Dr.V.A. Kanaykin, Dr.B.V.Patramanskiy, Dr.V.E.Loskutov – “Spetsneftegaz” NPO” JSC,
Russia*

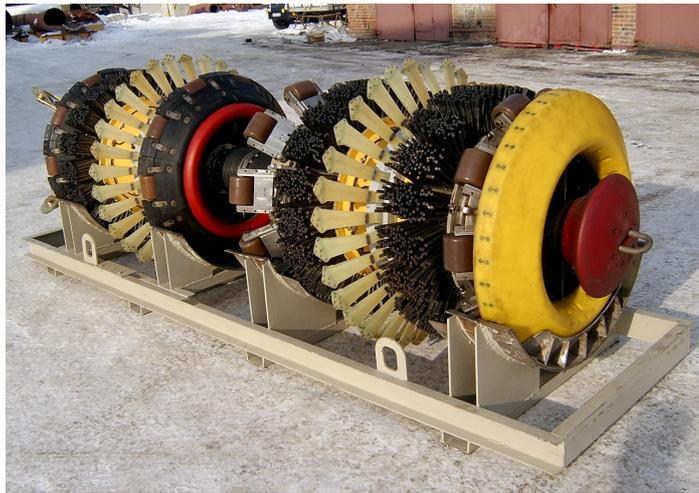
As far as the first trend is concerned, our specialists created the "inner vision" ILI tool, which is called intrascope or MFL+ type. This tool "clearly sees", like camera, only inner pipe wall defects on the basis of magnetic method. Its resolution ability is not worse than UT tool. This tool 30" diameter and a special pipe test stand is shown on the photo.

Artificial defects of various depth are made in the pipe pull test stand. Now look at the image of test stand pipe layout obtained by the MFL+ tool. As we know, ordinary MFL tool has the same resolution capability for outer and inner defects. However, photographic resolution ability of inner pipe wall defects is obtained only by MFL+ tool.
