ORMEN LANGE PIPELINE INSPECTION – A CLIMB TO SUCCESS

This paper presents a case study of a complex inline inspection (ILI) activity with multiple significant challenges that required innovative solutions to achieve an outcome of a safe and successful activity within required schedule and budget.

The Ormen Lange gas field, operated by A/S Norske Shell, is located in the southern part of the Norwegian continental shelf approximately 120km north-west of the Nyhamna gas and gas condensate processing plant in Gossa Island, Norway. The water depth in the field area ranges from 800m to 1,100m.

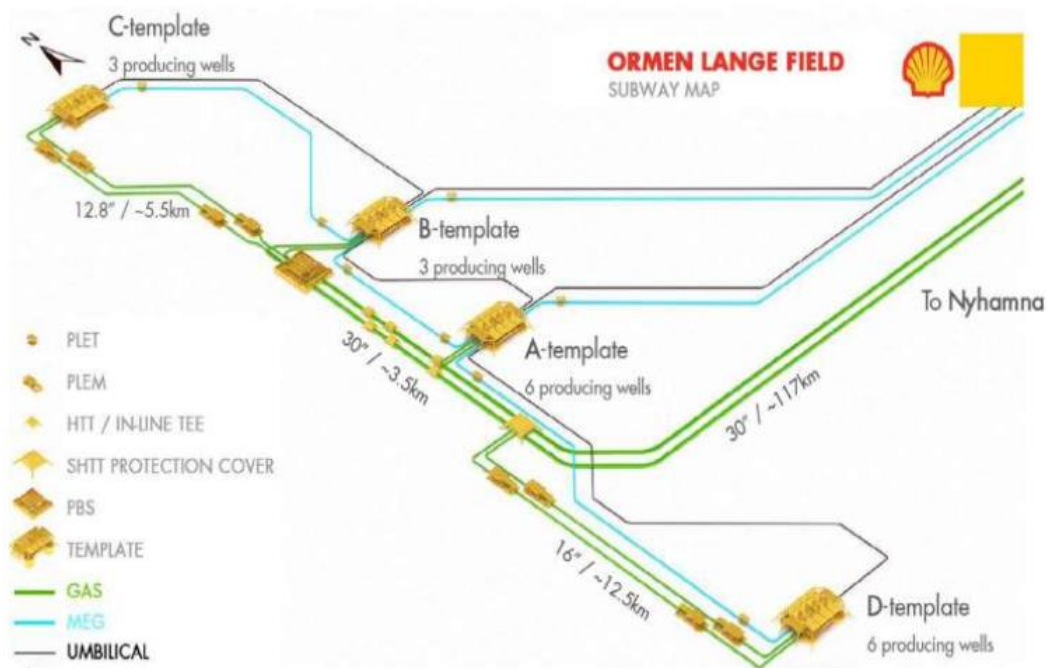
Figure 2: Ormen Lange Field Layout

Pigging System: Each pipeline is equipped with launcher/receiver stations, to conduct round trip pigging operations via a subsea pigging loop equipped with a subsea pigging valve. The system can be configured for bi-directional pigging operations. Dry export gas is used as the pigging medium supplied from the Nyhamna plant. Pigging operations requires subsea production to be shut in.

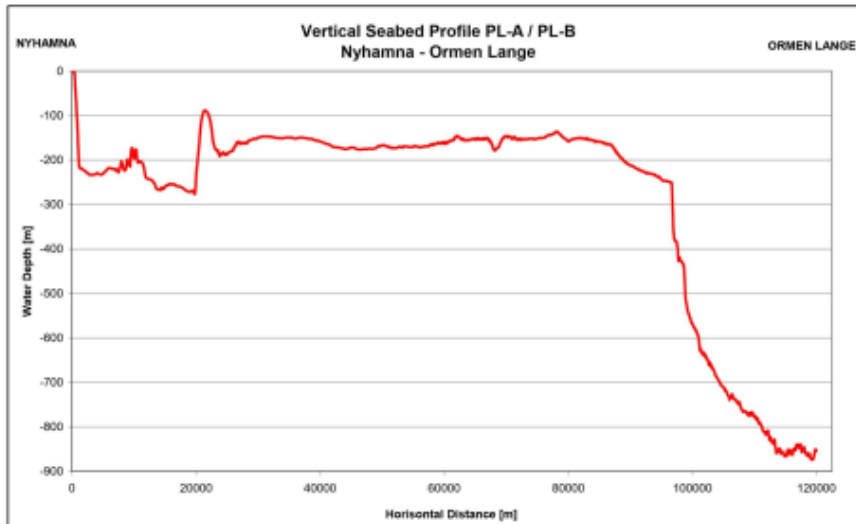
Figure 3: Vertical Seabed Profile Ormen Lange Pipeline

There was significant uncertainty regarding the transport mechanism of sand fines within the pipelines due to variations in pipeline profile and gravitational effects. Initial process design experiments suggested that fines would be transported by liquids within the pipeline. However, subsequent modelling predicted that up to 105 tonnes of sand deposits could have accumulated in each pipeline, resulting in a potential high case total accumulation of up to 210 tonnes across both pipelines. This volume if present and not well mitigated presented a high risk of creating a total blockage during pigging operations resulting in a high adverse consequence of a lengthy unplanned pipeline outage. This was considered by Ormen Lange stakeholders as an unacceptable outcome.

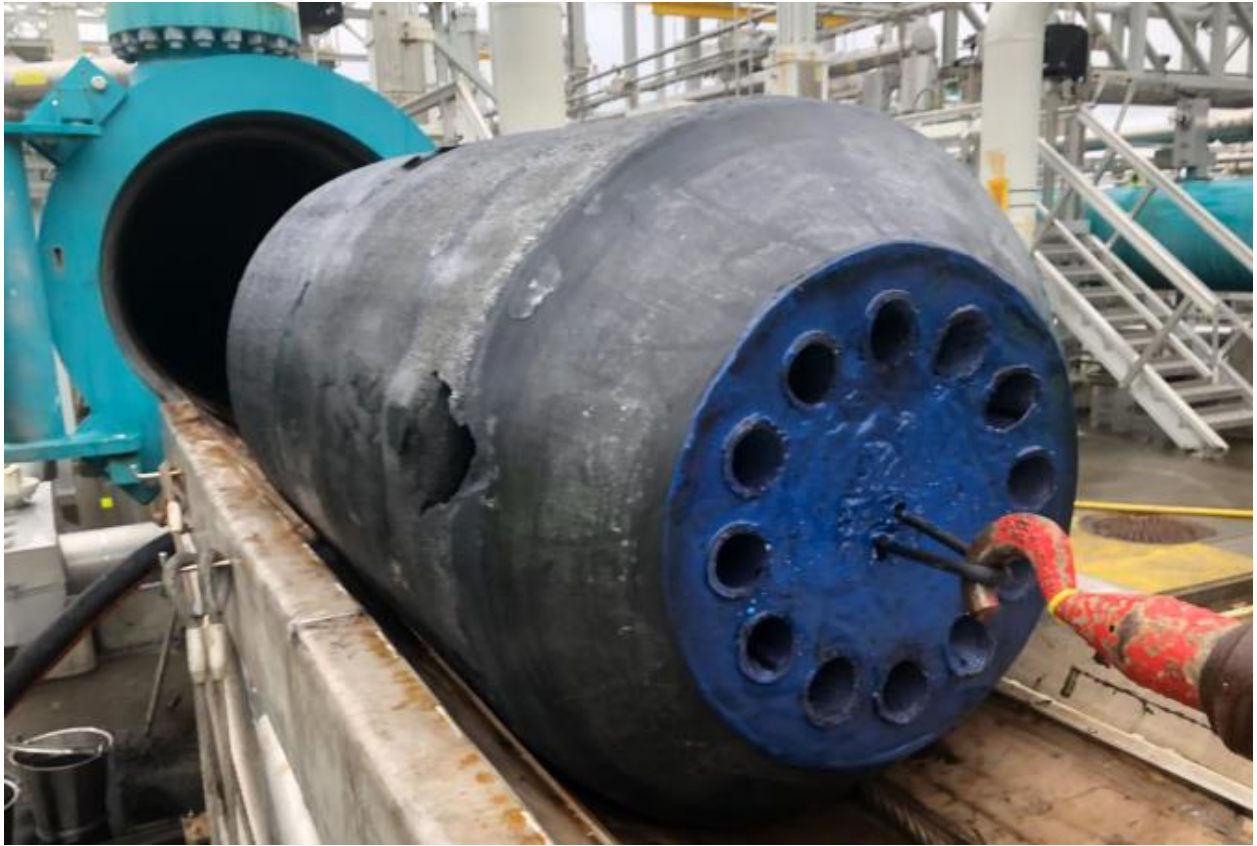
Figure 6: 98% Foam Pig Post run

A dummy Pathfinder foam pig, sized at 676 mm (98% of the pipeline ID of 690 mm), was run first to prove piggability. The dummy Pathfinder is identical in construction to the operational Pathfinder but is run without the embedded sensor system and electronic data pack being installed. Upon receipt, the condition was reviewed and assessed. This provided assurance to confirm or otherwise safe passage of the operational Pathfinder.

The undersized dummy Pathfinder was run at an average velocity of 4.4 m/s, though the velocity increased with pressure drop across the pipeline. The pig body sustained minor superficial damage, leading to the decision to proceed with the Pathfinder pig.

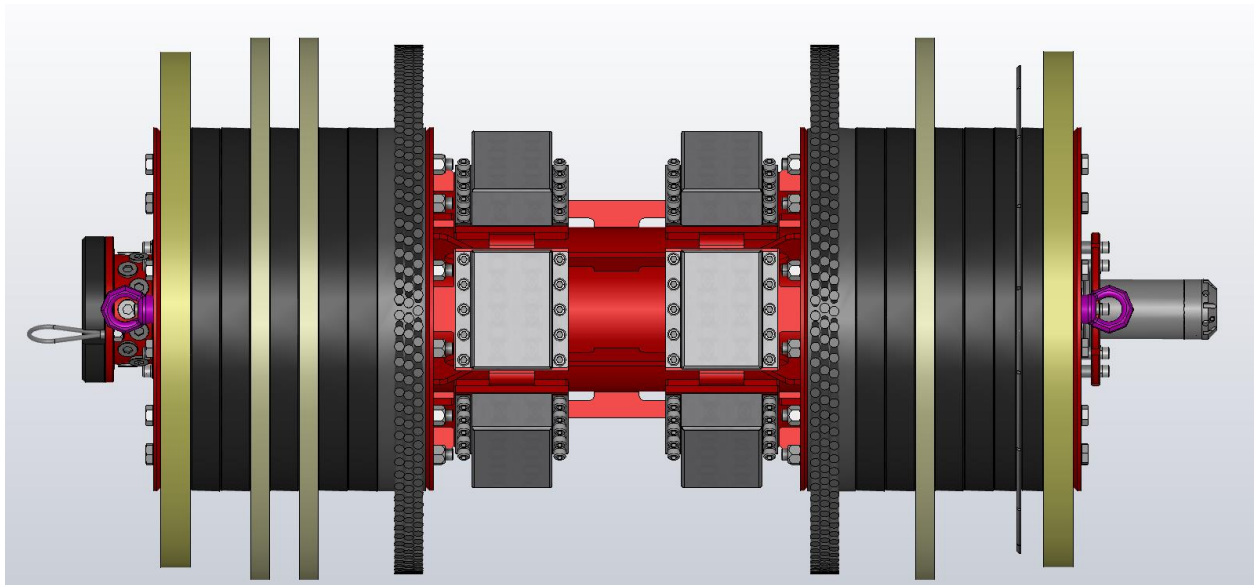
Figure 8: Gauge Pig

- Bi-Directional Gauge Pig: The campaign commenced with a bi-directional gauge pig designed to be reversed at low differential pressure (DP) if necessary. This feature allows for pipeline flow reversal in the event of a blockage, thereby reinstating production. A ROSEN Pipeline Data Logger (PDL) was attached to monitor significant DP buildup. The purpose of the PDL, equipped with accelerometers and gyros, was to assist in correlating tool location and identifying debris accumulation based upon data collected throughout the campaign.
- Bypass and Magnet Packs: Bypass mechanisms, similar to those used in Phase 1 with foam pigs, were incorporated to enhance debris flushing in front of the pig. Magnet packs were doubled to improve the removal of corrosion products. Undersized full guides were selected to reduce the risk of excessive wear.

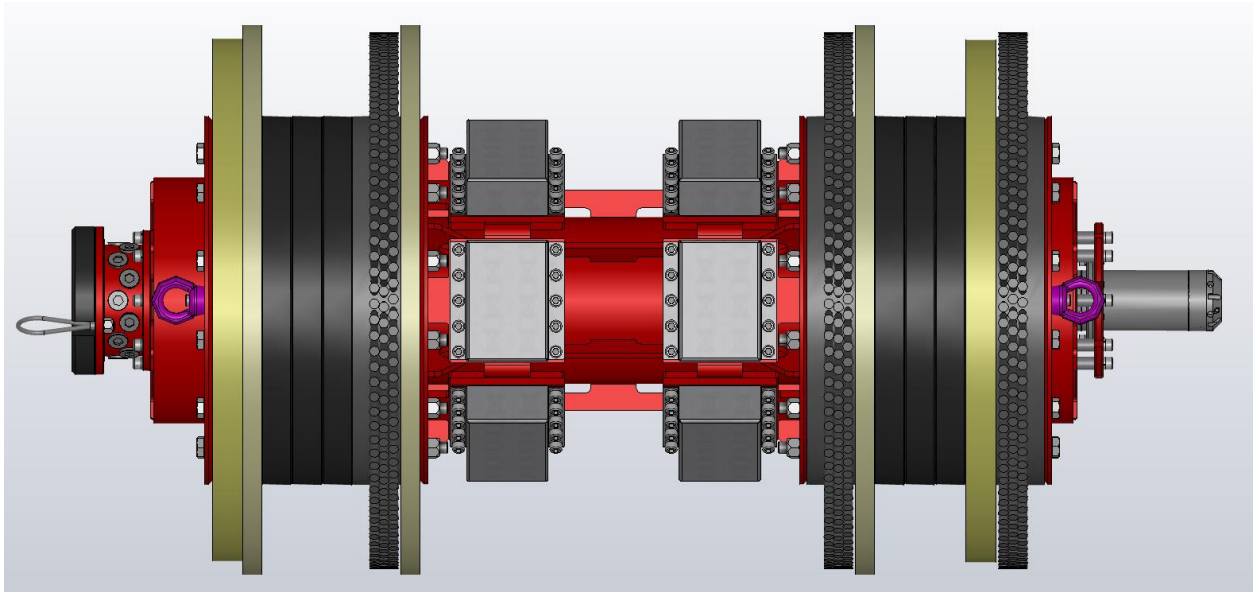
Figure 9: Brush - Mag Cleaning Pig

- Brush - Mag Cleaning Pig and Bulldozer Pig: The purpose of medium aggression cleaning pigs was to clean the pipeline effectively to a level where it would be considered sufficiently safe to proceed to running more aggressive pigs. Oversized discs were provided in order to offer higher aggression options. 4.2% bypass was installed on the pigs to maintain a high flushing effect. Data from the PDL was utilised for comparisons between cleaning runs, specifically for evidence of debris accumulations, which would present as DP spikes and potentially stop / start behaviour.

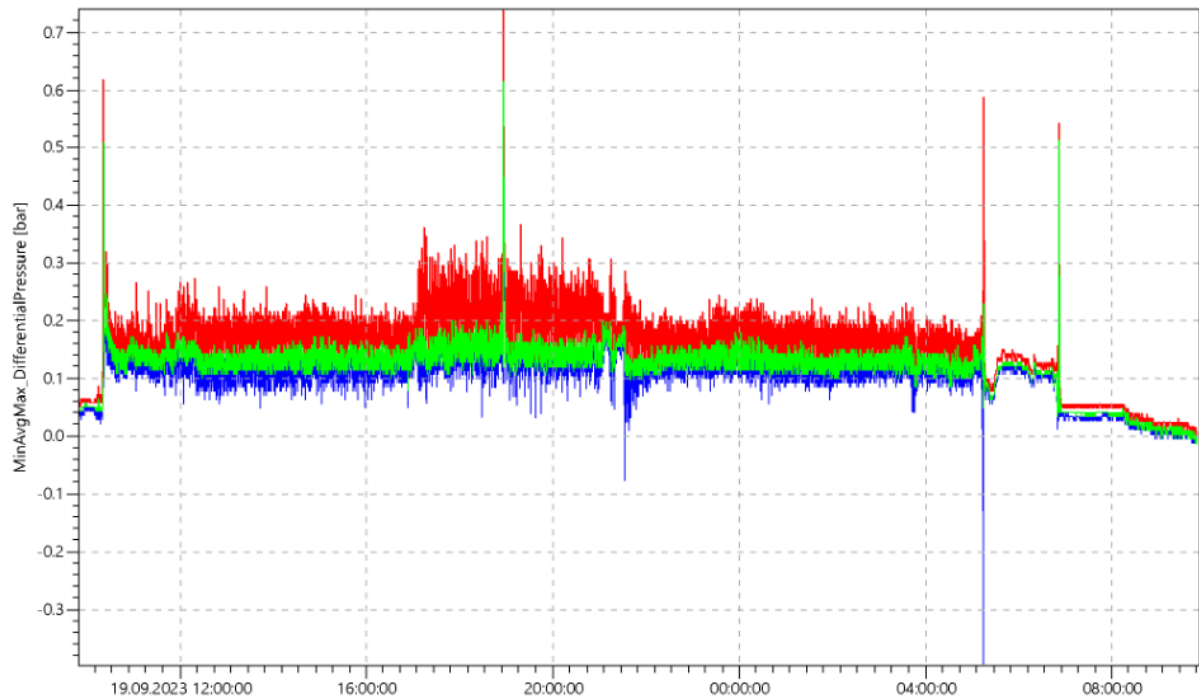
Figure 14: PDL Recorded Differential Pressure

The PDL data from the first gauge pig run did not reveal any significant DP spikes that could not be accounted for by known pipeline features. Based on this analysis, the decision was made to continue with the cleaning program as planned.

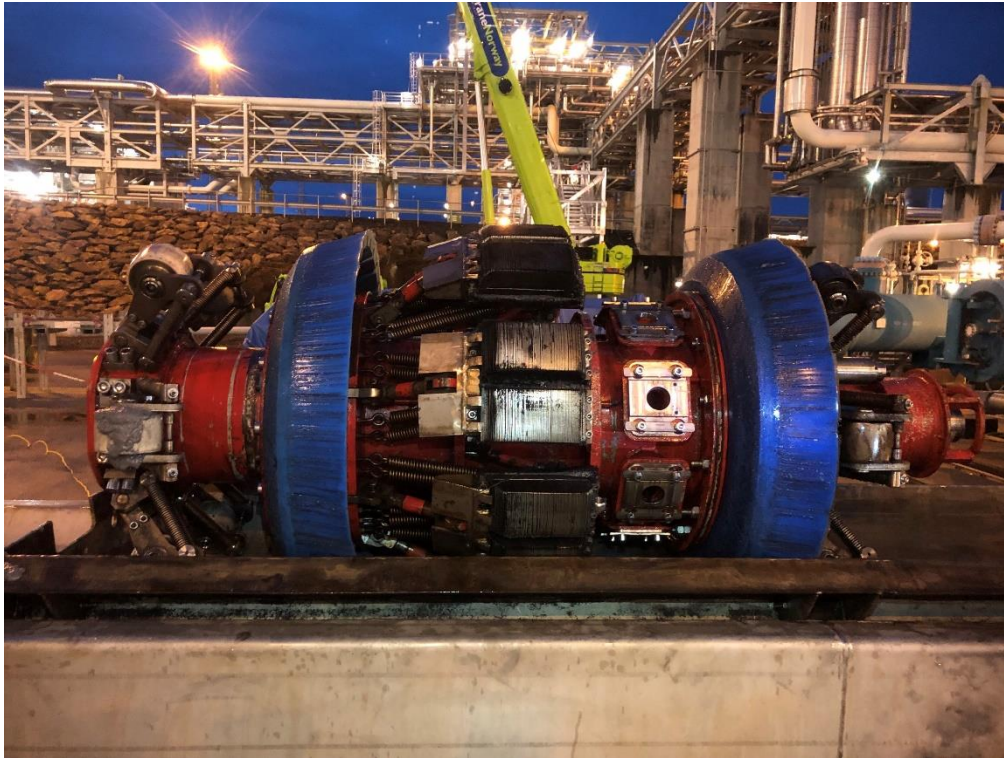
Figure 15: Run 4 ACT Post Run

Following the gauge pig run, the brush-mag cleaning pig and the bulldozer pig runs were successfully completed. Both runs were completed without any damage to the pigs or evidence of excessive DP according to the PDL data. These results indicate successful execution of the cleaning operations to date. As such a decision to progress the cleaning campaign onto the higher aggression pigs was taken.

Due to an observed increase in ferrous debris collected on the magnets, repeat runs of the ACT and the HDCP were requested. This additional cleaning as deemed necessary to address the higher levels of ferrous debris and ensure optimal pipeline condition and inspection accuracy.

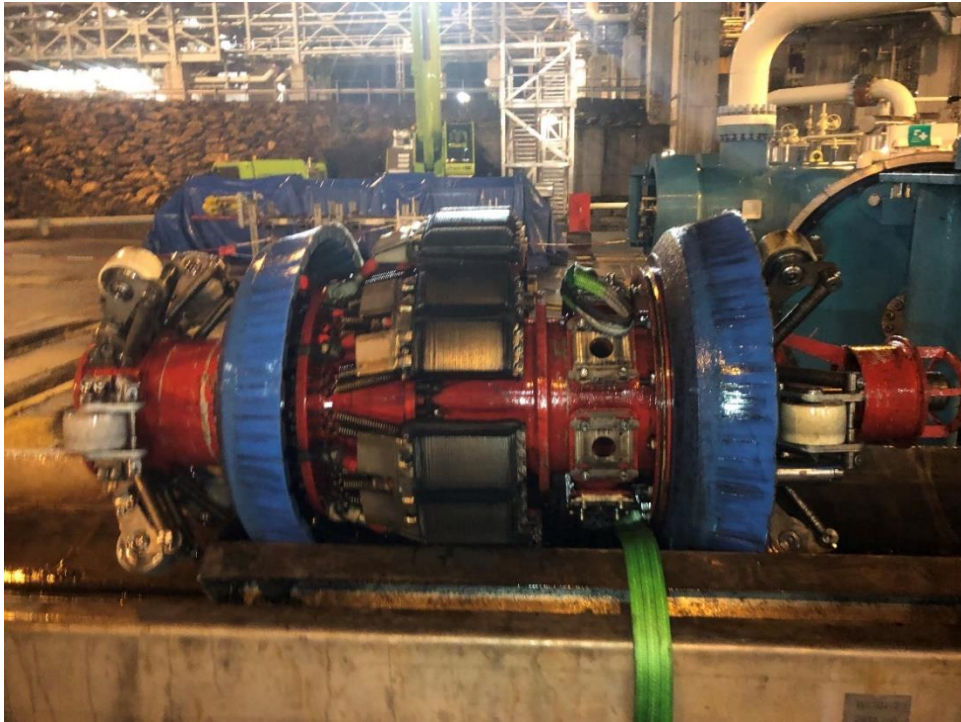
Figure 18: Run 6 ACT

Following a decrease in the amount of ferrous debris recovered the decision was made to proceed with the MFL A + IEC inspection. This decision was based on the improved condition of the pipeline and the reduction in debris, indicating readiness for the next phase of inspection.
