Visual Assessment of Pipeline Cleanliness for CCUS Conversion

A New Diagnostic Approach: Liverpool Bay Case Study

PPSA Conference - November 2025

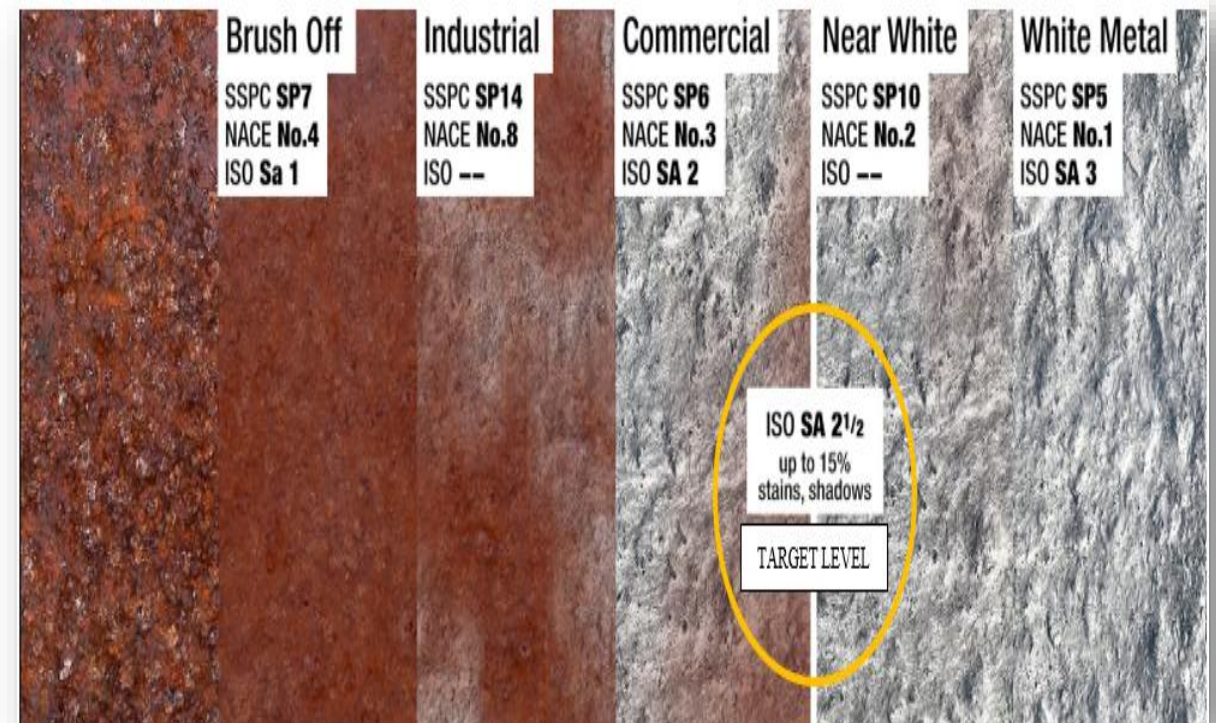
ISO 8501-1 Standard

- Mechanical and Chemical cleaning programme
- Structural integrity assessment
 - Inline Inspection (ILI) type tools
- Ensuring surface cleanliness of ISO SA 2.5 or better
 - Video assessment tool

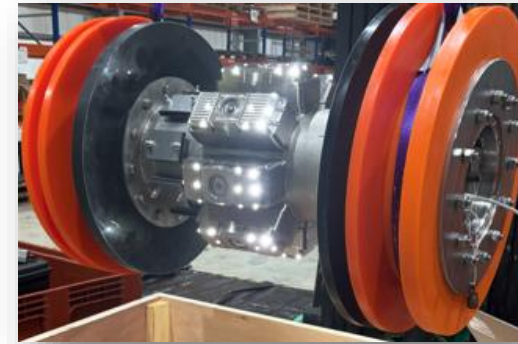
PigCAM®8

A multi-camera sideview array tool was deployed:

- 4 or 8 sideview array cameras to cover 360-degrees (10-36")
- Focuses directly on the pipe wall in high-resolution
- Operates for up to 96 hours continuously (176km)
- Has internal/onboard ODOMeters, azimuth & gyro (+0.5%)

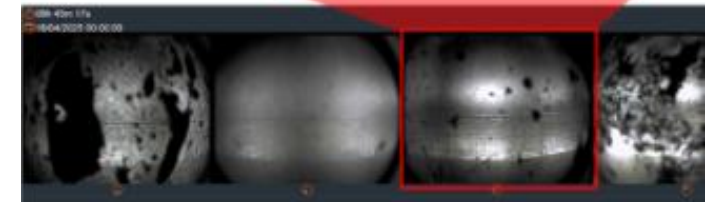
Gated "T"

- The 8-camera pig system was deployed to assess the internal condition and cleanliness of a 24", 27 km pipeline
- The inspection was deemed a success, with multiple areas of interest highlighted
- A gradual build-up of debris partially contaminated the camera lenses towards the end of the operation
 - Debris & liquid pooling was identified
