Evaluation of a High Resolution GEOPIG to detect and size Slab Erosion

Stephen Westwood

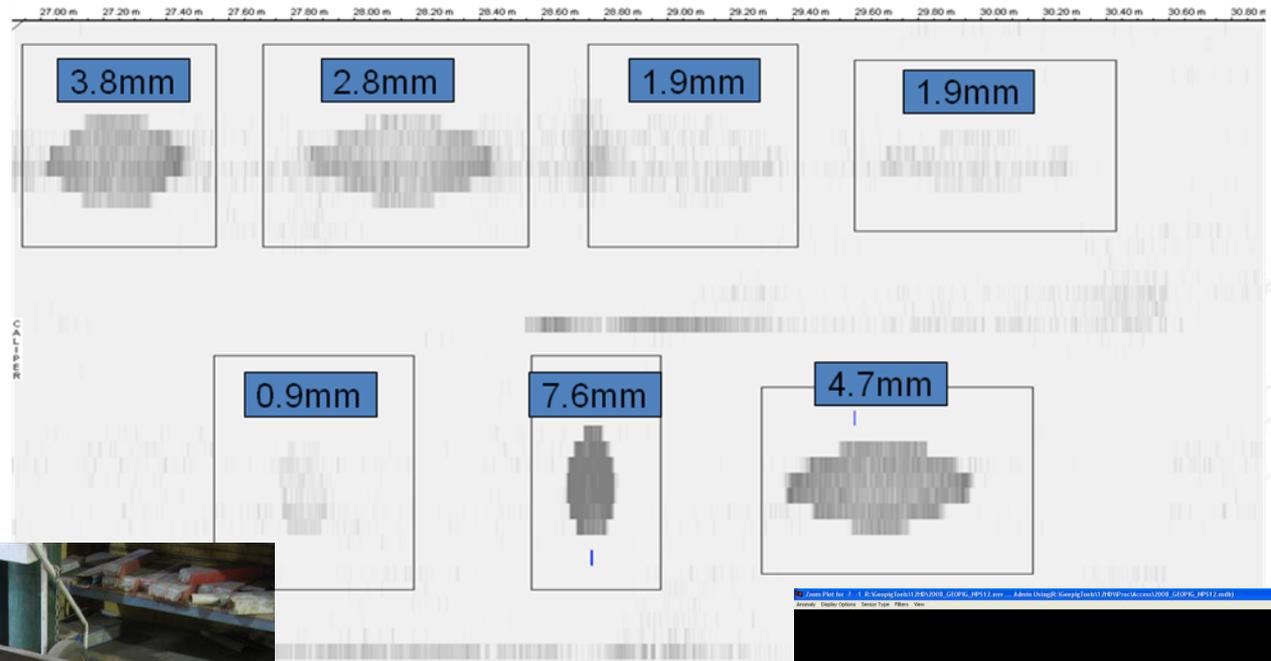
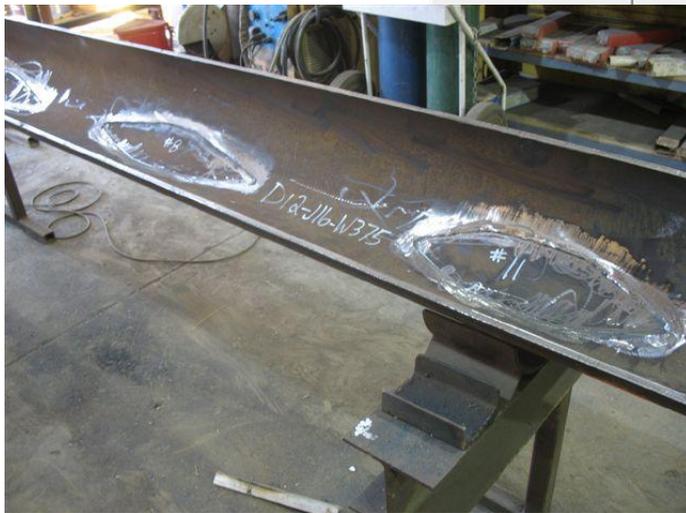
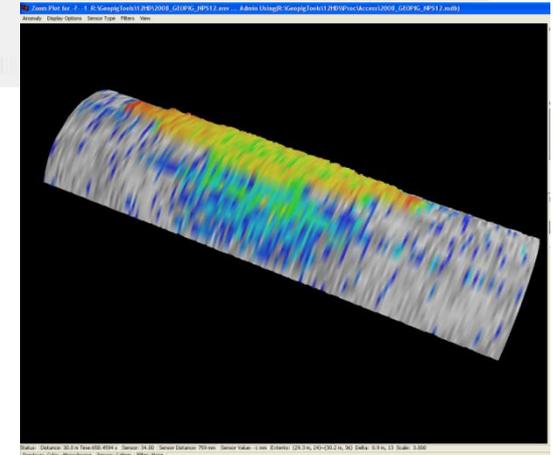
- First Series mimic Large Internal Defects
- Second Series mimic Slab Erosion

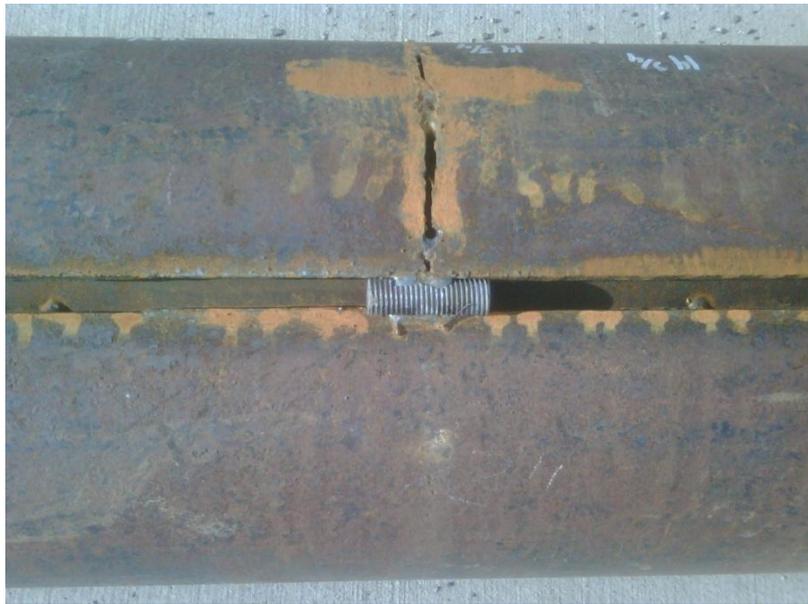
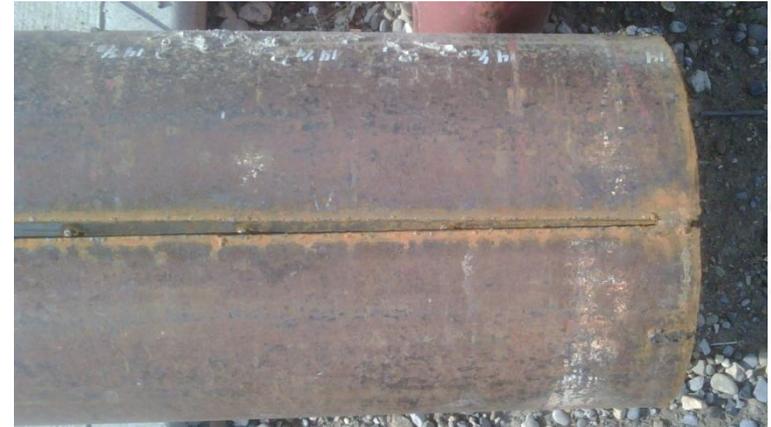
Slab Erosion Pull Test

- Special Defect Spool Made
- $\frac{1}{4}$ Section cut from Pipe
- Welded Back in as Two Tapers
