EXPERIENCES WITH ULTRASOUND IN WAX RICH PIPELINES

By: Roger Hunsbedt, Thomas Jung, Mikael Georgson, Alf Tordal, Kristine R. Martinsen
Statoil ASA

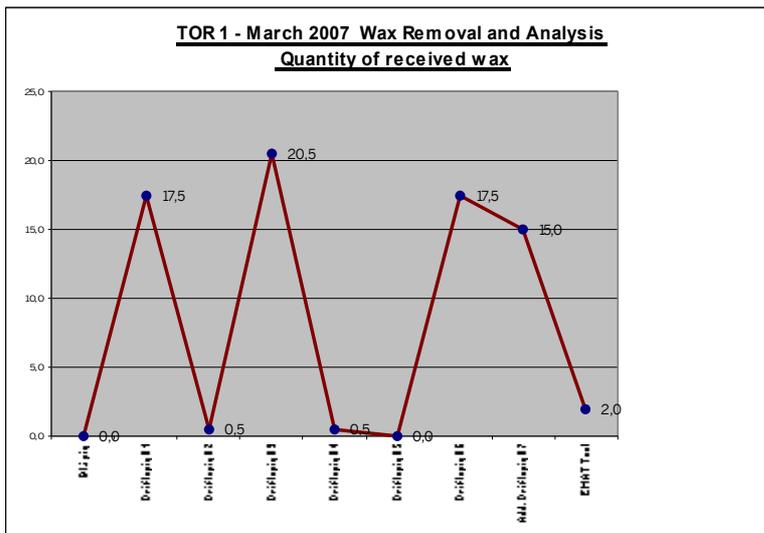
As a result the amount of received wax was rather moderate but varied significantly between pig runs as can be seen in the graph below.

Graph showing amount of wax per pig run

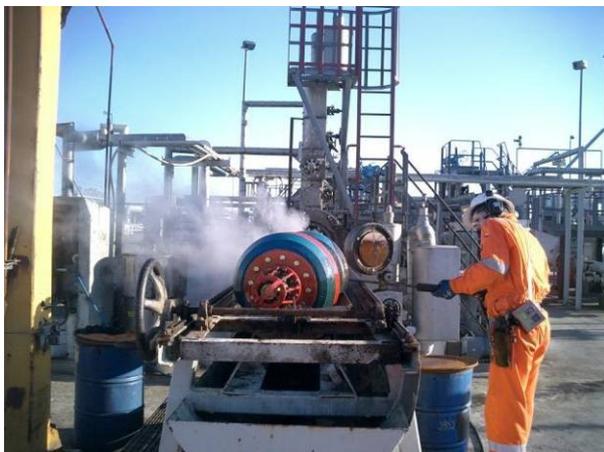
The survey indicated that

- The deepest (“thickest”) features were towards the end of the pipeline
- The features were expected mainly between 10:00 and 12:00 orientation

Eddy Current - based ILI in receiver tray at Mongstad

The results from this survey did tell us we had some wax still in the pipeline. It was difficult to draw any significant good conclusions from the results of this survey.

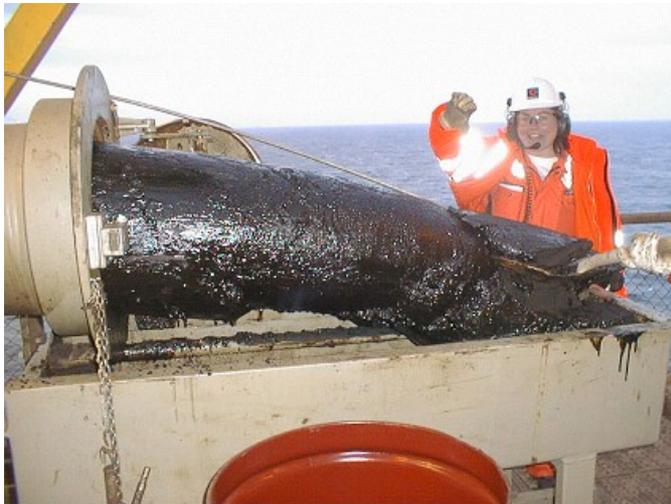
Famous picture from Statfjord B, this pipeline is also successfully inspected.
