UNPIGGABLE PIPELINES – WHAT A CHALLENGE FOR IN-LINE INSPECTION!

By Dr. Rainer Schmidt, 3P Services, Lingen, Germany

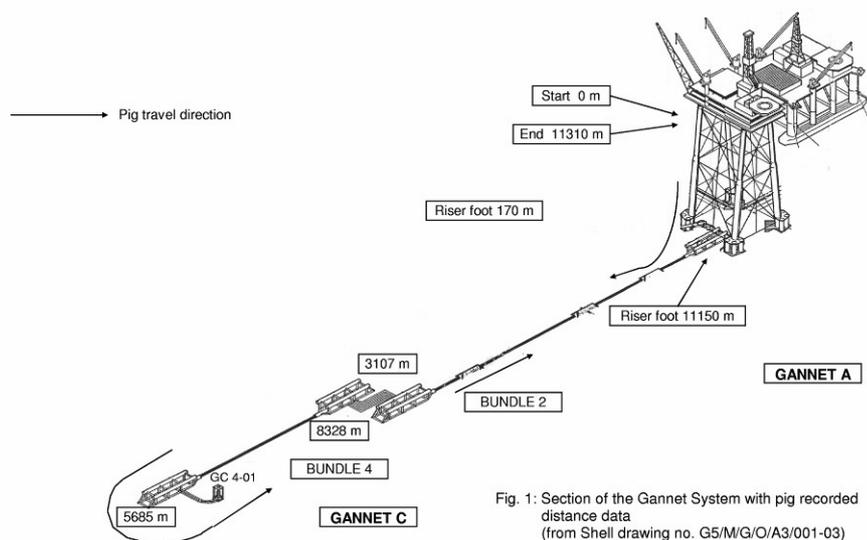
Pipeline description: Offshore flowlines 4", wall thickness ½", designed as a hair pin loop starting from the Gannet A platform (Central North Sea), passing by two subsea production templates and back to Gannet A (see Fig. 2). The total length is 11.7 km. There are flexible riser sections at the foot of the platform and bend radius of 5D within the risers.

Fig. 1: Section of the Gannet System with pig recorded distance data (from Shell drawing no. G5/M/G/O/A3/001-03)

Fig. 2: (Case history no. 2) Schematics of the flowline Gannet A

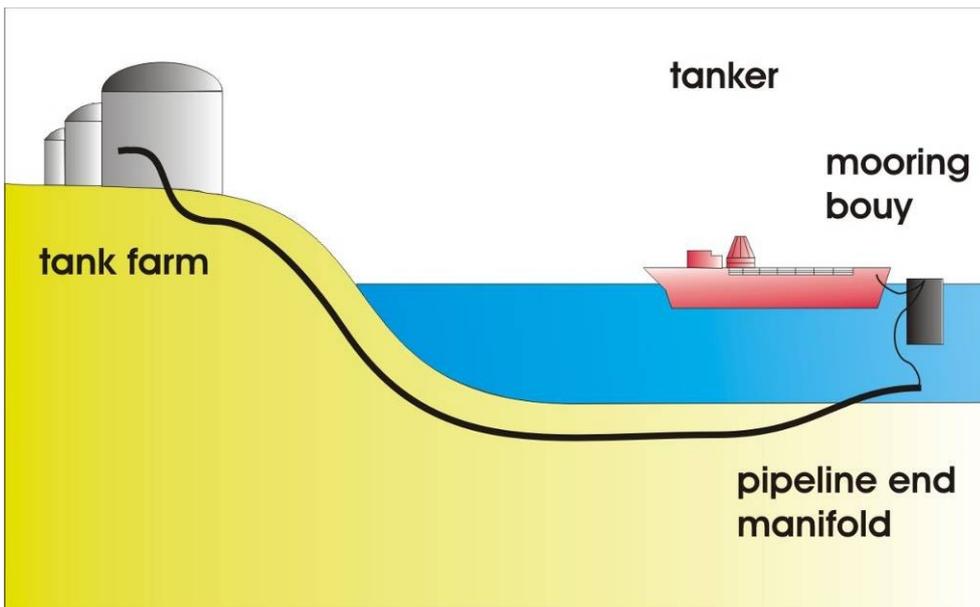
Pipeline description: 36" – 9 km long tanker un-loading pipeline, connecting the offshore pipeline end manifold with the tank farm onshore (see Fig. 4).

Fig. 4: (Case history no. 3) Schematics of the tanker unloading facilities

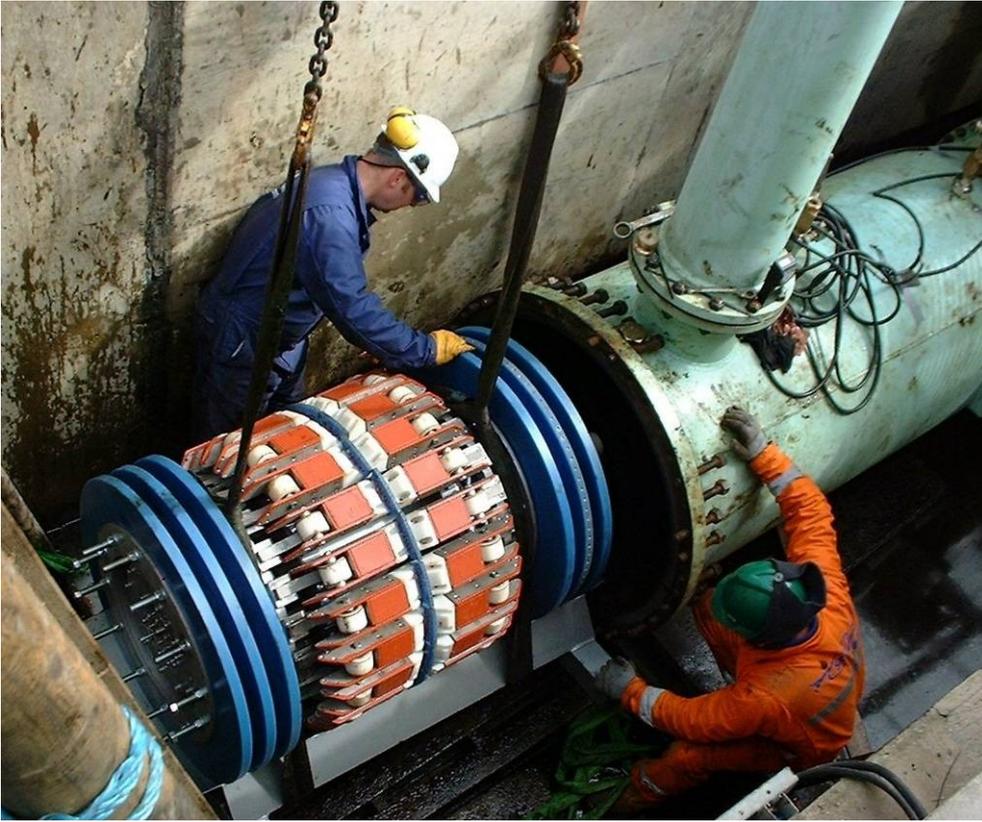
Performance: The client installed a temporary pig trap at the tank farm. The MFL tool (see Fig. 5) was pumped by sea water towards the pipeline end manifold located on the sea bottom underneath the tanker unloading buoy. The contaminated water was pumped into a tanker moored for this purpose at the pipeline end. The tool returned to shore by reverse flow pumped from the tanker.

Fig. 5: (Case history no. 3) Bi-directional 36" MFL pig
