## **PIPELINE INTEGRITY ANALYSIS BASED ON INTERDISCIPLINARY COOPERATION**

This paper presents an overview of the validation process undertaken on a 51 km (32-mile) section of 457 mm (18-inch) pipeline. This pipe section was inspected in 1999 and again in 2003 by the same inspection company. This provided an opportunity to evaluate improvements in inspection technology, assess repeatability of performance and develop an engineering based approach to review, analyze, and validate high-resolution metal loss MFL data. Field verification and data validation included the use of several NDE techniques to acquire field measurements to overlay and compare to the ILI inspection data.

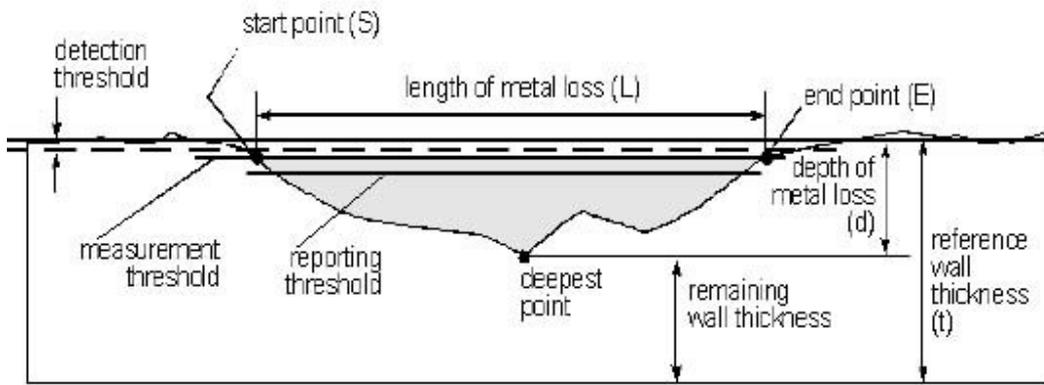
Figure 4 – Metal Loss Profile

This is to be expected. The depth and length measurements that define feature categories in the POF document cannot be duplicated in the field. Length and width measurements are obscured by the fact that the tool will report dimensions based on the threshold-of-detection profile-line, (refer to Fig. 4 “Metal Loss Profile”), typically 0.05t, while the field measurement will be from the zero depth profile line. This can lead to significant differences as can be seen in Fig. 4 and reflected in the Feature Prediction graph.

- The length and width of features measured in the field does not necessarily relate exactly to the dimensions predicted by the tool. The tool will report length and width based on the reporting threshold and the threshold of detection profile-line, while field measurements will be from the zero depth profile. (refer to Fig. 4, “Metal Loss Profile”)

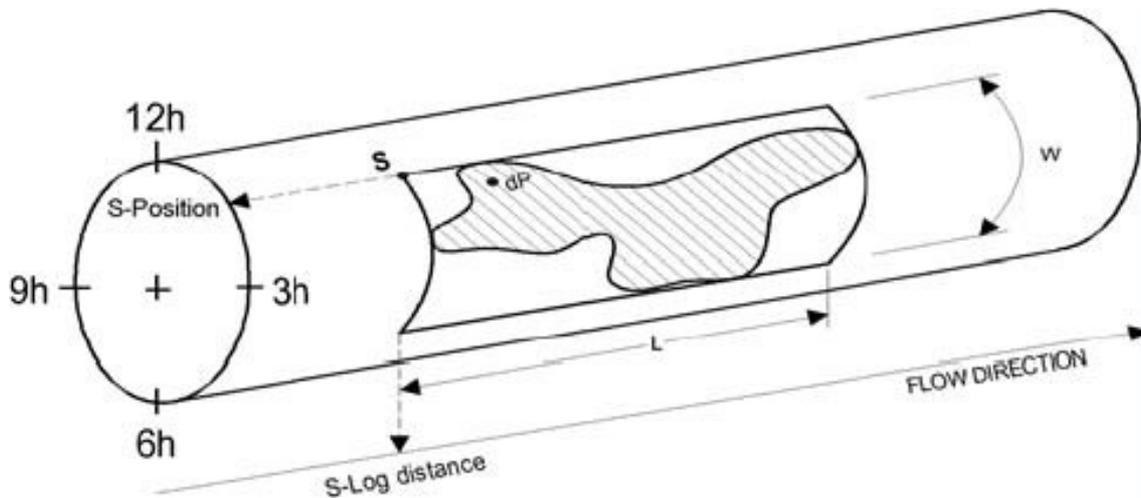
Figure 7 – Metal Loss Orientation (POF)

- There can be issues with the methods used to locate features on the pipe. The ILI Service Provider will enclose the signal from a feature in a rectangular box with dimensions equal to the length and width of the feature. The location of feature from the upstream girth, and its circumferential position on the pipe, will be referenced to the upper left corner of this box (S). This is the method recognized in the POF document (Fig. 7, “Metal Loss Orientation”) and used as a standard by most ILI Service Providers.
