October 2017

Pigging Industry News

the newsletter of the Pigging Products & Services Association

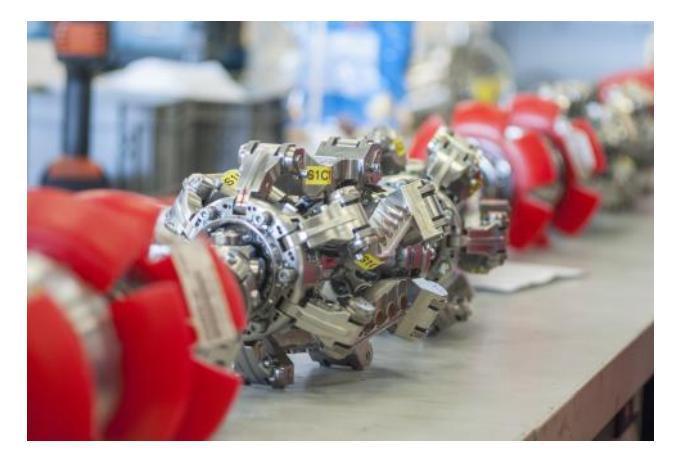
Key functions implemented into the RoCD UT-C fleet include 1.5D bend capability, precise sensor guidance with a central tensioning system, and well-known full data gathering for the whole pipe surface.

ROSEN made no compromises in overall runtime, inspection speed, and sensor resolution to develop this tool. Key functions of the RoCD UT-C fleet like 1.5D bend capability, precise sensor guidance with a central tensioning system, as well as the well-known full data gathering for the whole pipe surface have been implemented. With measurement data for every point in the pipeline, ROSEN delivers run-to-run comparison capabilities as well as analysis below the reporting threshold. Best-in-class passage capabilities of 122 mm inner pipeline diameter and an overall tool length below 4.5 meters will allow operators to use this solution in the majority of the existing 6" pipeline systems, without having to deal with the limitations of the past.

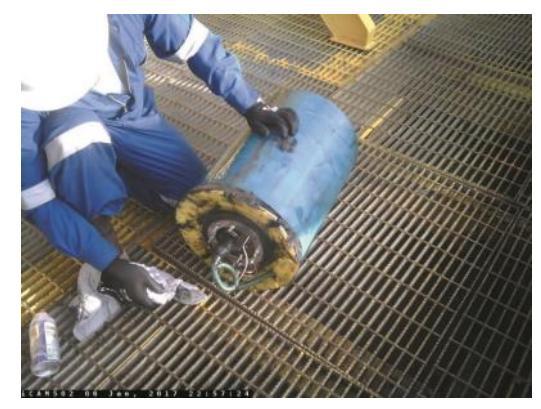
SmartFoamTM pig with rear-mounted DDMD at receive.

For those reasons, **i2i Pipelines** have developed a simple and innovative product that can attach to an i2i SmartFoamTM to locate and quantify the amount of debris in the line – introducing the DDMD or Dent and Deposit Mapping Disc.

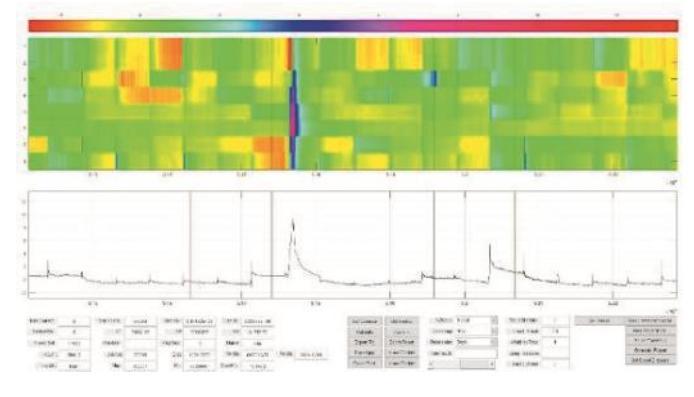
False colour image and sensor output showing wax distribution in waves along the length of the pipeline.

I2i recently completed an operation in the Far East for a client with a strategically important offshore 16" pipeline. Frequent pigging led the client to realise that the pipeline was badly affected by wax to the extent that only under-sized foam pigs could be run. In need of an inspection solution for the pipeline as well as a desire to gather any flow assurance information on the line drove the client to contract i2i for a SmartfoamTM inspection solution, with the added benefit of the DDMD attached to the rear of the pig. Not only did the SmartFoamTM tool successfully inspect the pipeline, the addition of the DDMD enabled the wax deposits to be mapped and quantified through the pipeline and a total volume of wax calculated.

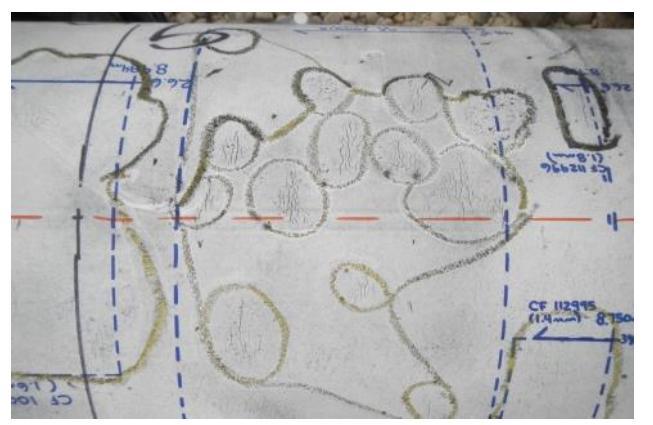
Several positively validated circumferential crack fields

Displayed above is an image that shows several positively validated circumferential cracks in a section of a pipeline. Clearly visible in the image, the third-party dig verified the presence of the features reported by NDT Global. Although circumferentially-orientated cracks are unique and not as frequent a threat as axial, for instance, the knowledge and experience that NDT Global's team possesses puts them in a position to deliver comprehensive inspection reports. The experienced data analysis team correlates information from previous runs, further enhancing the service offering. NDT Global's ability to rely on an industry-leading range of ILI tools, and how they capture data relating to defects, enables the team to take into consideration all types of cracking. The existing integrity assessment methodologies used for axial cracking can be used for circumferential cracks or flaws. Resultantly, the team ensures that it delivers the best possible data, used as

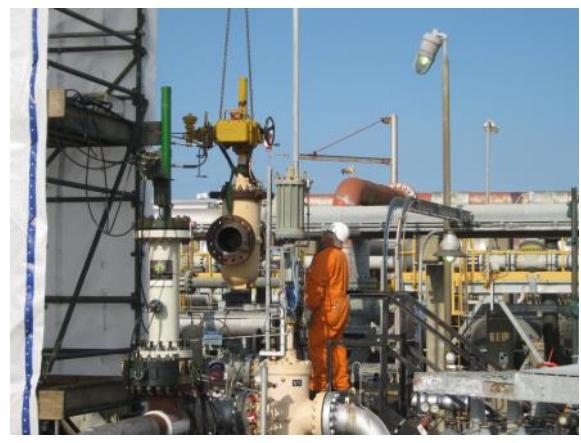
BISEP® isolation allows 10" launcher valve removal

The BISEP® isolation is provided by a spherical dual seal plug, deployed from a pressure competent launcher through a slab valve and rotated towards the pressure threat. The spherical head houses twin compression seals and provides a facility to bleed the seal annulus (void) providing a zero-energy zone between the fully proven seals. The annulus bleed port is initially used to test each seal at 110% of the isolated pressure, it is then used to constantly monitor the isolation during the intervention work.

The elastomeric seals are activated by a hydraulic cylinder inside the plug, which compresses the seals. The resultant radial expansion pushes the seals out against the pipe bore. Venting the pressure downstream of the plug causes a piston effect on the plugging head, which acts to further energise the seals providing leak -tight isolation, even in corroded or pitted pipework. A differential pressure across the plug enhances the hydraulic actuation and maintain both seals, even with no hydraulic pressure present. This self-energisation feature makes the isolation fail-safe with dual redundancy in activation, providing the specified minimum differential pressure is maintained.

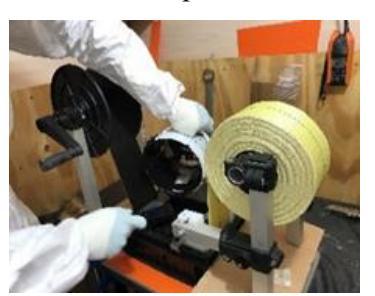
BOBIPREG - 3X specific machine for Kevlar[®] tape impregnation
